History of Construction

December 2019

Report of the Expert Panel on the Technical Causes of the Failure of Feijão Dam I
Appendix A – History of Construction

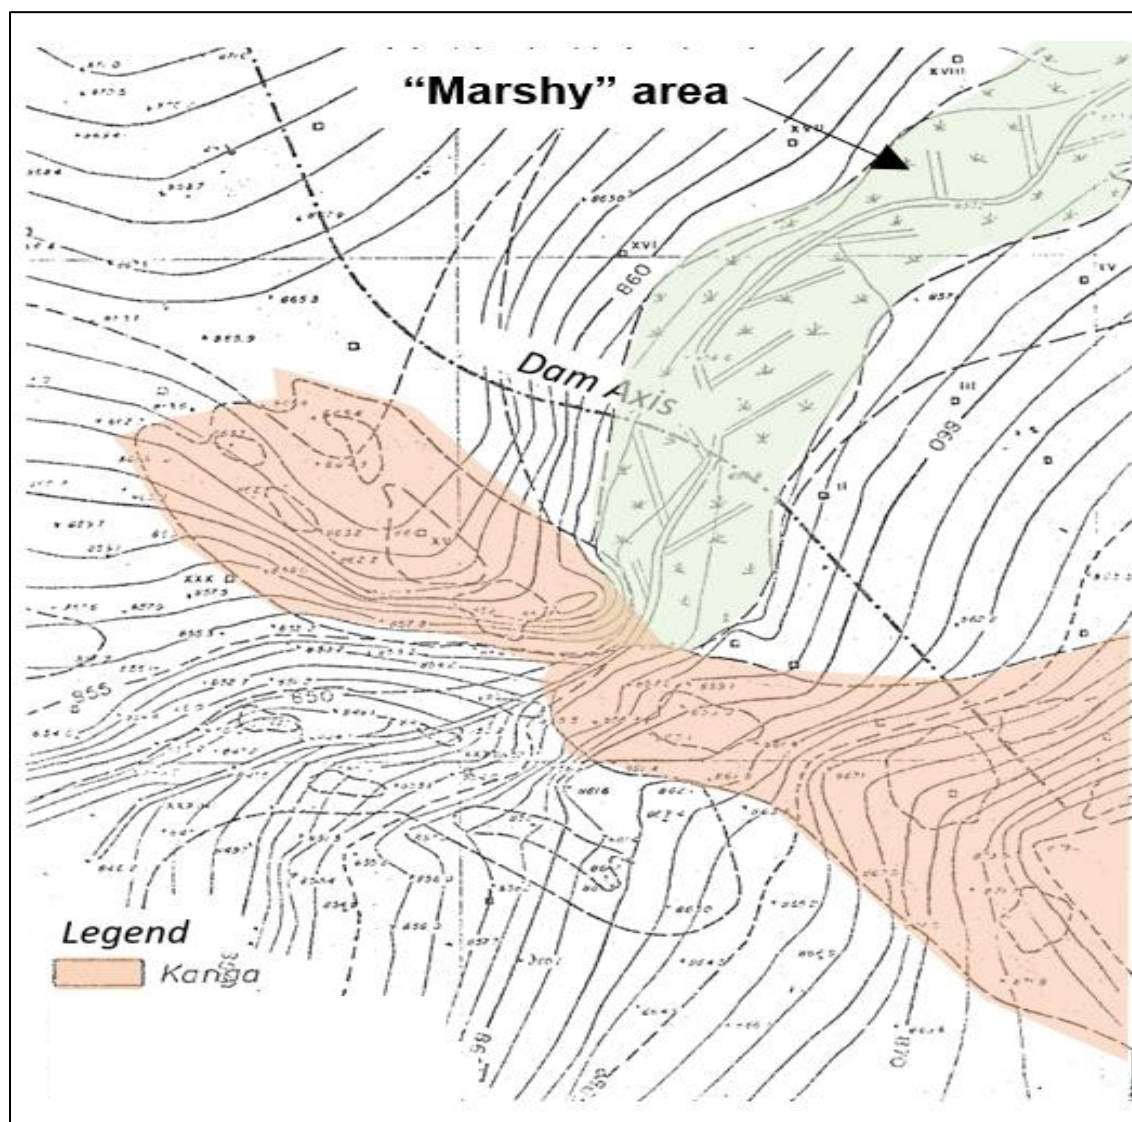
Figure 6: Site Conditions Before Dam I Construction¹⁹

as being covered “without exception” by stiff laterite “red earth” soils having a high proportion of silt. The description further suggests that the laterite soils were covered with a layer of broken quartz and ore rubble having a thickness of less than 0.3 m. The site was characterized as good for building an impoundment because the surface was covered with water-holding cohesive soils having a thickness of at least 0.5 m.¹⁷

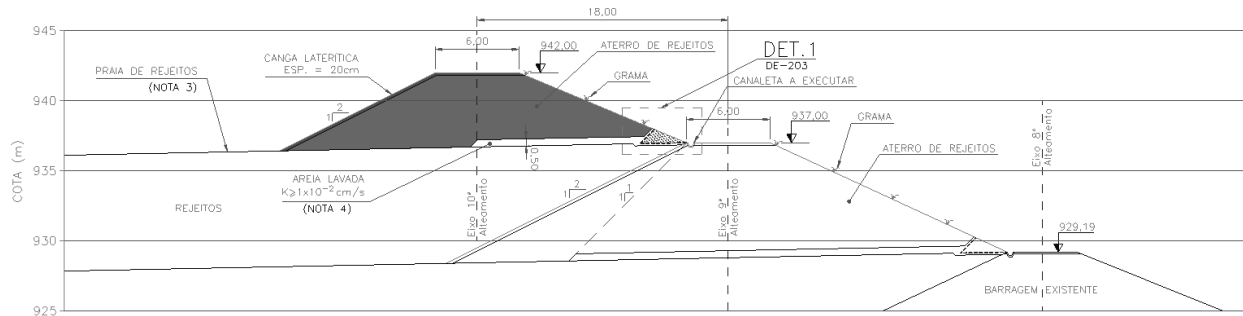
Figure 29: Ninth and Tenth Raising As-Built²¹⁸

specifications were not available. Also, no reports of materials used for construction were found; however, subsequent reports indicate that the Ninth Raising was constructed using compacted clay instead of the tailings that were called for in the design.²¹⁷

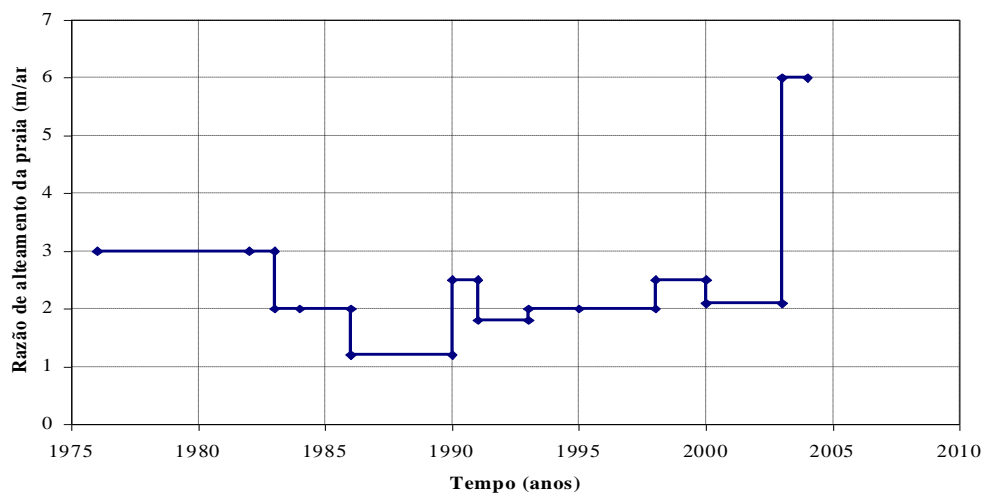
Figure 30: Ninth and Tenth Raising Design Loading²²¹

The design report indicated that the anticipated filling rate of the impoundment behind the dam would be approximately 2 m to 3 m per year after the construction of the Ninth Raising.²¹⁹ However, the actual filling progressed at 6 m per year (Figure 30).²²⁰

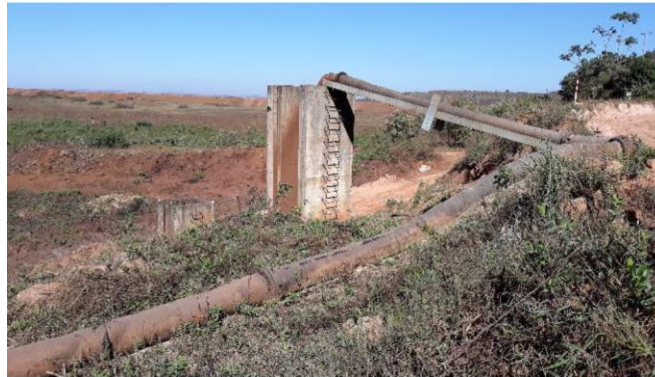
Figure 31: Impoundment Dewatering System After Tailings Disposal Ceased²³³

located far from the decant tower, preventing drainage to the towers by gravity flow. Dewatering efforts therefore required pumping water from the standing water area to the decant tower, from which surface water flowed to Dam VI. Therefore, to maintain the low surface water levels, a pump and piping system was designed and installed after the dewatering of the impoundment was completed in mid-2016. The system consisted of a pump system connected to a discharge pipe that routed water to the decant tower (Figure 31).²³² A backup pump was required in case the primary pump failed. The system was only put into operation in late 2018.

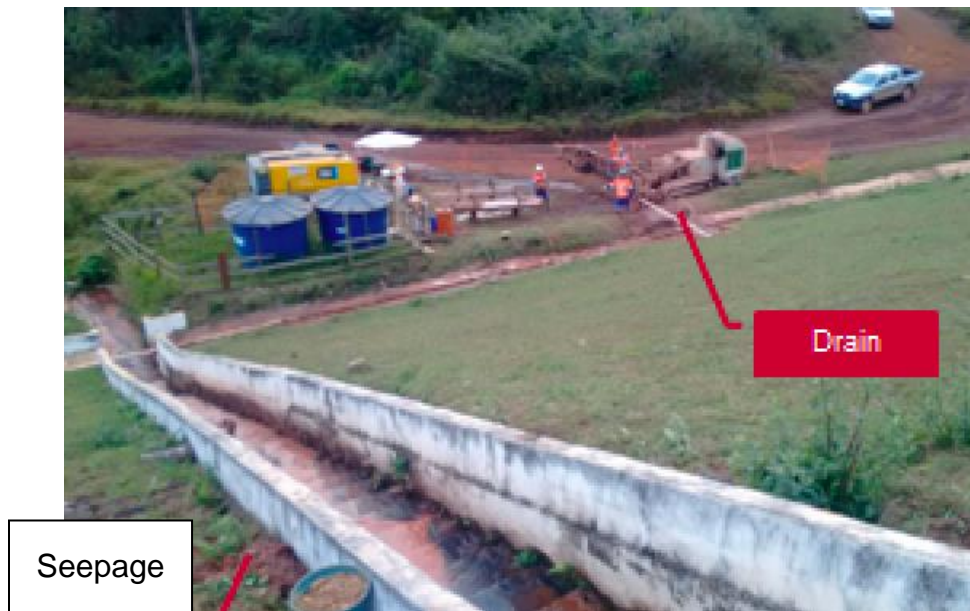
Figure 33: Location of Observed Seepage Near DHP 15²⁵²

The installation of DHP 15 began on the morning of June 11, 2018 by drilling a pre-bored hole through the Starter Dam. Drilling stopped temporarily between 12 and 1 pm for a lunch break.²⁵⁰ When drilling resumed, problems were encountered that included: (i) loss of pressure in the borehole as it crossed from the berm to the tailings; (ii) loss of water recirculation in the borehole, preventing advancement of the borehole; and (iii) apparent collapse of the hole around the drill rod and loss of the drill rod in the hole. At some time between 2:00 pm and 4:30 pm, localized discharge of water and fines was observed near a surface channel approximately 15 m away and 7 m higher than where DHP 15 was being installed, as shown in Figure 33.²⁵¹ The ground based radar detected small but rapid deformation in an area slightly above DHP 15, as described in Appendix D. Subsequent analysis of nearby seismograph records performed by the Panel is described in Appendix I.
