## **3D Computer Model Development**

**December 2019**

**Report of the Expert Panel on the Technical Causes of the Failure of Feijão Dam I**  
**Appendix F – 3D Computer Model Development**

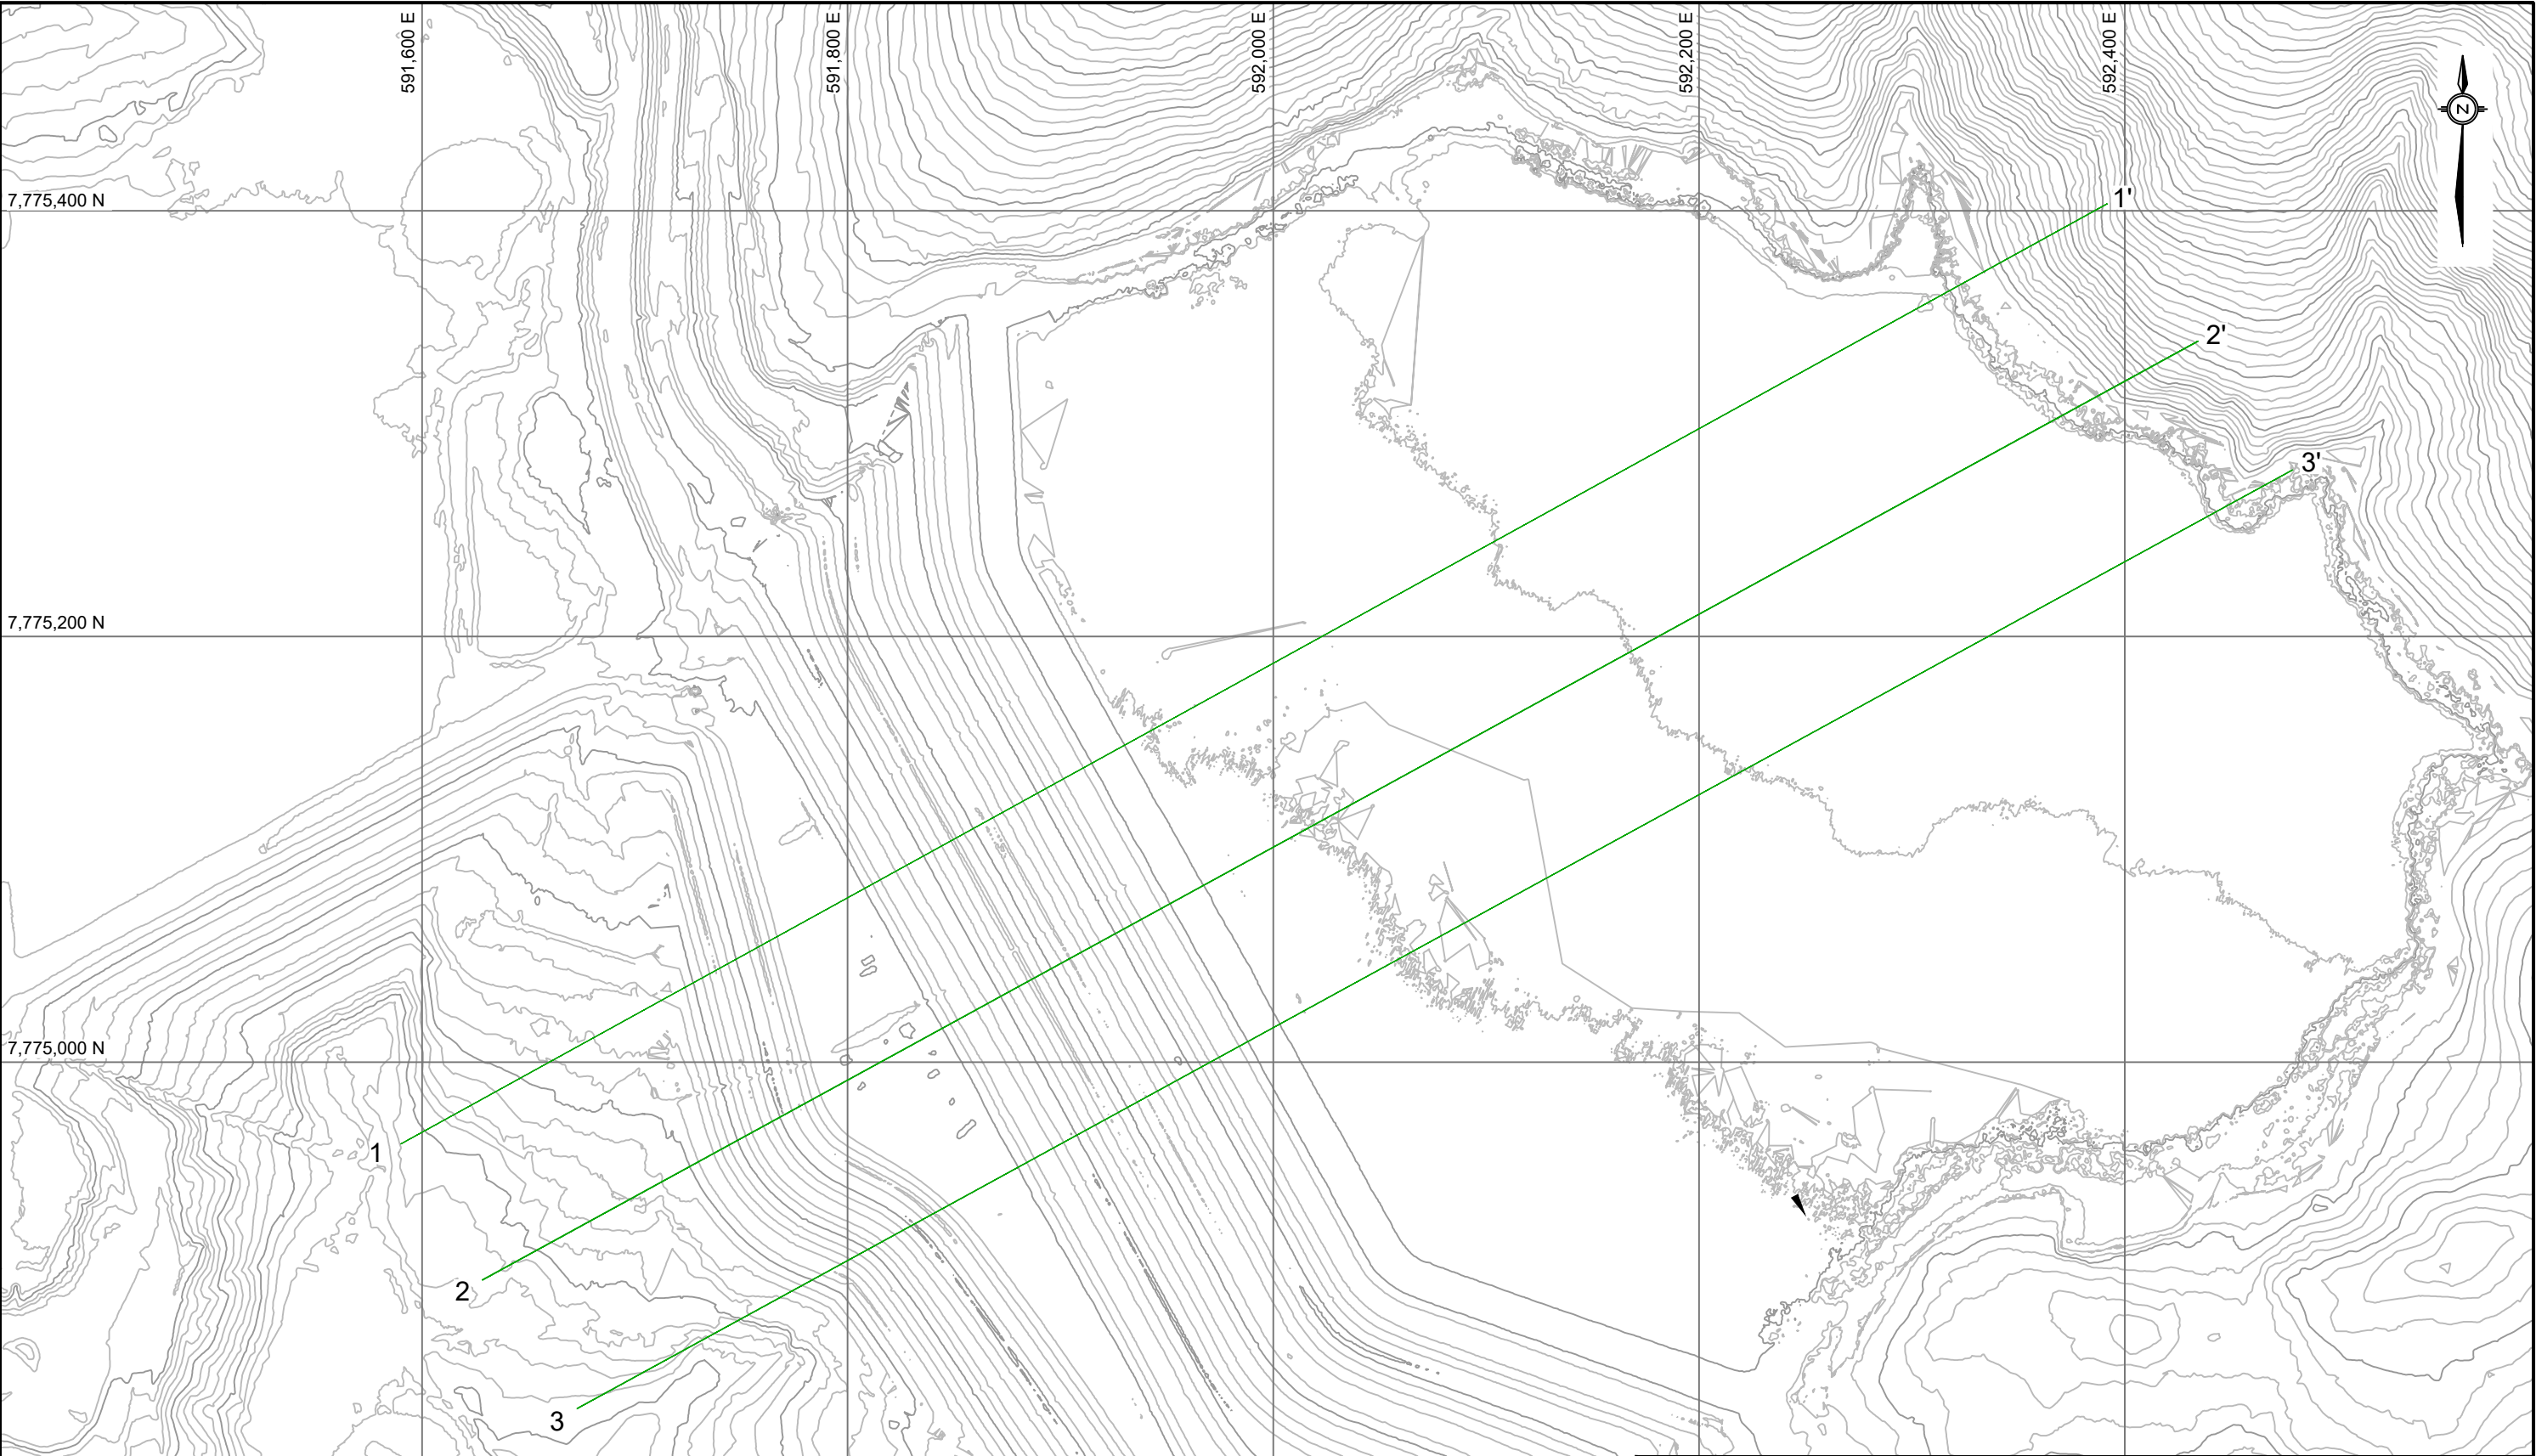
SCALE	PROJECT No.	FIG. No.
1:3,000	A03355A01	1

A summary of the topographic surveys used as part of the 3D computer model development is provided in Table 2. Figure 1 in Annex 1 provides a plan view of the Dam I design sections (1-1', 2-2' and 3-3') used to develop the 2D sections. Figure 2 of Annex 1 provides a profile view through Dam I at each of the three design sections shown in Figure 1.

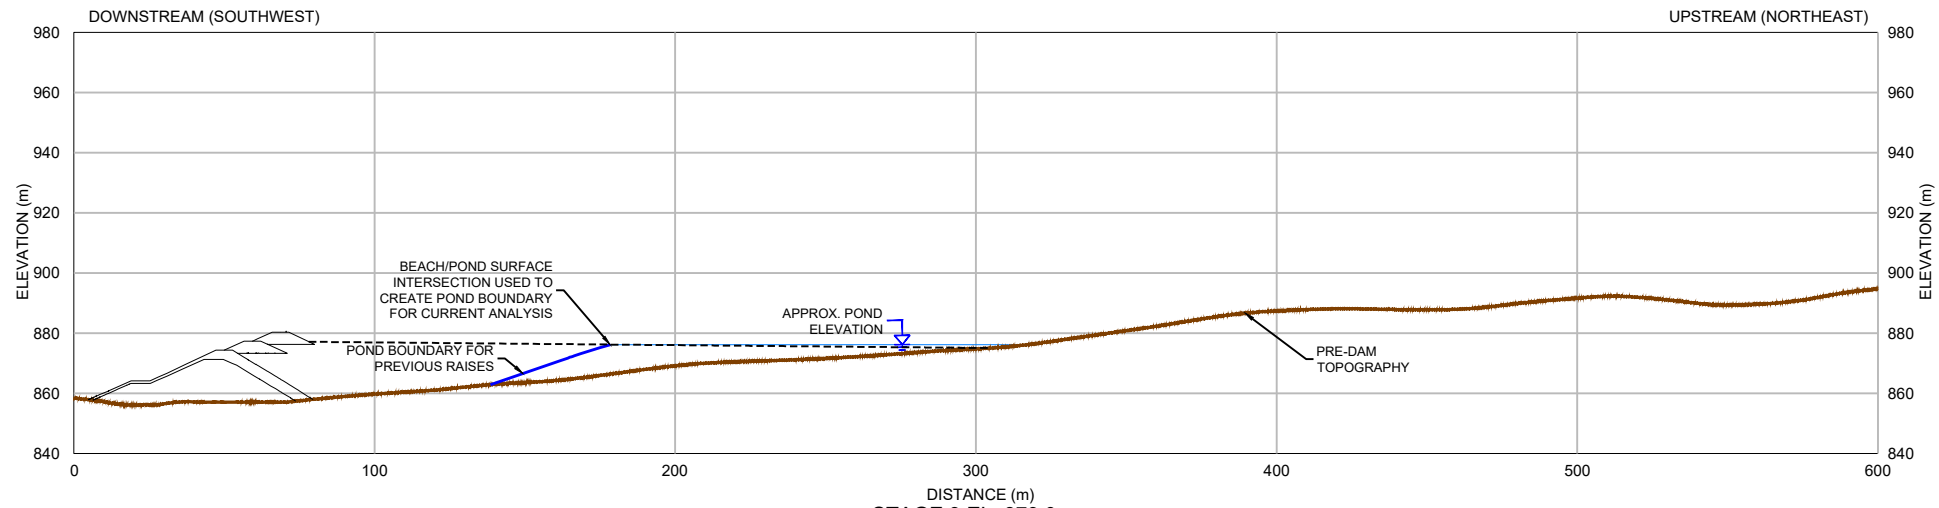
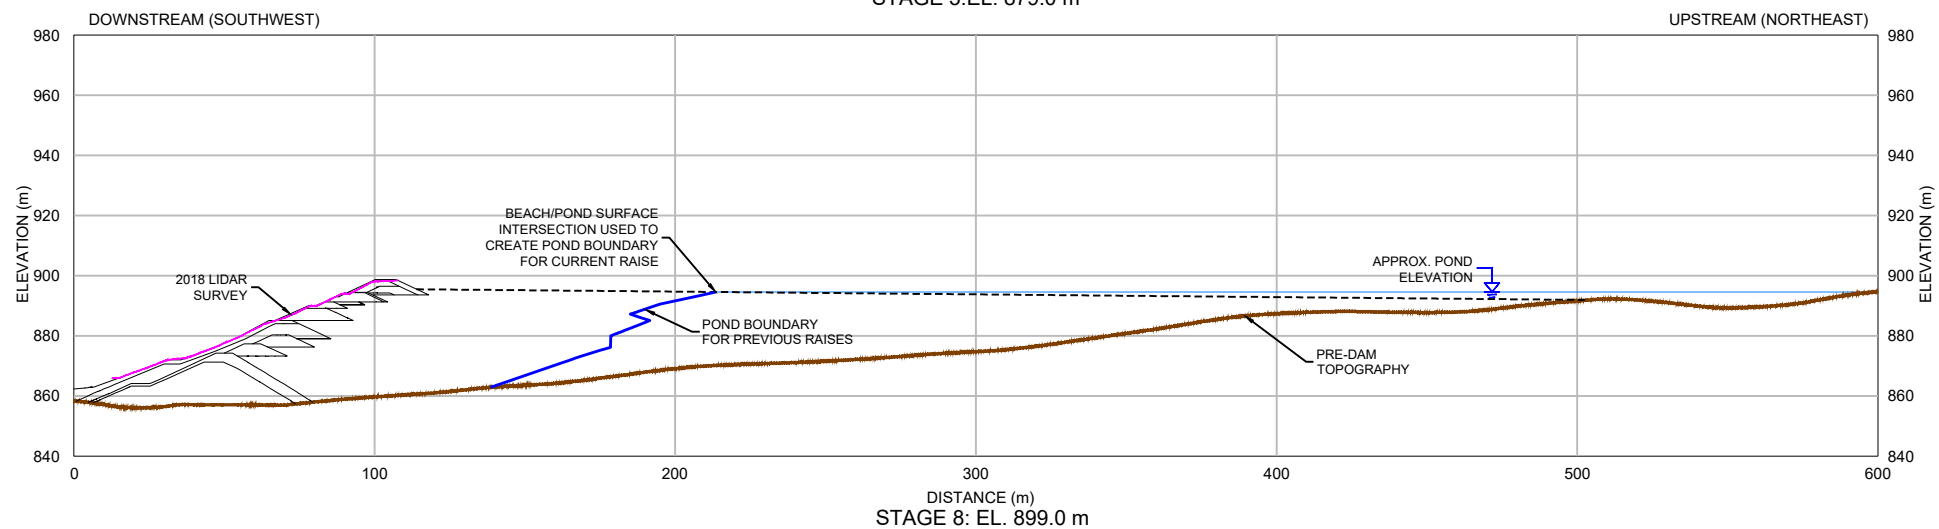
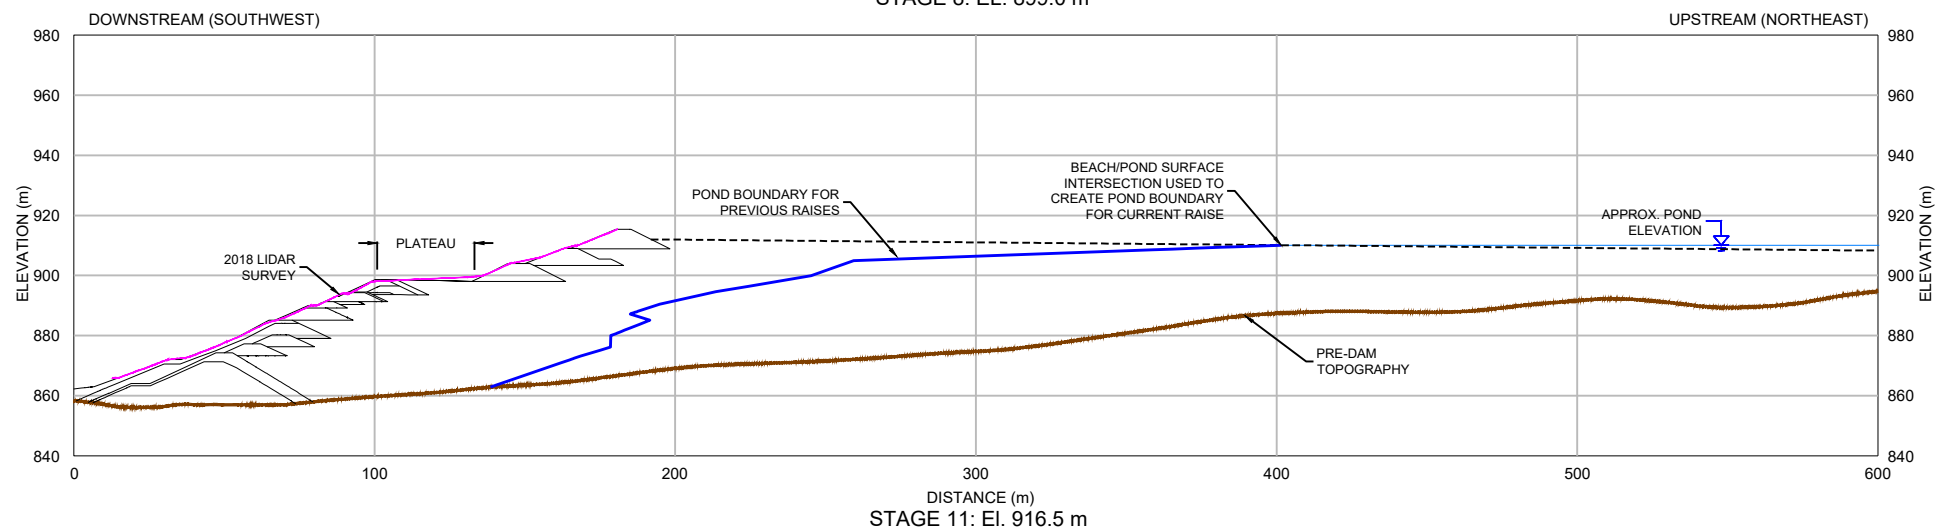
FIG. No.  
5

Using these estimates, a beach surface above and below the pond level was modelled in Civil 3D for each construction stage. These surfaces are shown in Figure 5 of Annex 1.

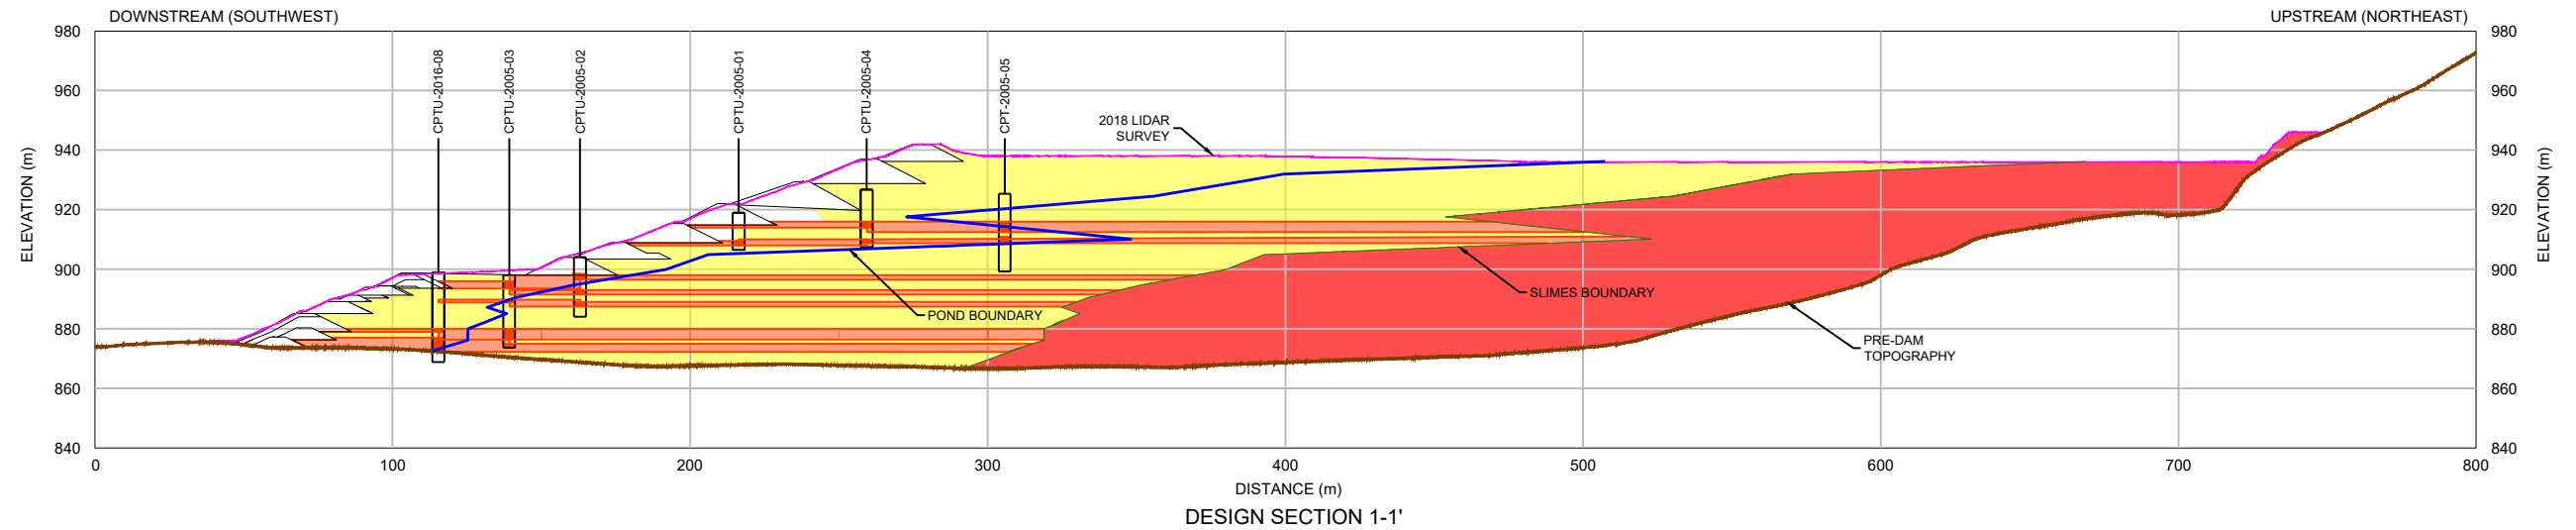
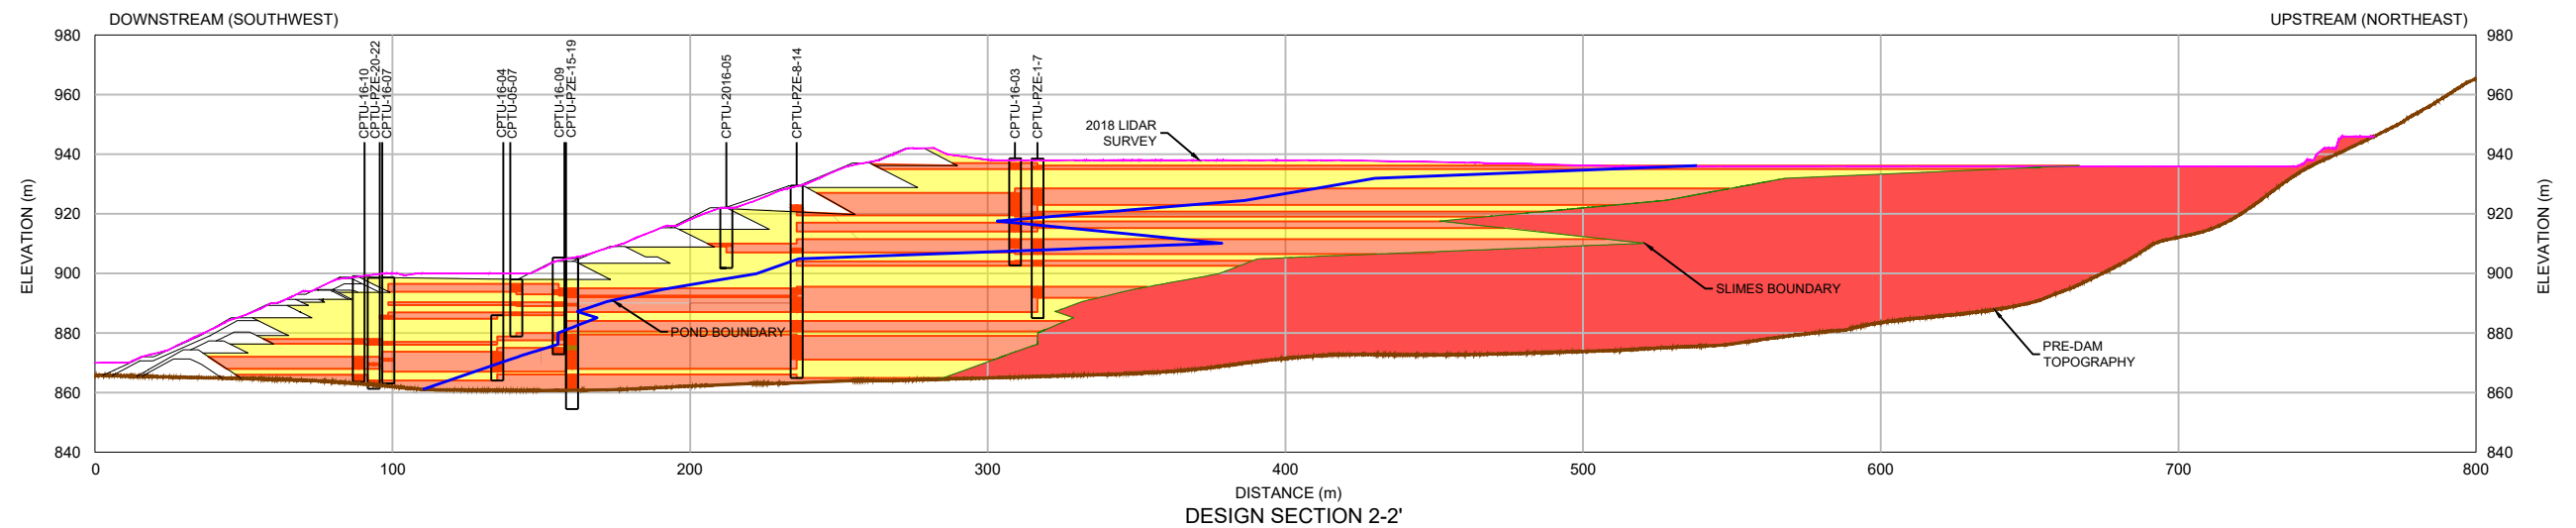
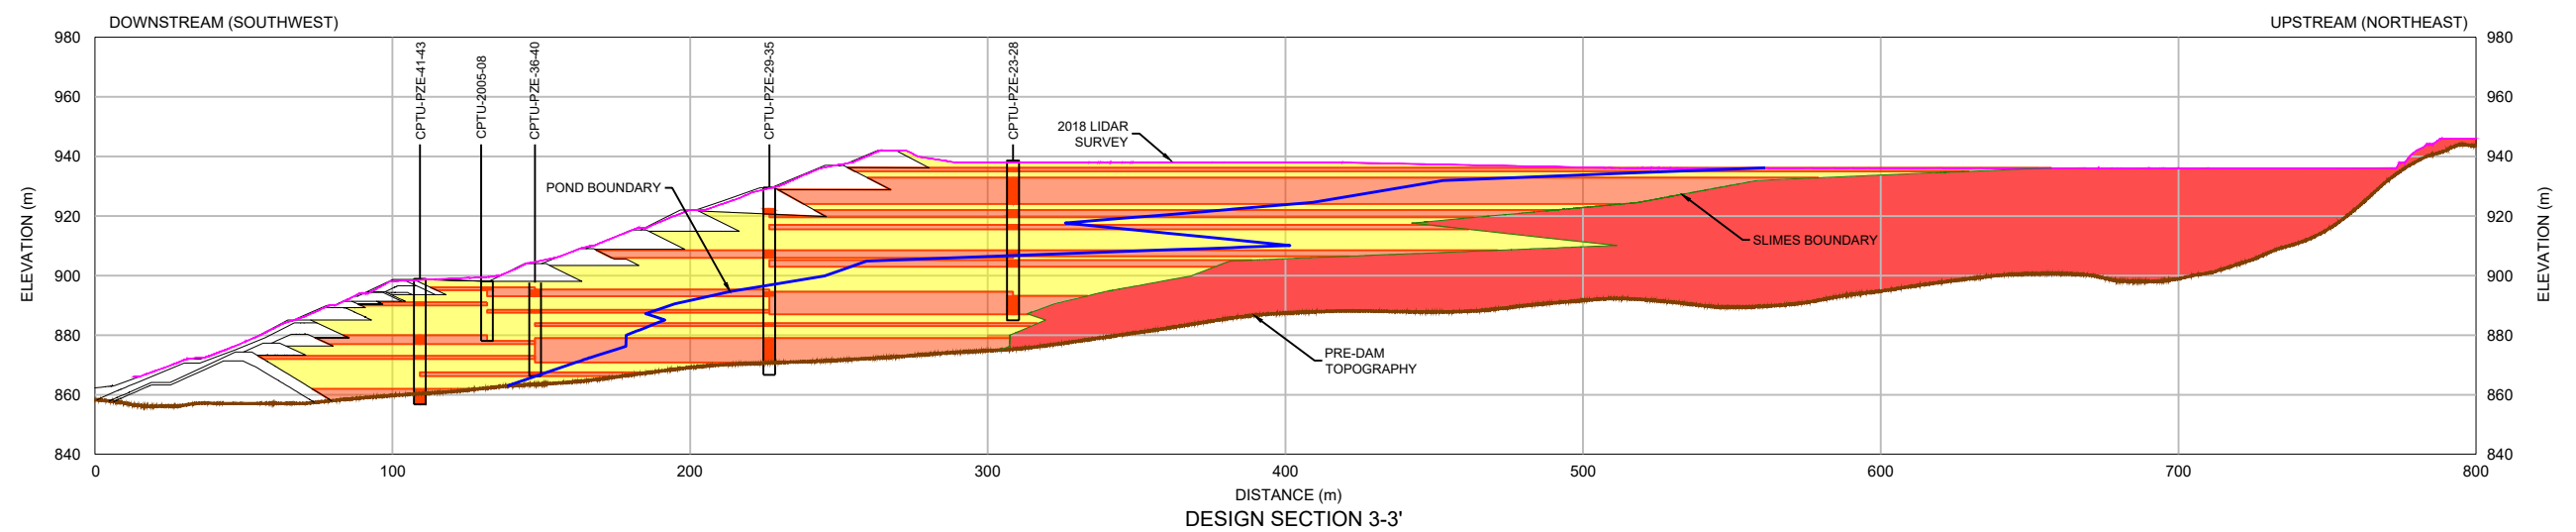
FIG. No.  
8

The Slimes boundary surface, representing the boundary between Fine/Coarse Tailings and Slimes material, is shown in Figure 8 of Annex 1.

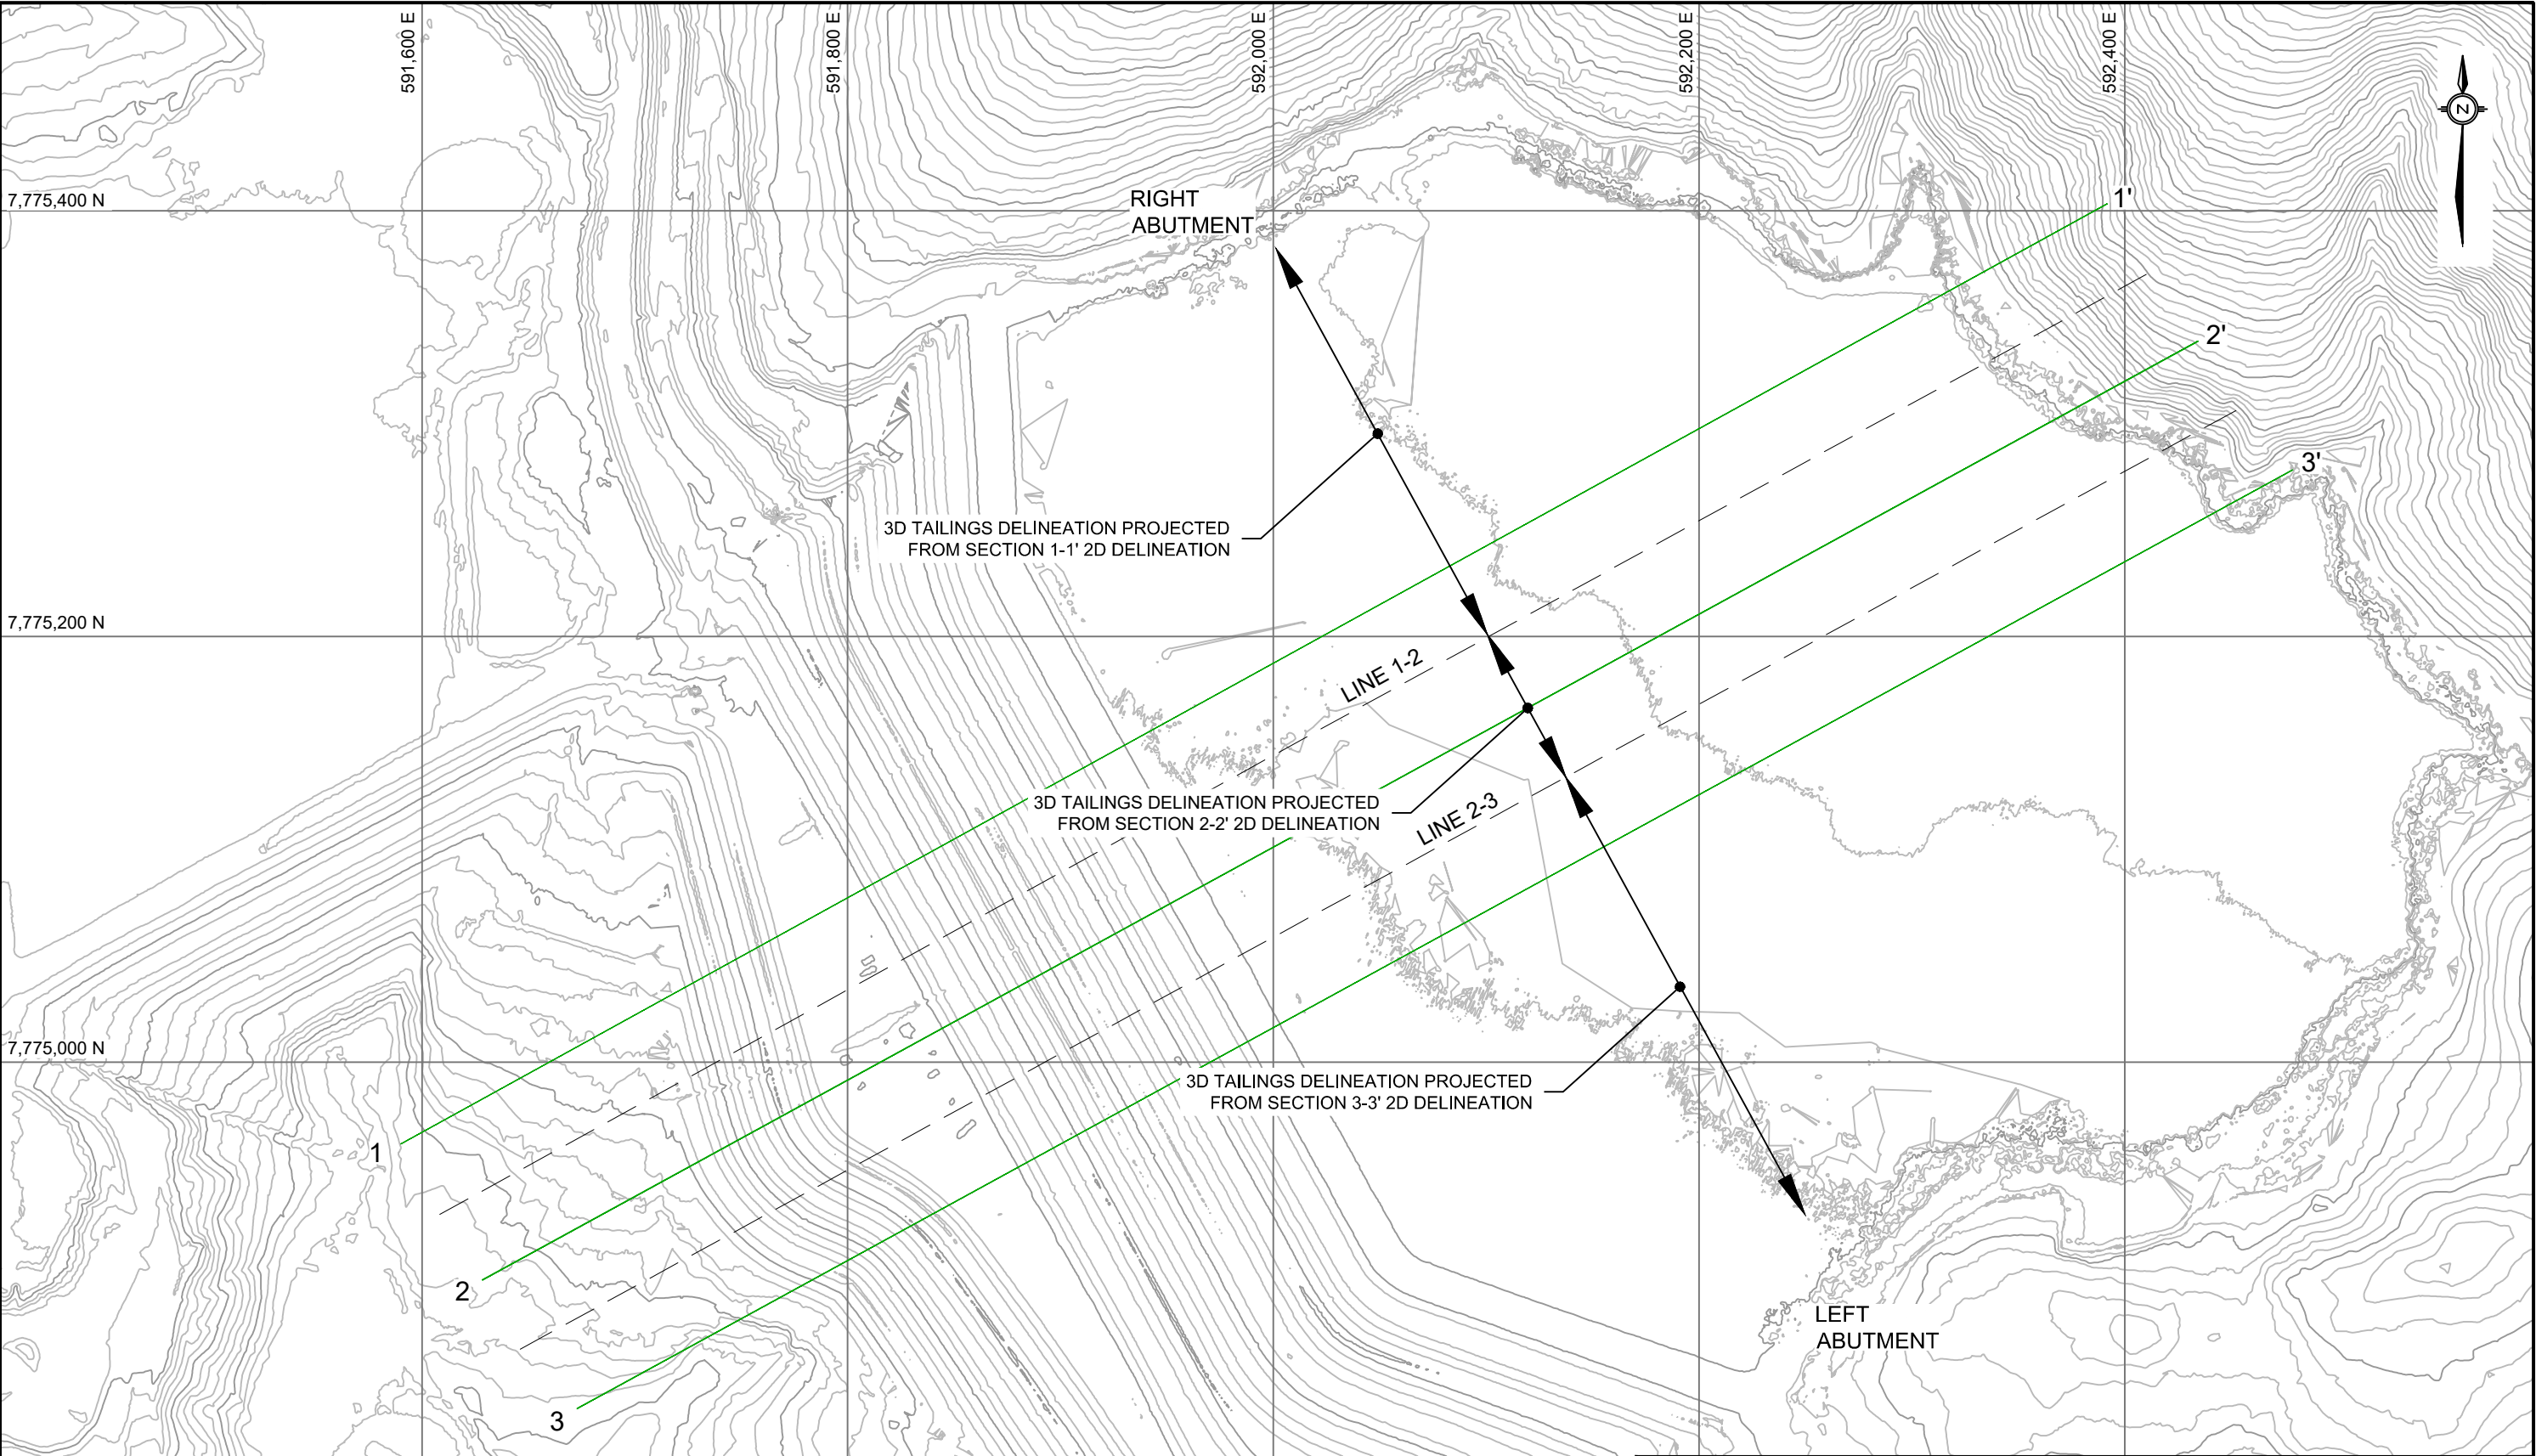
FIG. No.  
9

The final 2D tailings delineation is presented in Figure 9 of Annex 1.
