Appendix G

Seepage Analysis

December 2019

Report of the Expert Panel on the Technical Causes of the Failure of Feijão Dam I
Appendix G – Seepage Analysis

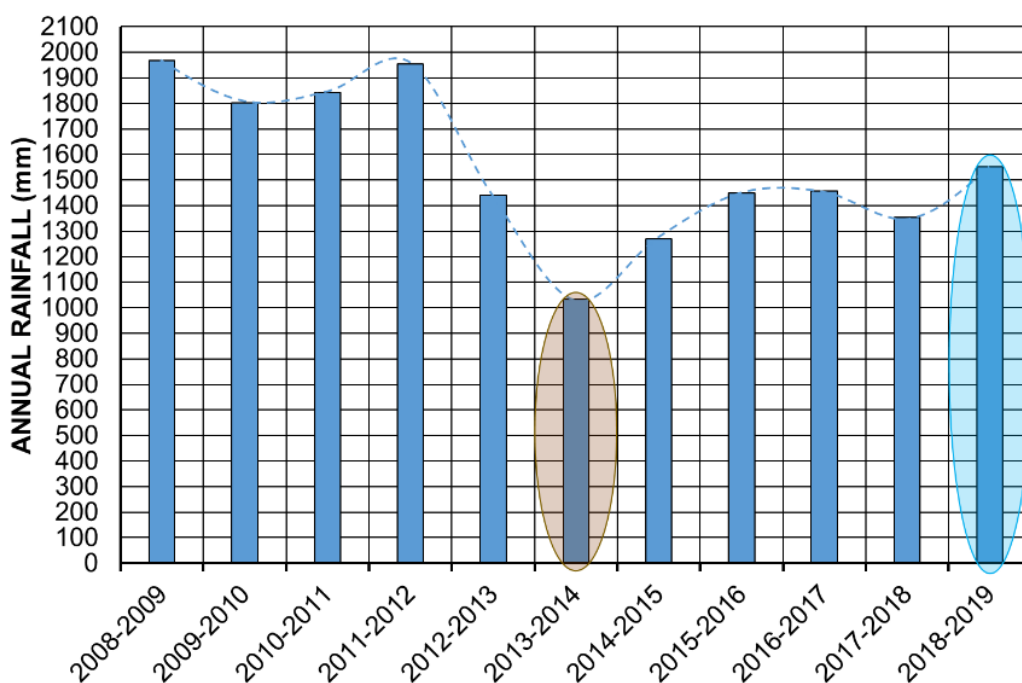
Figure 1: Annual Rainfall for the 10-year Period from 2008-2009 to 2018-2019 at the INMET Ibitiré Weather Station

Figure 1 shows the annual rainfall for the 10-year period from 2008-2009 to 2018-2019 at the INMET Ibitiré weather station, plotted from July to June of the following year, so as not to split the wet season. The years from 2008-2009 to 2011-2012 were the wettest, with 2018-2019 being the next wettest, up 53% from the driest year in 2013-2014.

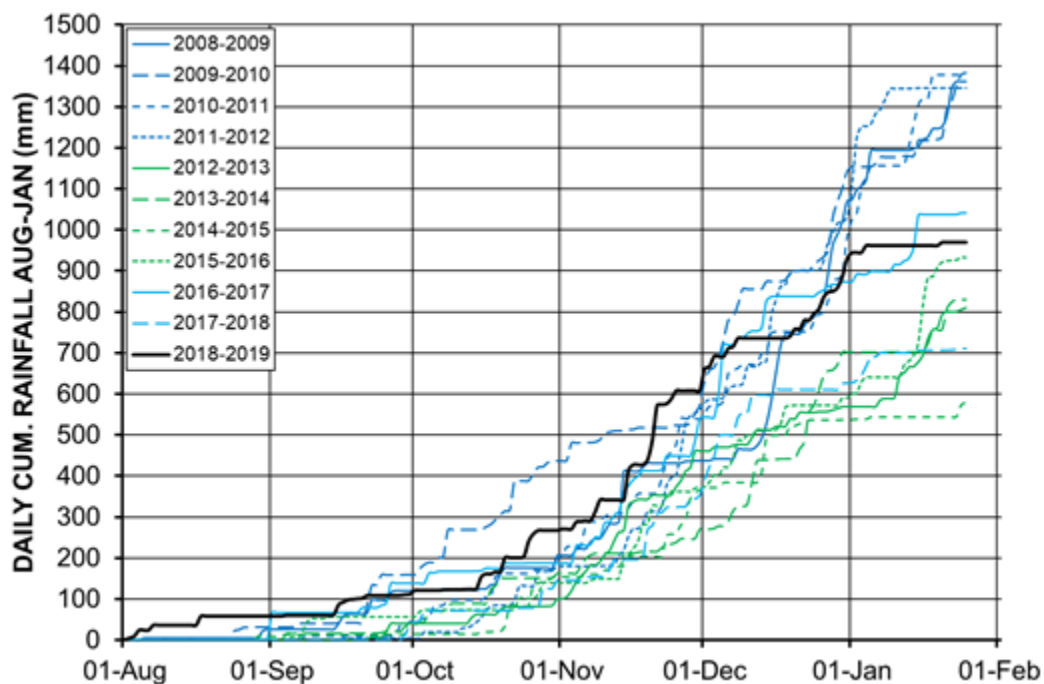
Figure 2: Wet Season Rainfall from August 1 to January 25 for Each Year of the 10-year Period from 2008-2009 to 2018-2019 at the INMET Ibirité Weather Station

Figure 2 shows the cumulative daily rainfalls from August 1 to January 25 (i.e., including the wet season) for each of the last 10 years at the INMET Ibitiré weather station. In the early part of the 2018-2019 wet season, this station showed that the area had close to the wettest cumulative rainfall in the 10-year period.

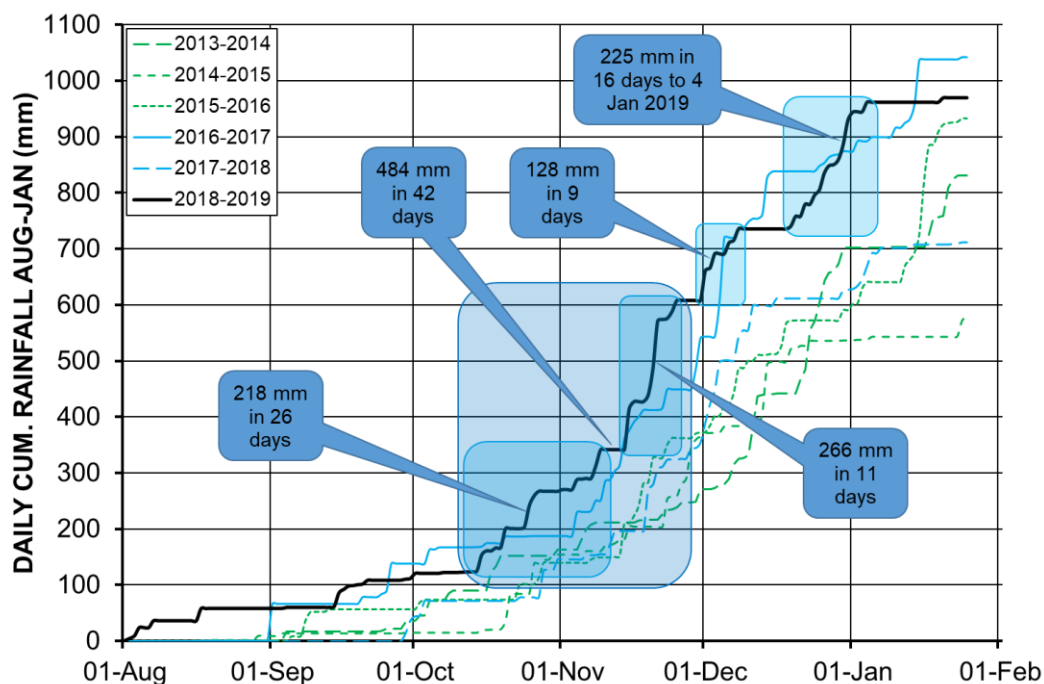
Figure 3: Wet Season Rainfall from August 1, 2018, to January 25, 2019, for INMET Ibirité Weather Station with Highlighted Intense Periods

Figure 3 highlights the periods of intense rainfall during the 2018-2019 wet season leading up to the failure.

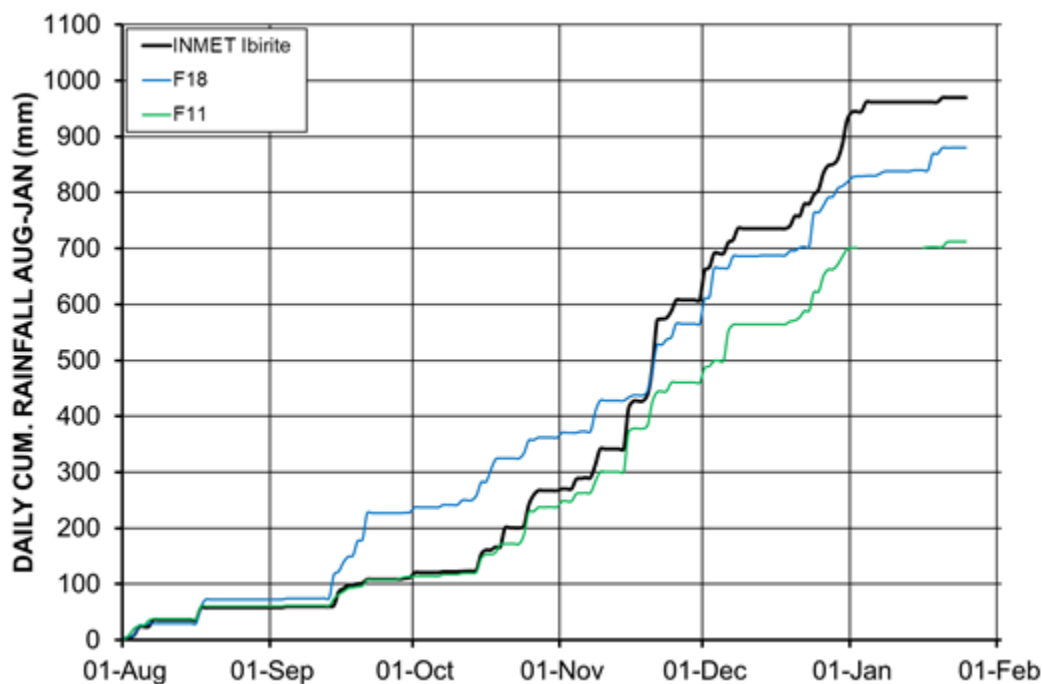
Figure 4: Comparison of Wet Season Rainfall from August 1, 2018, to January 25, 2019, for the INMET Ibirite Weather Station and for the F11 and F18 Automated Rain Gauges

In addition to a review of the INMET Ibirité weather station, data from F11 and F18 were considered. Figure 4 compares the cumulative daily rainfalls for the period from August 1, 2018, to January 25, 2019, for the INMET Ibirité weather station and for the F11 and F18 automated rain gauges, and shows they are broadly comparable and are all suitable for use in the seepage analyses.

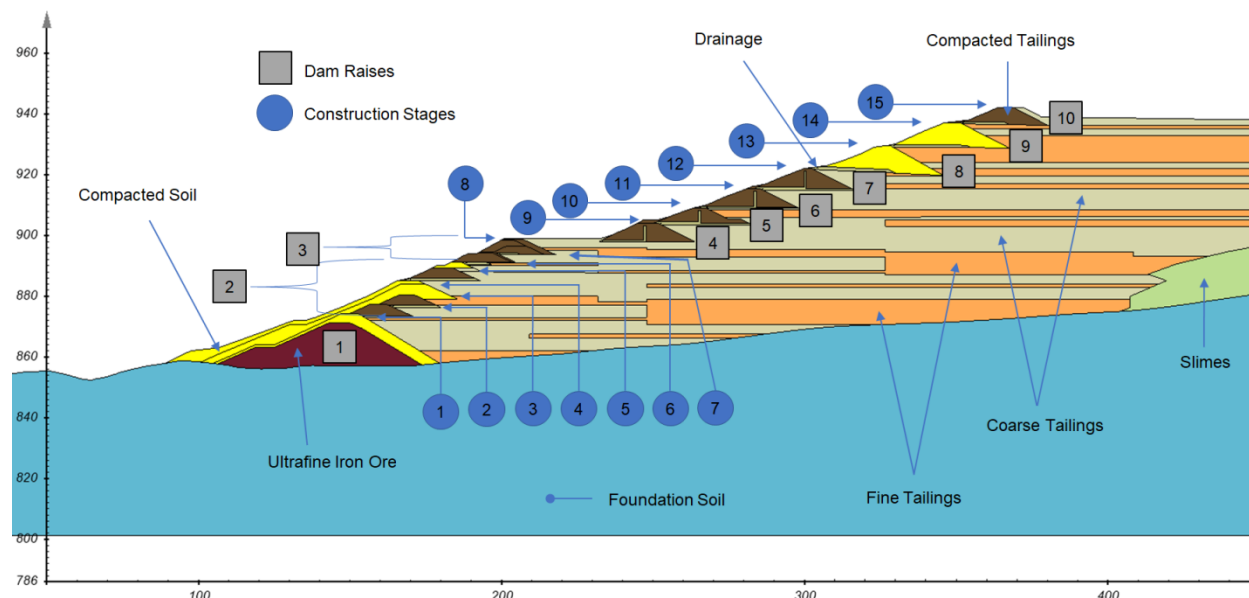
Figure 7: Raises and Stages of Dam I⁵

The seepage model for Dam I was constructed as a series of 10 raises (15 stages) shown in Figure 7. The assumed location of the vertical and/or blanket drains detailed in the design documents can be seen in Figure 7 on raises 4-10. Results of the calibration of the seepage model corroborated

the understanding that drains recommended in design documents for the Second Raising were likely installed (Appendix A). These drains are discussed in Section 4.5.5.

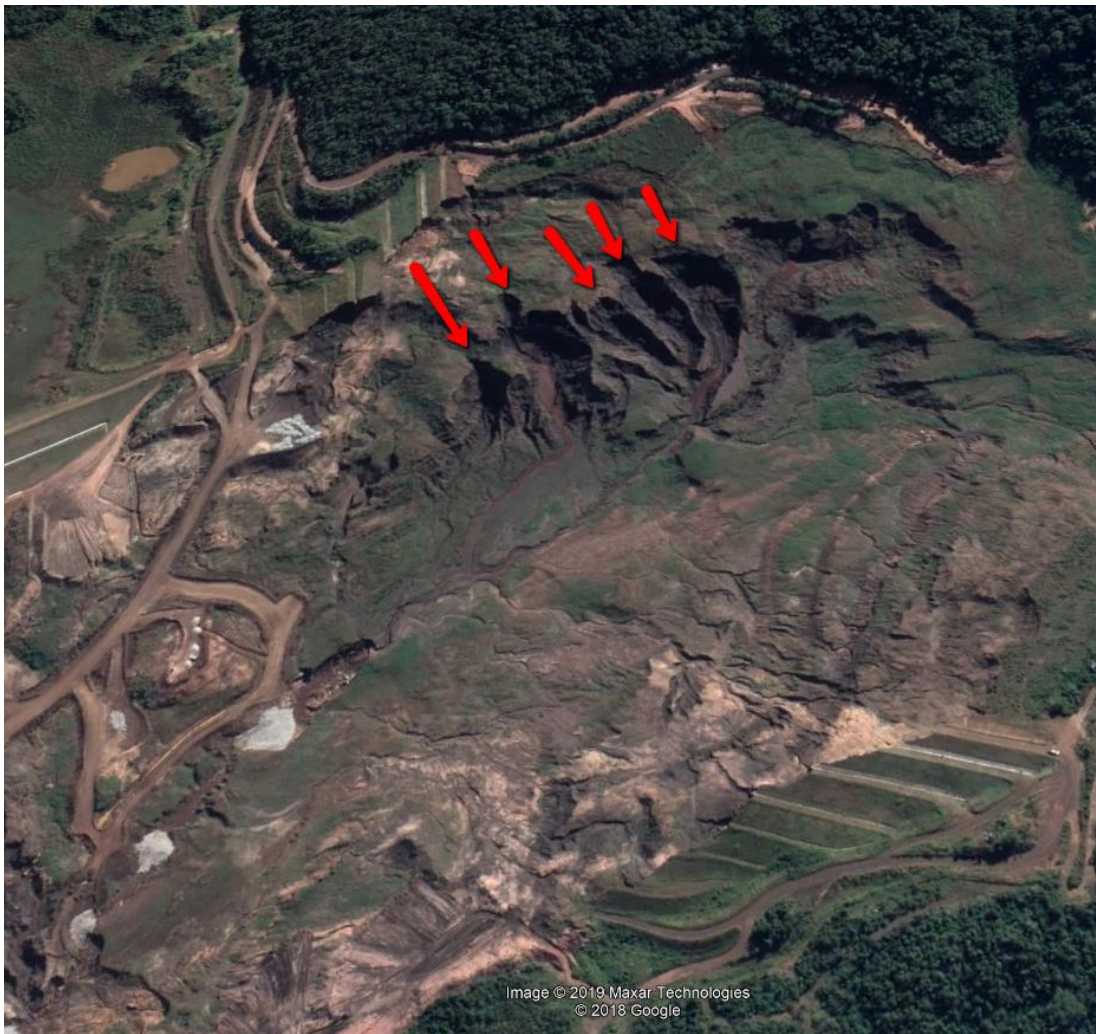
Figure 21: Location of Post-failure Daylighting Springs

Springs were observed daylighting at locations identified in Figure 21 and flow rates were measured (Appendix E).

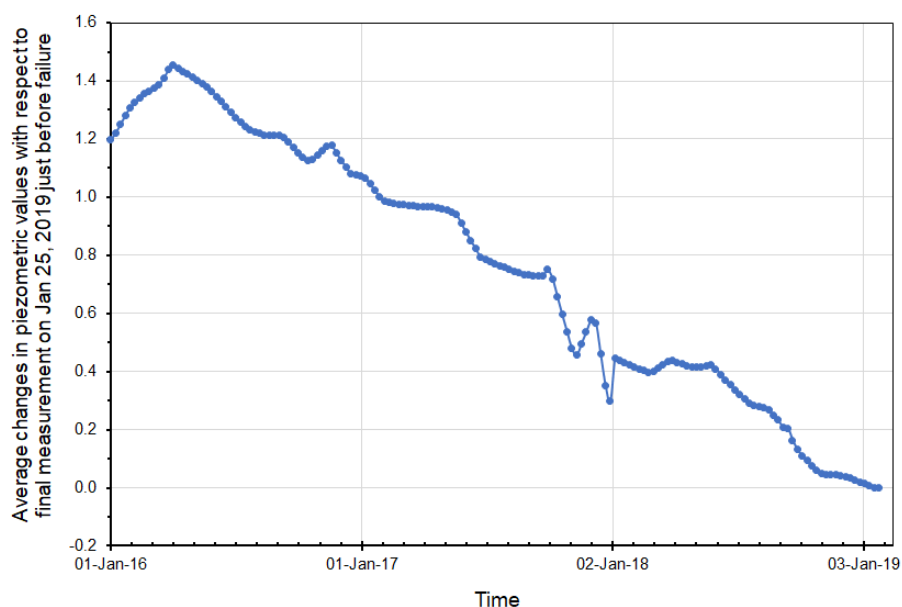
Figure 24: Changes in Piezometer and INA Readings Above Elevation 900 m msl

The results show that there was a gradual decline in the mean water level since 2016. The decline was about 1.4 m for the installations above the setback (900 m msl) and about 0.5 m for the installations on or below the setback. This observation is attributed to a slow net drawdown of water after tailings deposition ceased in 2016. The water appears to be draining from the upper portions of the dam toward the lower portions. The drawdown also creates an increasing unsaturated zone in the upper portions of the dam. The results also show minor short-term increases in water level that appear to be linked to responses during the wet seasons.

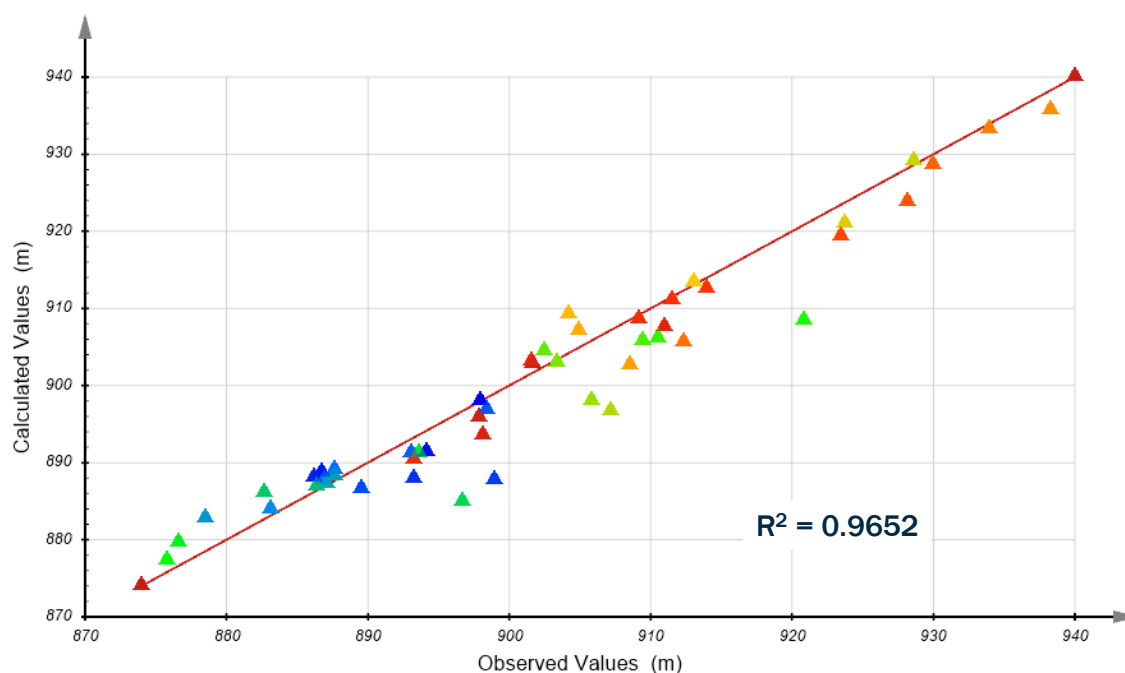
Figure 36: Difference Between Observed and Model-calculated Heads for Cross-section 2-2

The correlation coefficient (R^2) value between model results and all CPTu, piezometers, and INA data was 0.965 and can be seen in Figure 36.

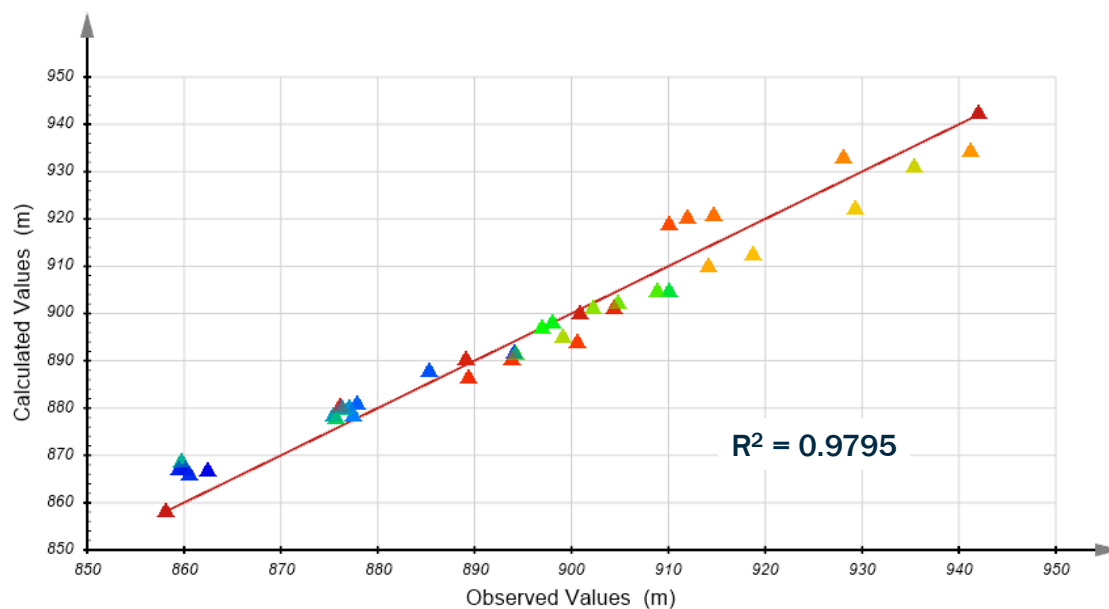
Figure 41: Difference Between Observed and Model-calculated Heads for Cross-section 3-3

The overall R^2 calibration result is shown in Figure 41 and can be considered excellent. The related final coefficient of permeabilities and anisotropy values based on the calibrations are shown in Table 4.

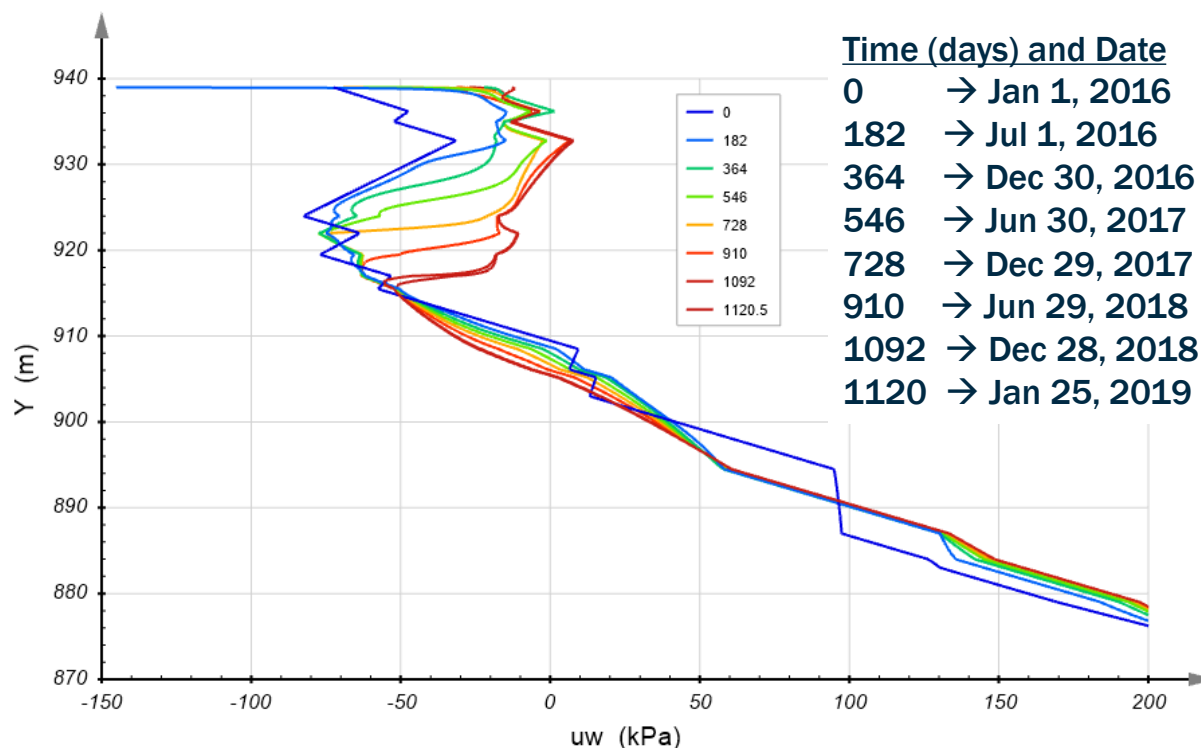
Figure 48: Results of 1D Model Near Dam Crest for Cross-section 3-3

The results (Figure 48) show close similarity to the results of the 2D model, which confirms that wet years caused suctions to be reduced in a zone that moved down through the unsaturated zone and reached a depth of about 25 m after three years. The results also confirm that applying a net infiltration rate equal to 50% of rainfall provided a similar change in suctions compared to the 2D model.

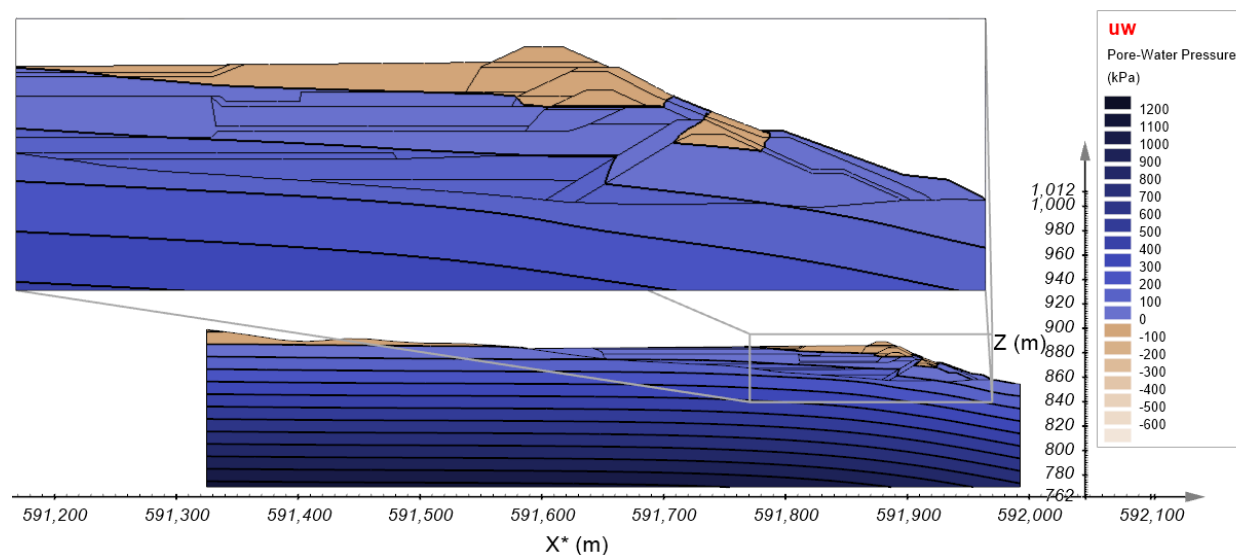
Figure 49: A 2D Profile View Along Cross-section 3-3 of Construction Stage 5 of a 3D Heterogeneous Unsaturated Tailings Model

The water level in Figure 49 is slightly lower when compared to the water level from a 2D analysis for cross-section 3-3 (Figure 50). The difference in the results can be attributed to the unsaturated material properties used for 2D analysis.

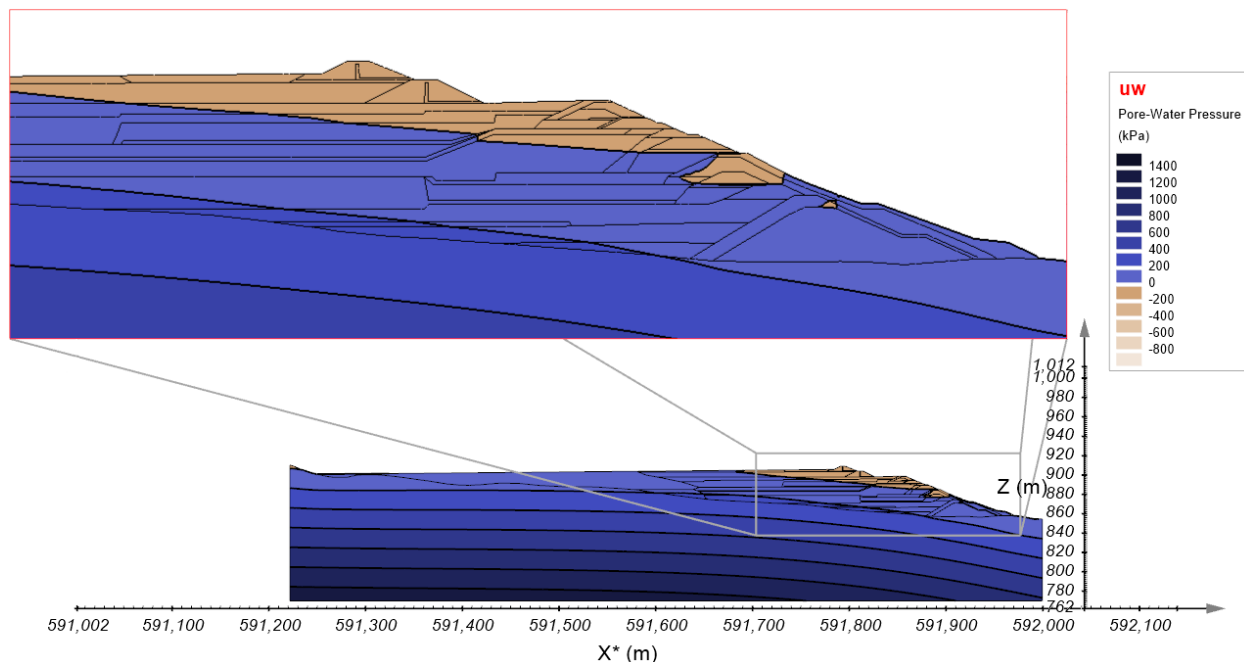
Figure 51: A 2D Profile View Along Cross-section 3-3 of Construction Stage 10 of a 3D Heterogeneous Unsaturated Tailings Model

Figure 51 shows the 3D results at Stage 10. At Stage 10, the beach length is larger for cross-section 3-3 as opposed to cross-section 1-1 and cross-section 2-2.

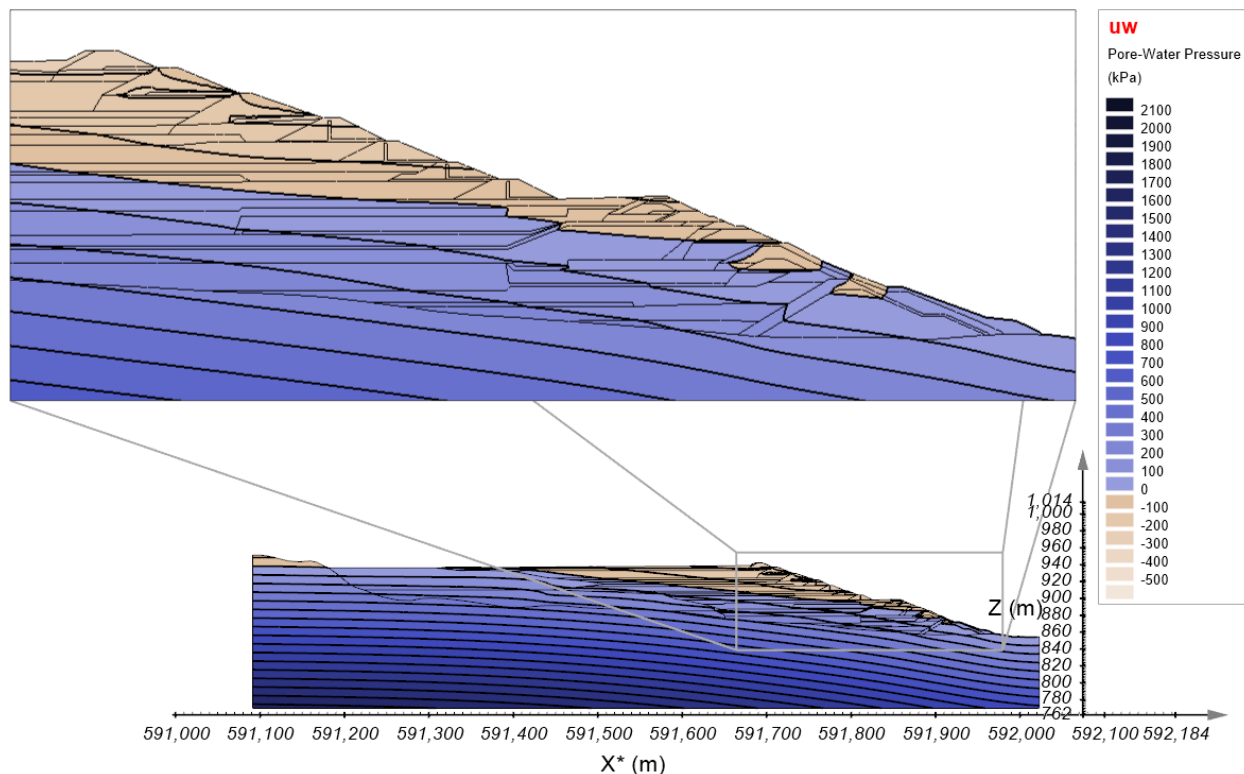
Figure 52: A 2D Profile View Along Cross-section 3-3 of Construction Stage 15 of a 3D Heterogeneous Tailings Model

Stage 15 represents the final raise (Tenth Raising) of the dam completed in January 2016. The pond boundary condition was applied as it was observed close to the start of 2016. Figure 52 shows a slice at cross-section 3-3 and shows that the water table is lower under the upper portions of the dam. This is mainly because of the use of compacted soil material for the Eighth and Ninth Raisings. The compacted soil inhibits the infiltration rate, and only the top surface zone can be saturated due to rainfall.
