## **Seismic Analysis**

**December 2019**

**Report of the Expert Panel on the Technical Causes of the Failure of Feijão Dam I**  
**Appendix I – Seismic Analysis**

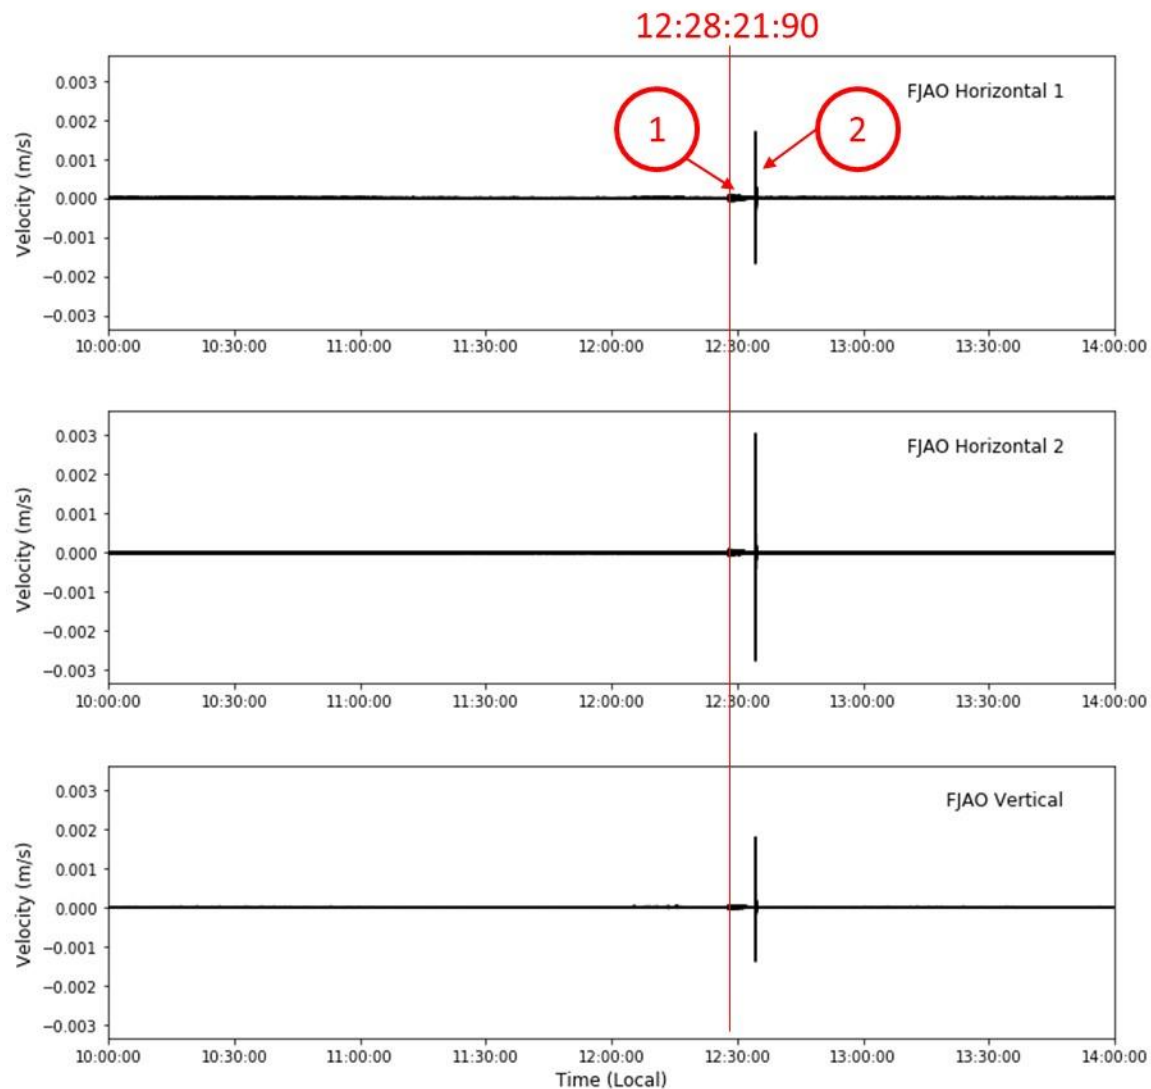
**Figure 3:** FJAO Seismograph Data for 10:00 to 14:00 Local Time on January 25, 2019

Figure 3 shows the recorded data at the FJAO seismograph station on January 25, 2019, between 10:00 and 14:00 local time. The time of the visible initiation of the Dam I failure (12:28:21:90) also is depicted for reference. The three seismograms present the measured particle velocity as a function of time in the H1, H2, and Z directions. The seismograph data were adjusted to local time (UTC -2) to facilitate comparisons with the time of the Dam I failure. There are two events recorded at FJAO that occur near the time of the failure: (i) a small-velocity event (“Event 1”) and (ii) a larger-velocity event that occurs subsequently (“Event 2”). No other events are apparent during this four-hour time period.

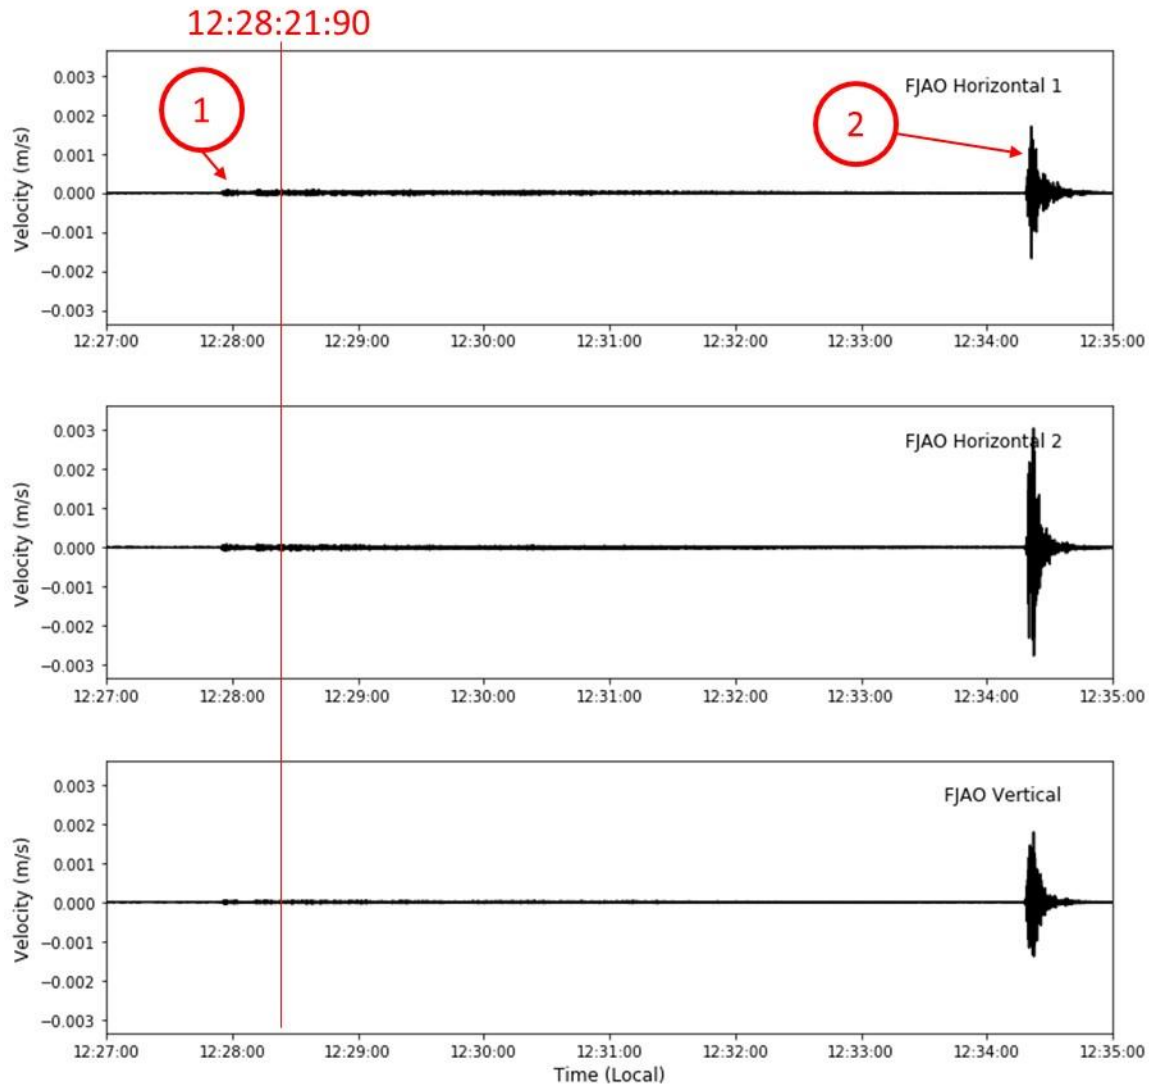
**Figure 4:** FJAO Seismograph Data for 12:27 to 12:35 Local Time on January 25, 2019

Figure 4 depicts the seismograms plotted on an expanded time scale from 12:27:00 to 12:35:00 local time. Event 1 appears to initiate prior to the first visible indication of the initiation of the Dam I failure as established by the video analysis, and Event 2 occurs approximately six minutes after the initiation of the failure.

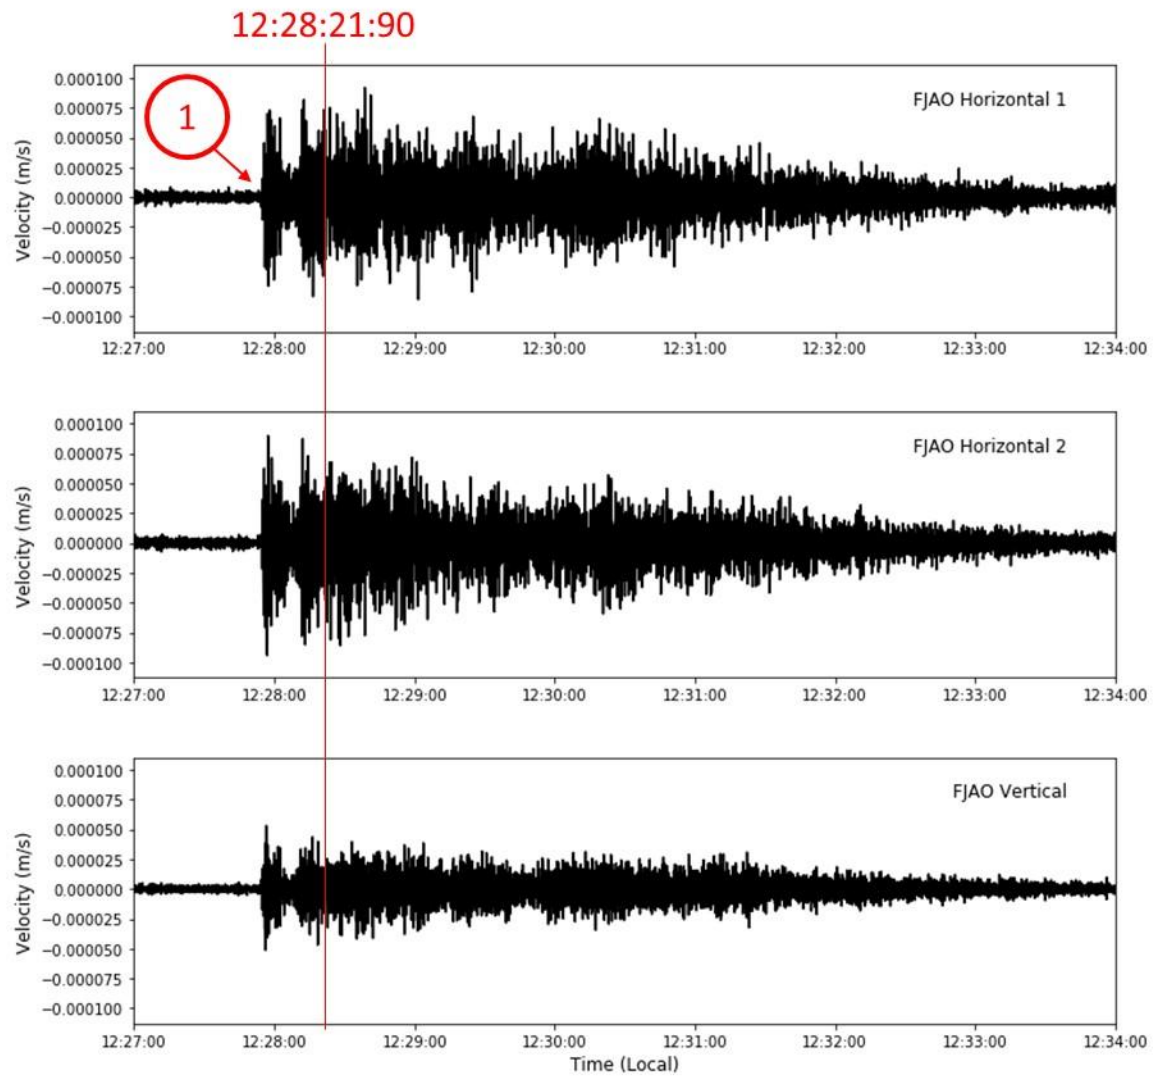
**Figure 5:** FJAO Seismograph Data for Event 1 on January 25, 2019

Figures 5 and 6 are expanded plots of Events 1 and 2, respectively, to enable additional details to be seen for each event. Event 1 initiated at approximately 12:27:54 local time with a duration of approximately six minutes, and the peak velocity (recorded on H2) is approximately  $9 \times 10^{-5}$  m/s. Event 1 appears to consist of two subevents – an initial subevent at 12:27:54 that had a duration of approximately 16 seconds, followed by a second, continuous event at approximately 12:28:10 local time. Event 2 initiated at approximately 12:34:17 local time with a shorter duration of approximately 10 to 20 seconds and a larger velocity (recorded on H2) of approximately  $3 \times 10^{-3}$  m/s.

A comparison of Event 1 (Figure 5) with the seismograms in Figures 7 through 10 reveals that Event 1 had a much lower peak velocity ( $9 \times 10^{-5}$  m/s) than the recorded blasts from the four prior dates. Based on this comparison, it can be concluded that Event 1 was not a blast. In addition, it appears that Dam I was subjected to various seismic events of a higher peak velocity than Event 1 in the form of the blasts, as shown above, on various occasions prior to January 25, 2019.

- Low-velocity ground vibrations (Event 1) were observed at FJAO approximately 28 seconds before the failure of Dam I was observed. Event 1 does not present the characteristics of a blast based on comparisons with known blasting events on four prior dates in January 2019. The peak velocity of Event 1 ( $9 \times 10^{-5}$  m/s) was very small. For comparison, safe levels of ground vibration for residential structures generally ranged from approximately  $1.5 \times 10^{-2}$  m/s to  $5 \times 10^{-2}$  m/s.

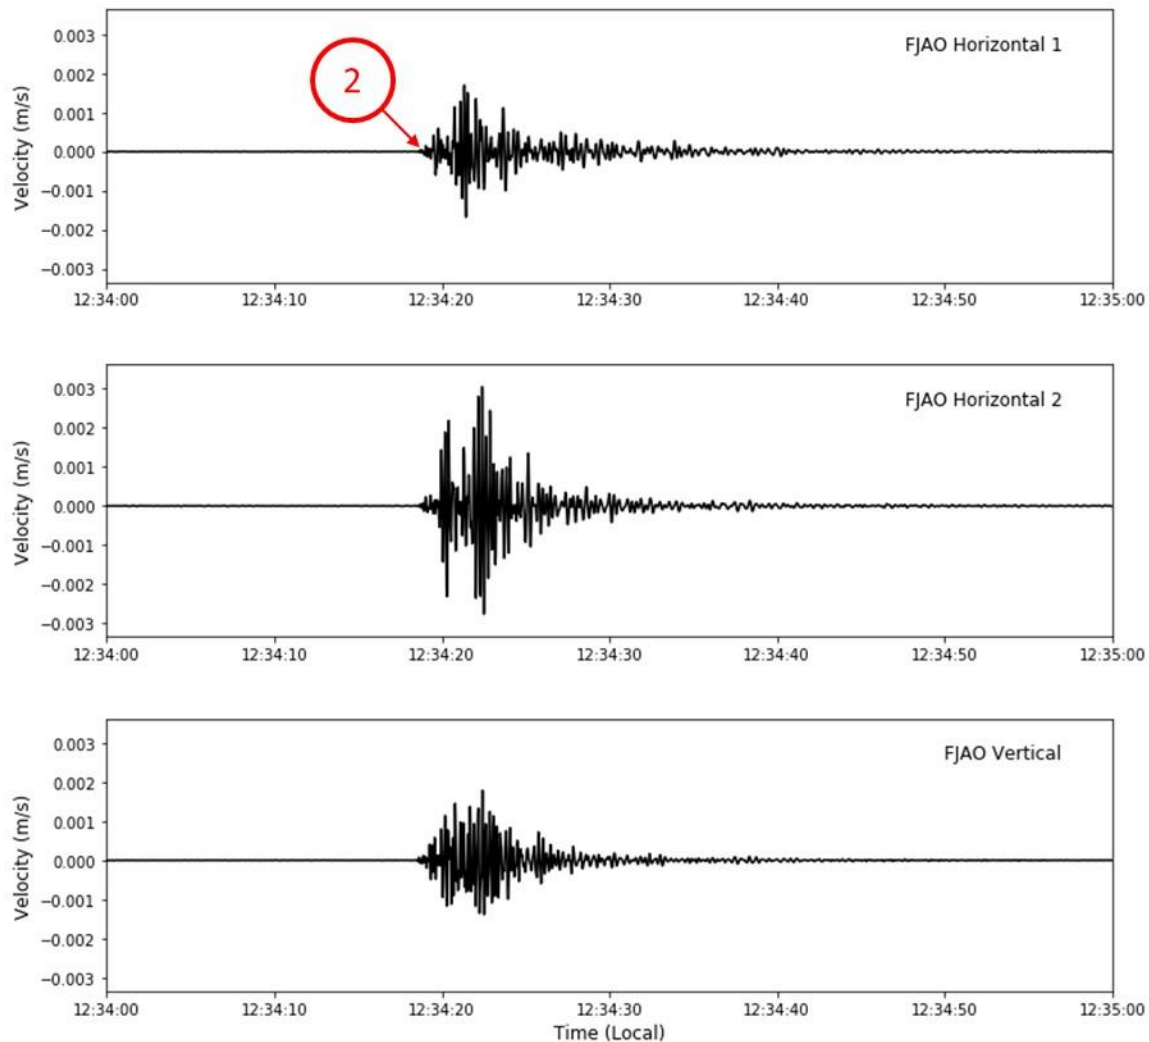
**Figure 6:** FJAO Seismograph Data for Event 2 on January 25, 2019

Qualitatively, Event 2 (Figure 6) had a very similar duration (10 to 20 seconds) and peak velocity ( $3 \times 10^{-3}$  m/s) to the blasts recorded on the four prior dates (Figures 7 through 10), and therefore, Event 2 is likely the result of a blast. To confirm this interpretation, Event 2 was compared with the blasts on the four prior dates quantitatively by calculating the cross-correlation function between each pair of seismograms. Figure 11 presents a matrix of plots showing the results. Along the diagonal of the matrix are the cross-correlation functions of each seismogram with itself; thus, the maximum correlation is 1.0. The off-diagonal plots show cross-correlation functions between

- Event 2 on January 25, 2019 is consistent with a blast based on a comparison with the known blasting events on four prior dates. Event 2 occurred approximately six minutes *after* the initiation of the failure was observed and had a peak velocity of  $3 \times 10^{-3}$  m/s.

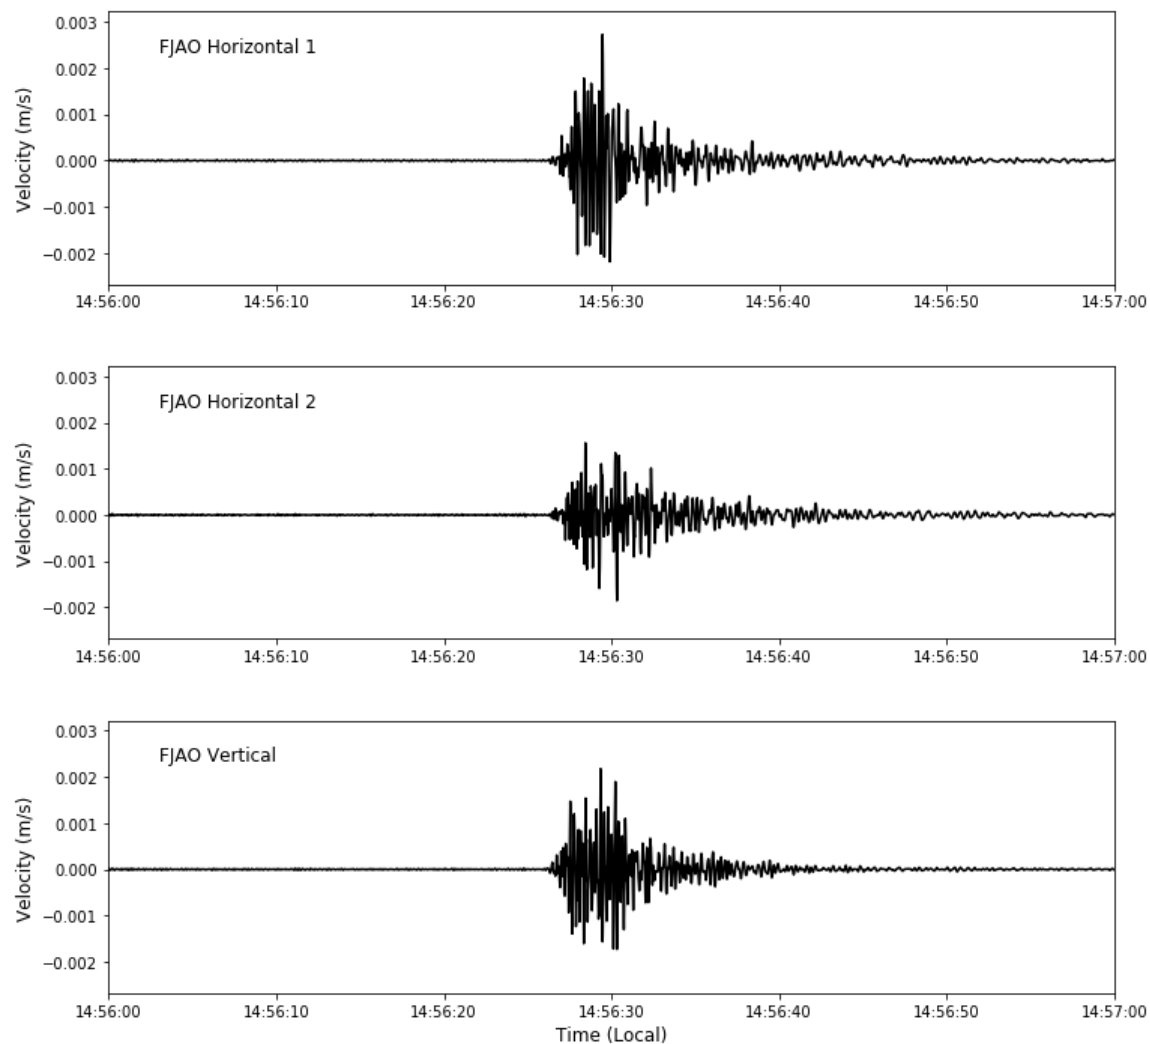
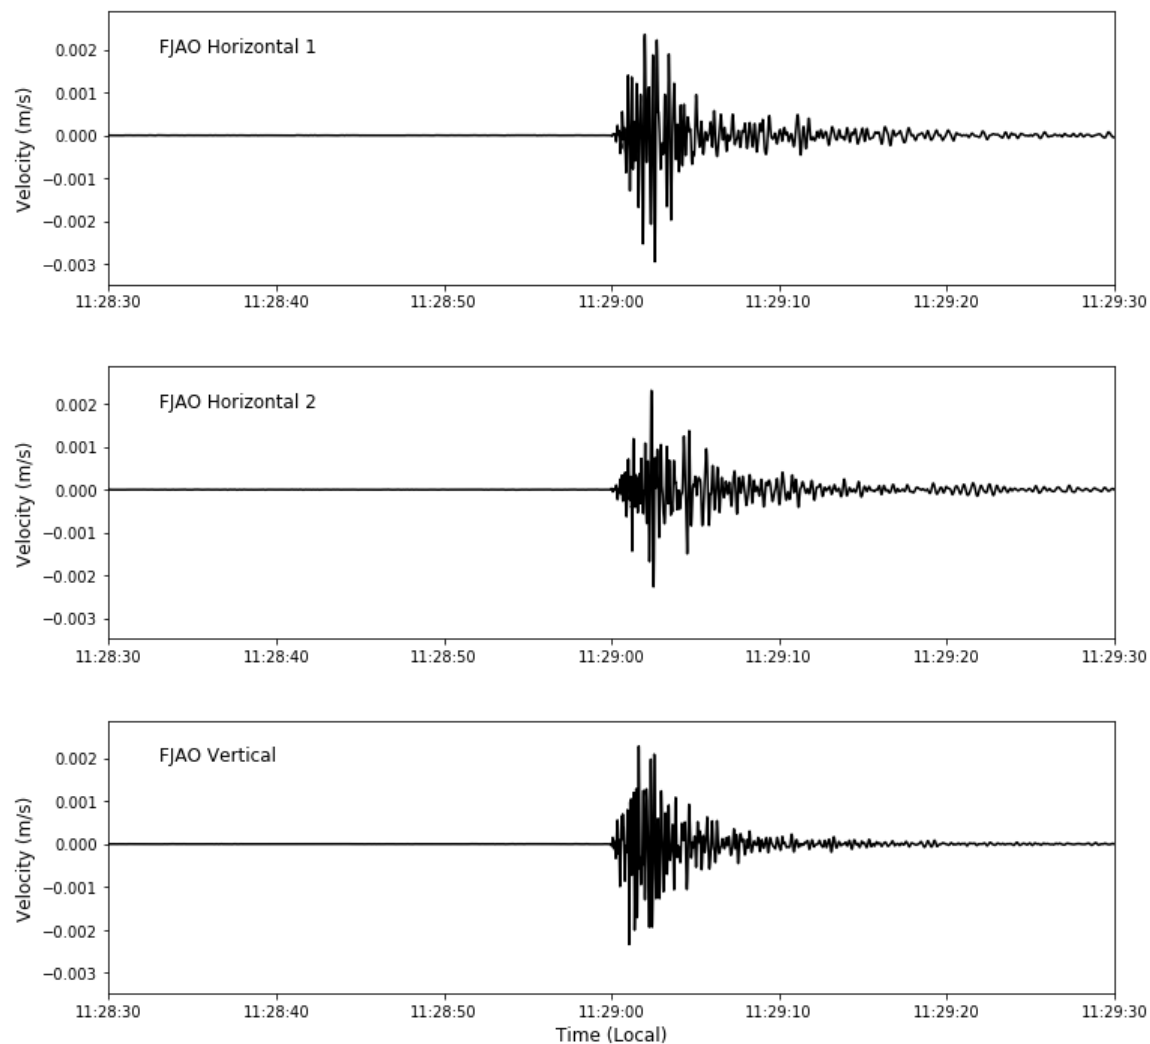
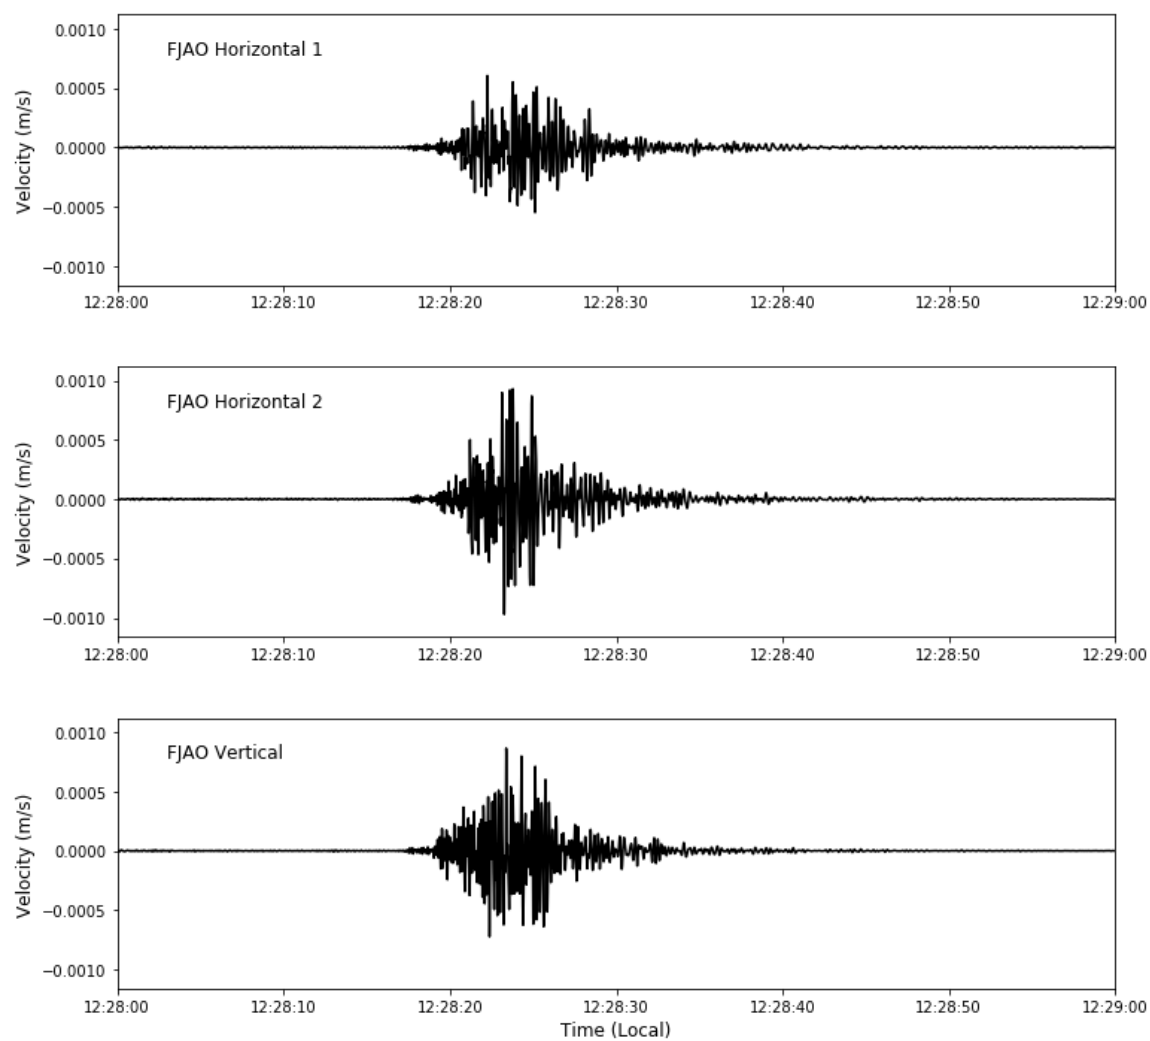
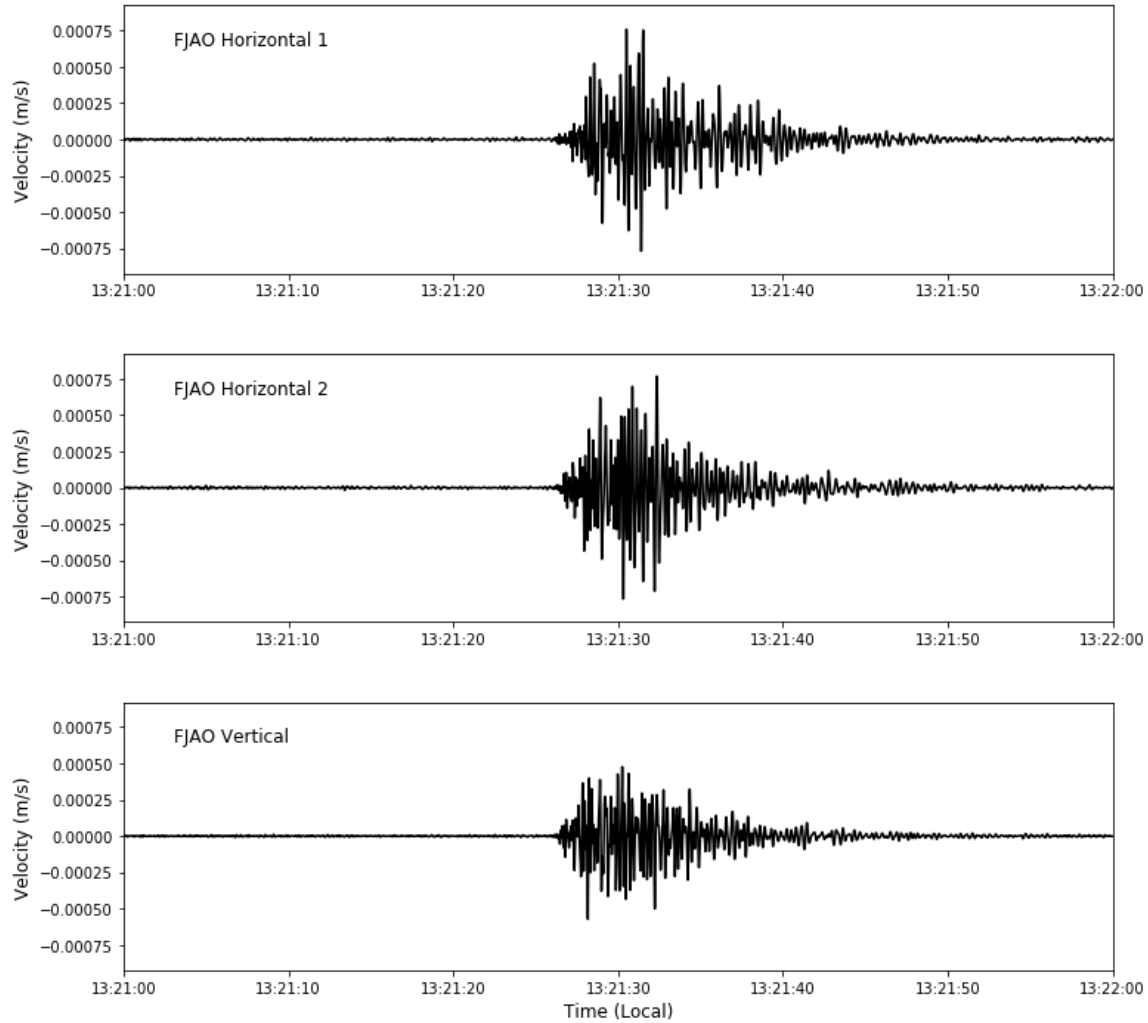
Figures 7 through 10 show the seismograms recorded at FJAO on the four prior dates at times that approximately correspond to the time recorded in the firing plans. The seismograms have durations of 10 to 20 seconds and peak velocities that range from approximately  $6 \times 10^{-4}$  m/s to  $3 \times 10^{-3}$  m/s. Differences in the observed peak velocities correspond reasonably well to the varying mass of explosives used for each blast.

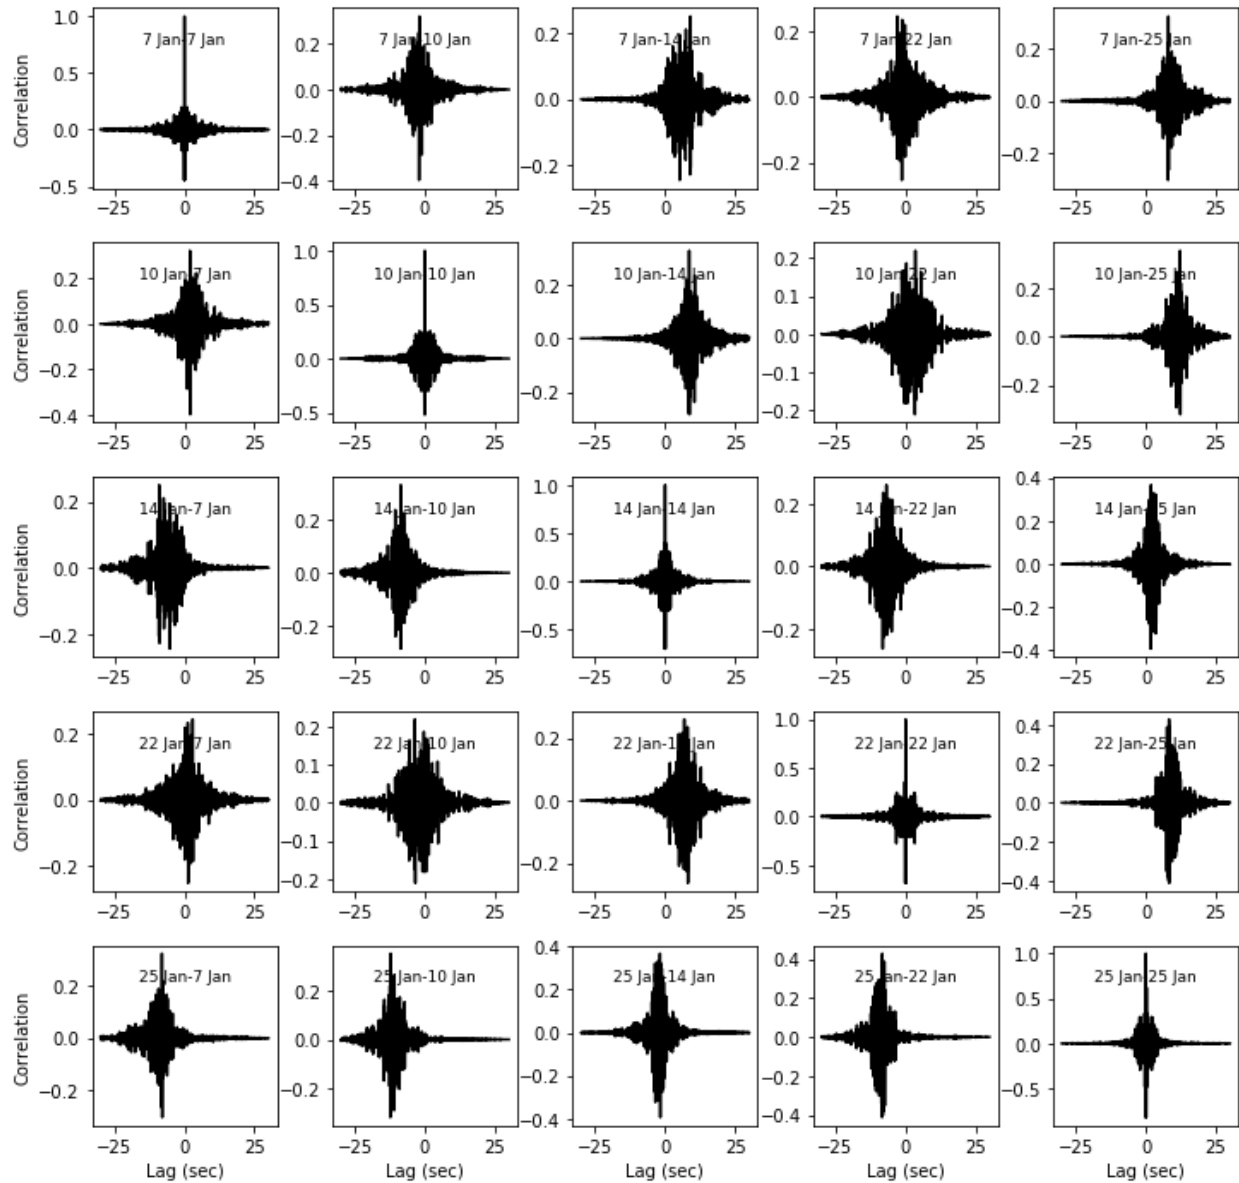
**Figure 11: Cross-Correlation Functions**

different days. The well-defined peak in each of the off-diagonal plots indicates that the two seismograms are correlated, confirming the interpretation that Event 2 is the result of a blast.

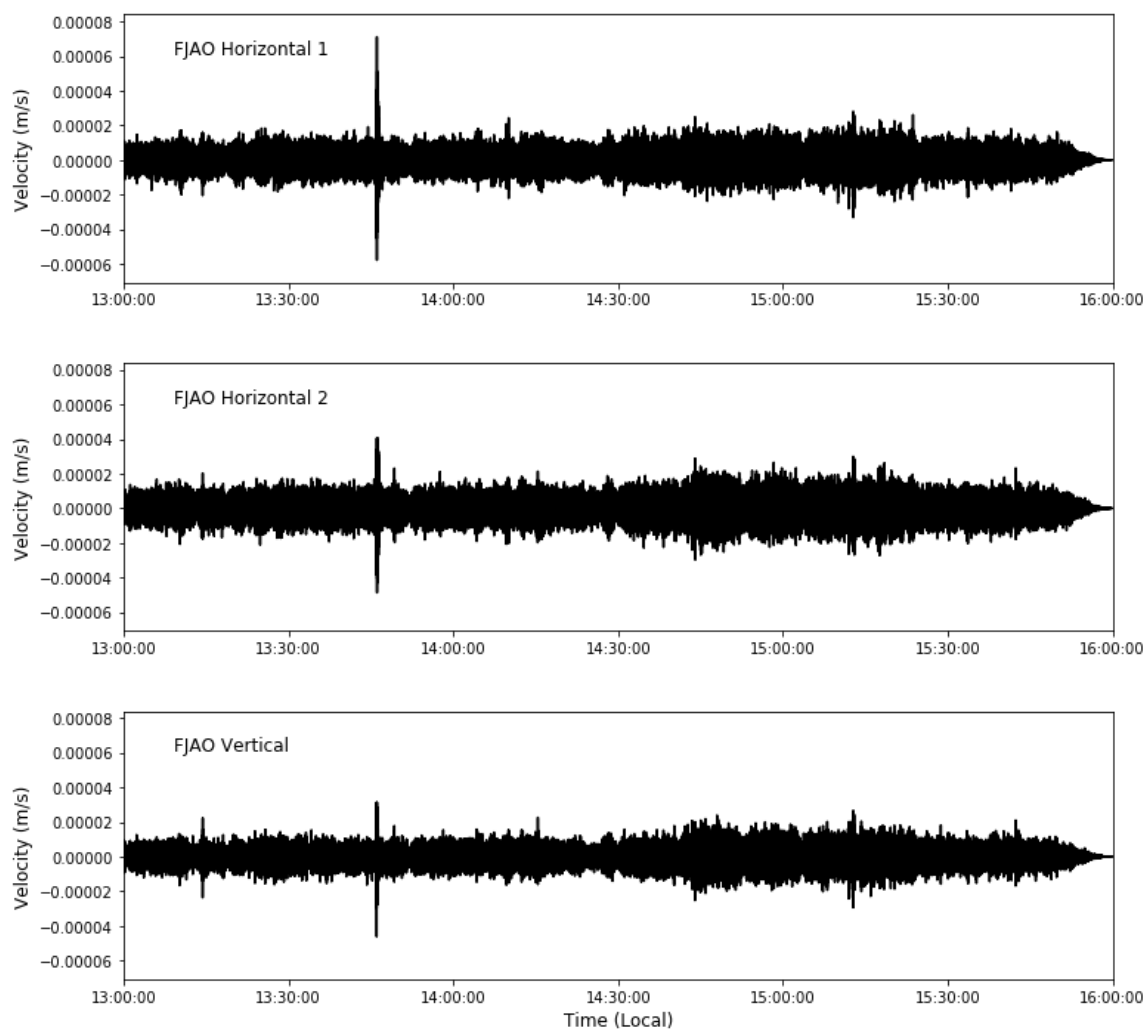
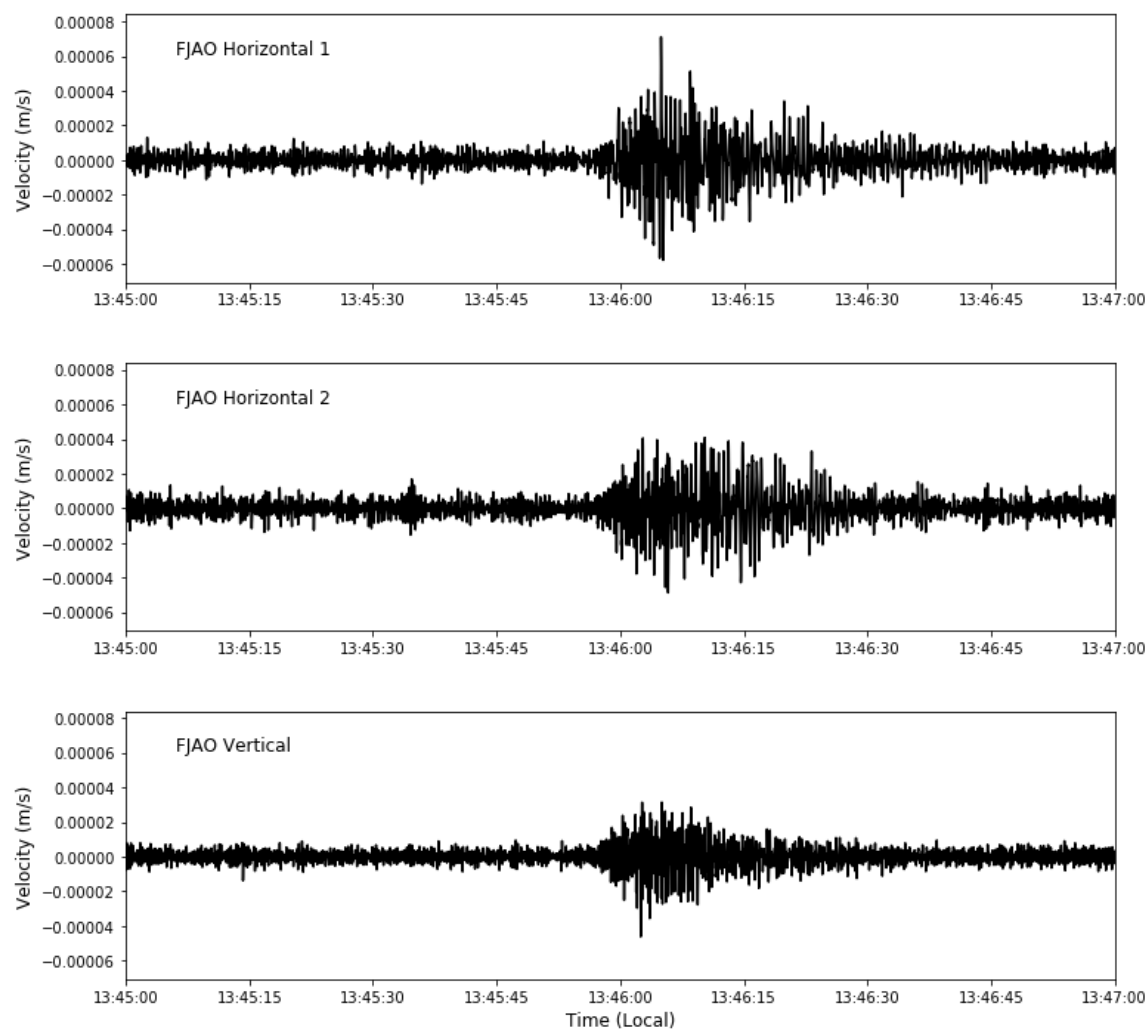
The data recorded at FJAO on June 11, 2018 was reviewed to compare measured ground vibrations on the day of the DHP 15 installation with those recorded on January 25, 2019. The only event observed between 8:00 and 16:00 local time that exceeded ambient noise levels occurred at approximately 13:46 local time. Figure 12 shows the data recorded at FJAO between 13:00 and 16:00 local time. The event that occurs at approximately 13:46 local time has a peak velocity of approximately  $7 \times 10^{-5}$  m/s. Figure 13 shows an expanded view of the event that indicates the duration was approximately 25 seconds.

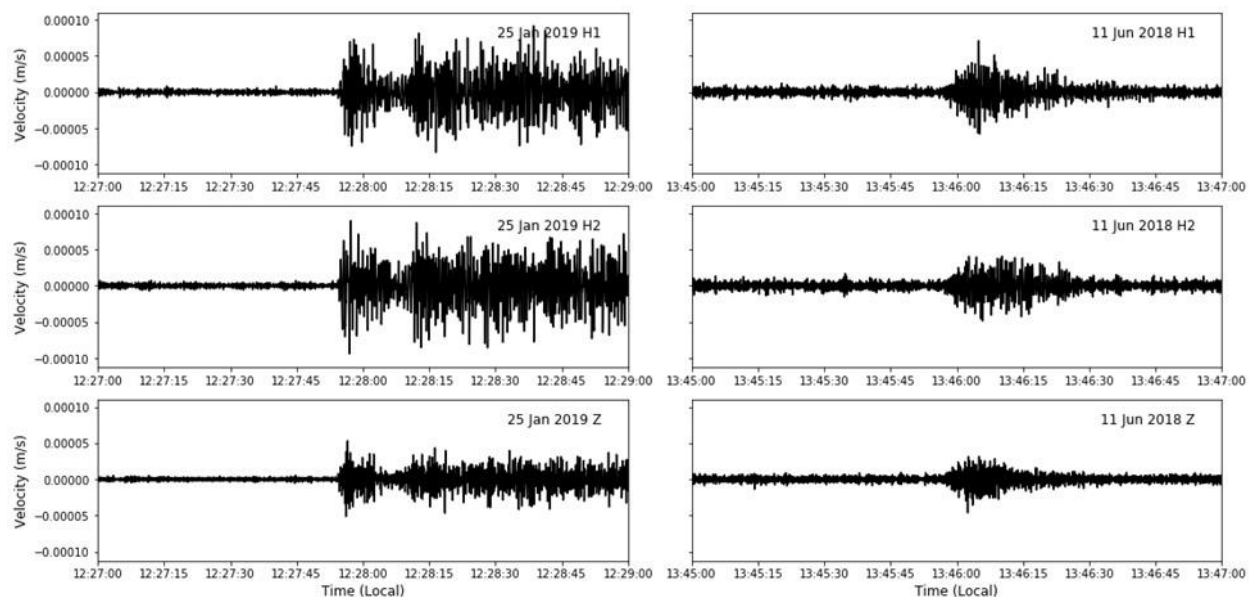
**Figure 14:** Comparison of Event 1 on January 25, 2019 with event on June 11, 2018

The event on June 11, 2018 was compared with Event 1 on January 25, 2019 to evaluate whether there are similarities between the seismograph records of the two events. The event on June 11, 2018 had a similar peak velocity to Event 1 on January 25, 2019. The duration was much shorter compared to the total duration of Event 1. However, as shown in Figure 14, the duration of the event on June 11, 2018 was similar to the duration of the initial subevent associated with Event 1. Both events were small in velocity and significantly smaller than blasting events that occurred at the dam on prior occasions.

- An event was observed on June 11, 2018 during the drilling incident at DHP 15 that had a similar velocity to the peak velocity of Event 1 on January 25, 2019. The June 11 event also had a similar duration to the initial subevent taking place within Event 1.
