Appendix D Image Analysis

December 2019

Report of the Expert Panel on the Technical Causes of the Failure of Feijão Dam I Appendix D – Image Analysis

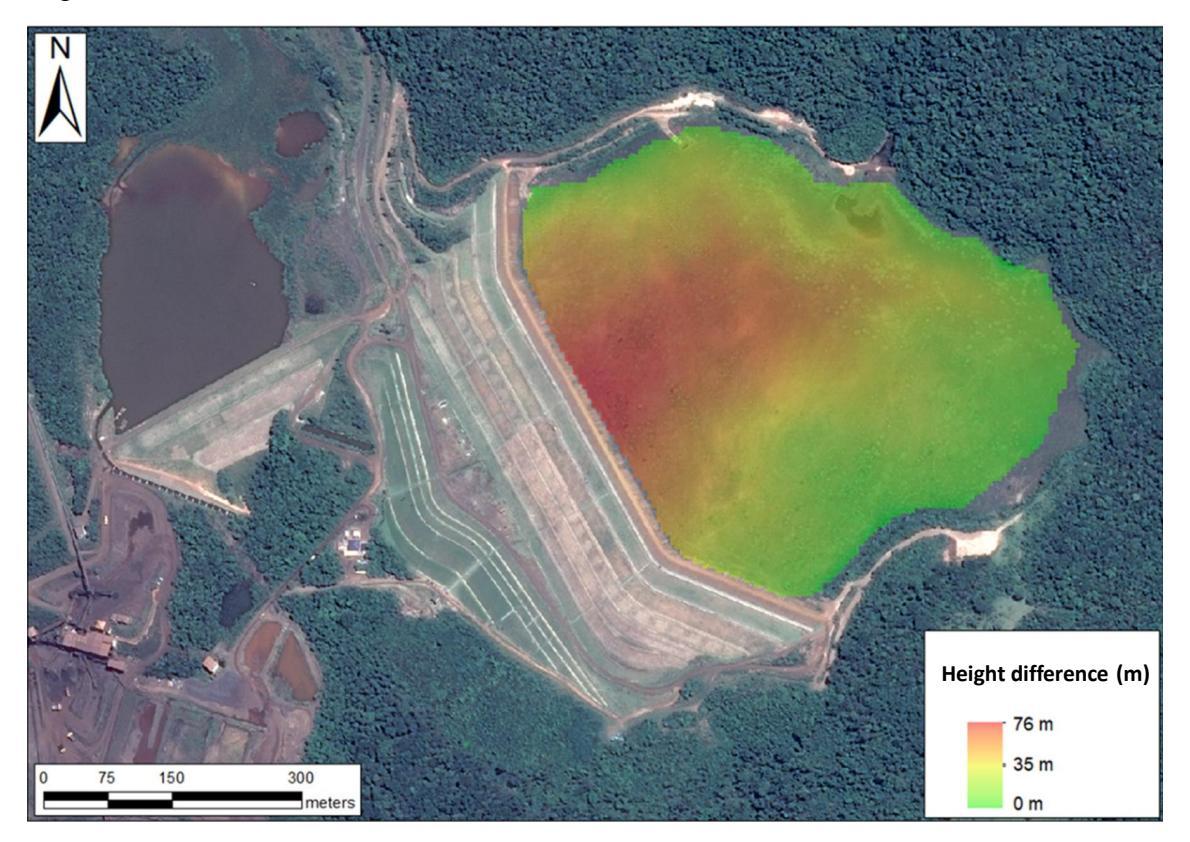
By comparing the pre-dam topography and pre-failure LiDAR point clouds, it was possible to estimate the volume and thickness of the tailings. The estimated volume of tailings stored in the dam at the time of failure is 8,413,000 cubic meters (m³). This number does not include the embankment or tailings under the embankment. The thickness of the tailings is estimated to have reached a maximum depth of 76 m in the central storage portion of the dam and gradually reduces in thickness

Figure 1: Height Difference Between the Original and Pre-failure Topographies, in Relation to the Tailings, Starting from the Crest of the Dam

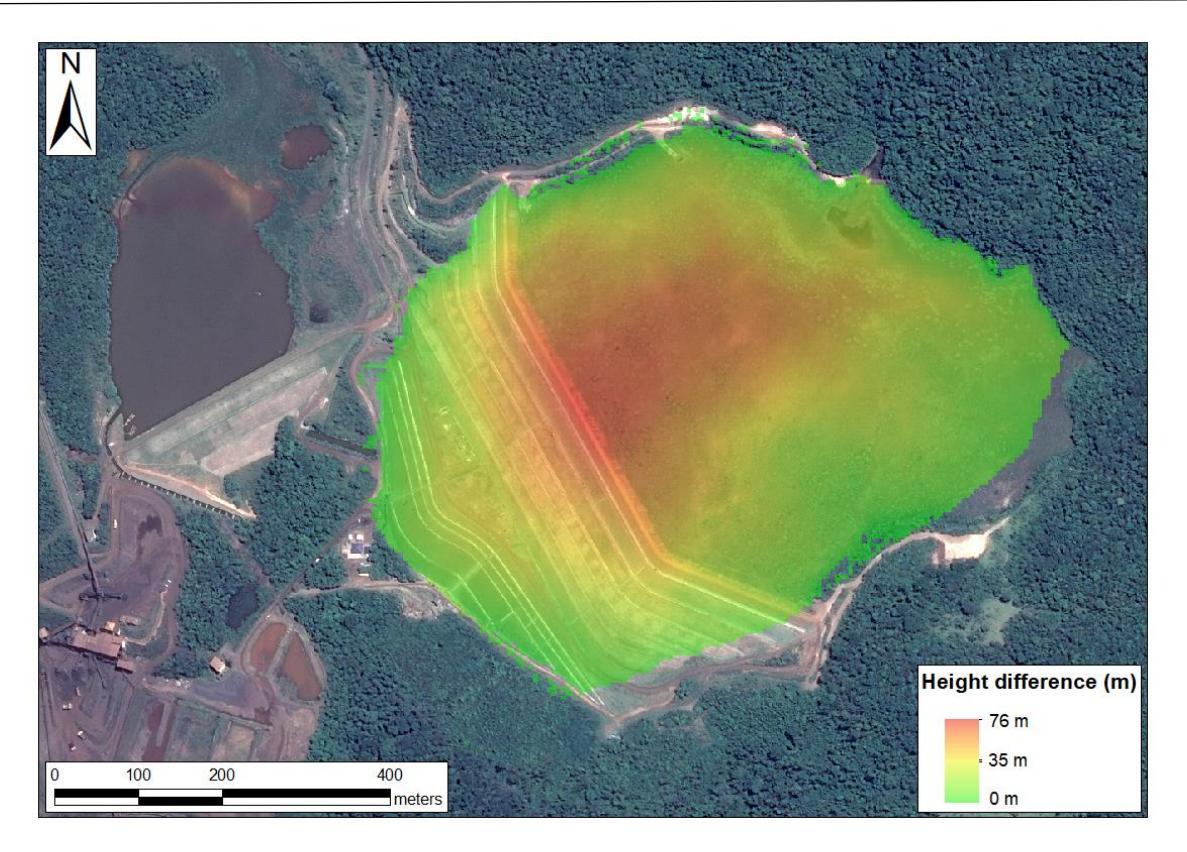
The total volume and thickness of the tailings, including the embankment and the tailings under the embankment, is estimated to have been $12,726,000 \text{ m}^3$. The maximum difference in elevation between pre-dam and pre-failure topography is 76 m in relation to the central portion of the dam's crest (Figure 2).

Figure 2: Height Difference Between the Original and Pre-failure Topographies, Including Embankment and Tailings Under Embankment

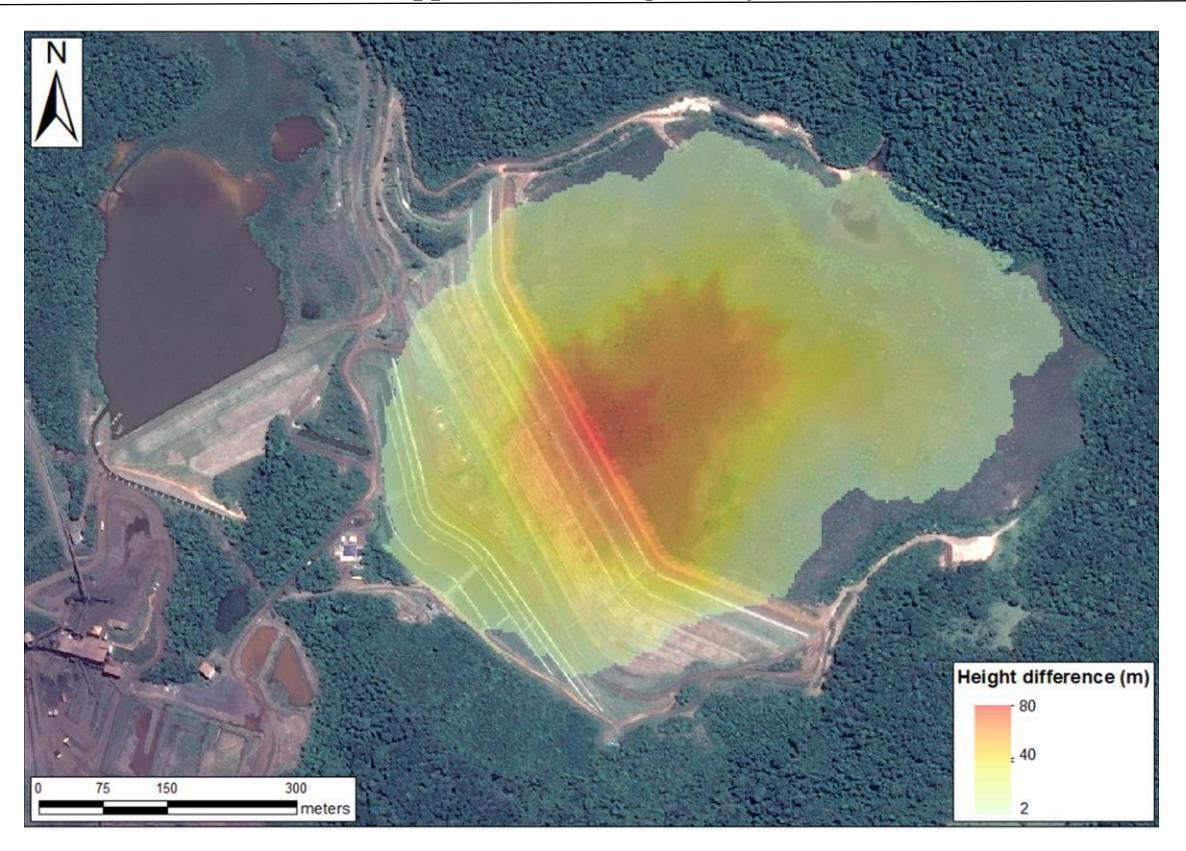
By comparing the pre- and post-failure topographies of Dam I, the volume of the failure is estimated to be $9,651,000 \text{ m}^3$, including the tailings, the dam, and some natural soils. The maximum difference in elevation between the pre- and post-failure surfaces is 79.2 m, located right behind the crest of the dam in the center (Figure 3).

Figure 3: Height Difference Between Pre- and Post-failure Topographies

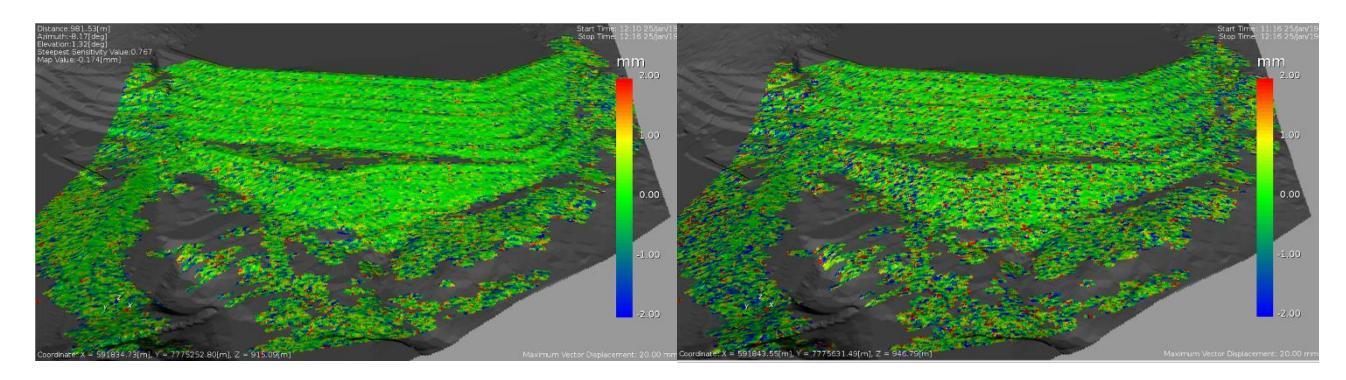
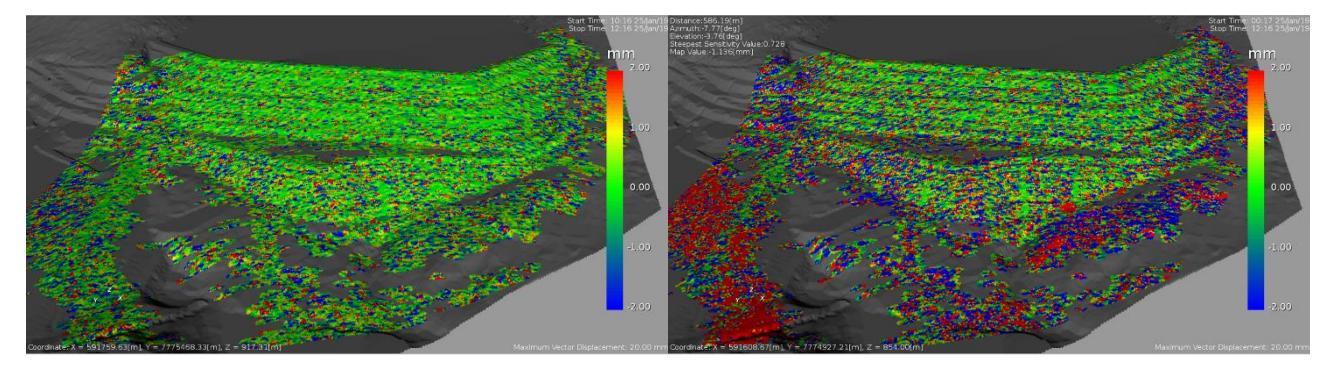
Considering the above described precision, the review of the radar deformation maps for the last 48 h prior to the failure did not detect any deformations above the noise level of the radar (Figure 13). By increasing the temporal window of the cumulative deformation maps to include maps from 2 h, 4 h, 12 h, 24 h, and 48 h prior to failure, it is possible to observe a gradual increase in the deformation values with a scattered spatial distribution without any evident consistent pattern. We interpreted the measured deformation values as the effect of cumulative noise induced by the presence of vegetation on the dam face.

Figure 13: Cumulative Deformation Map from IBIS-FM Radar Covering: (a) time of Failure, (b) 2 h Prior to Failure, (c) 4 h Prior to Failure , (d) 12 h Prior to Failure, (e) 24 h Prior to Failure, and (f) 48 h Prior to Failure

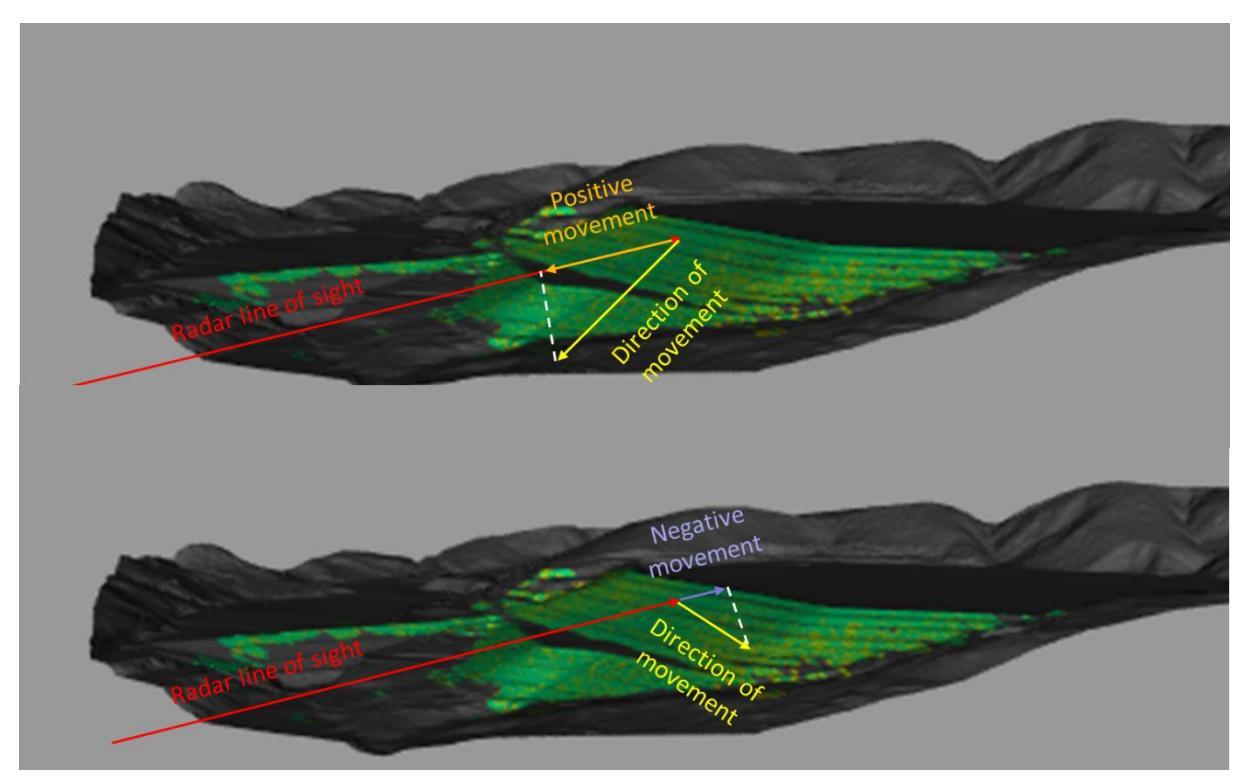
The two largest areas where deformations were reported by the ground-based radar (Areas 3 and 5 of Figure 16) show them directed away from the radar. Such a direction of deformation is not compatible with any reasonable failure mechanism, considering the geometry of the radar line-of-sight and the geometry of the dam (Figure 18).

Figure 18: Sketch Showing the Radar Line-of-Sight Geometry and Sign Convention

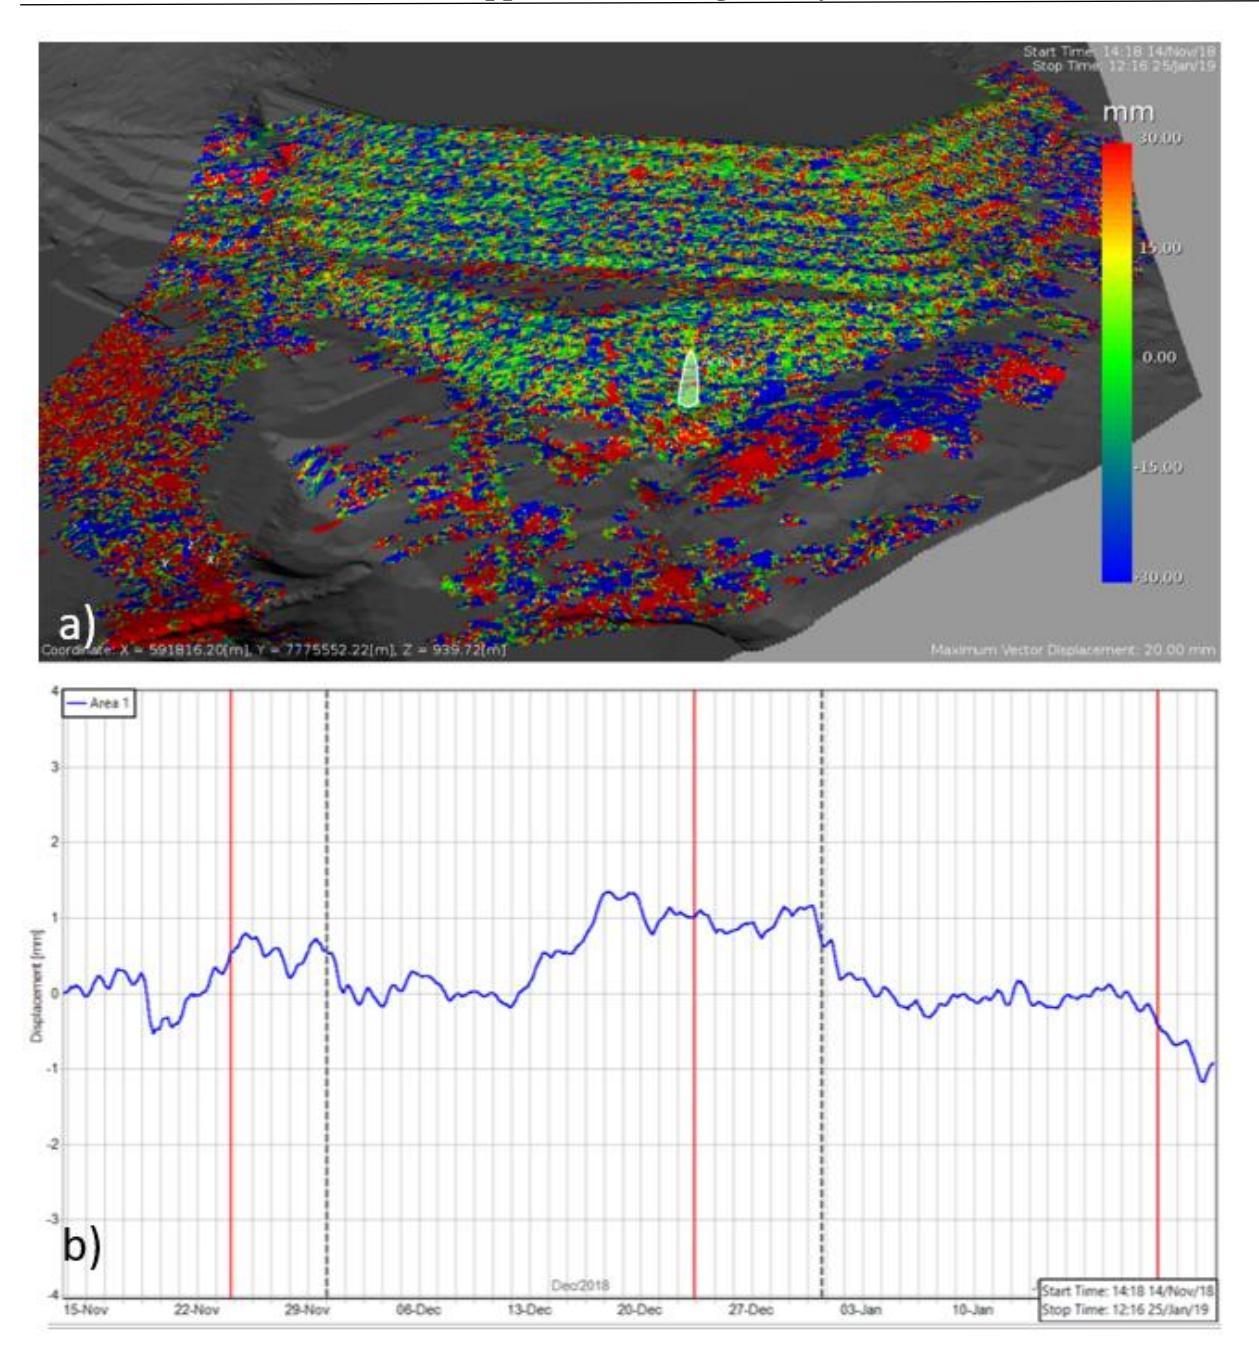
As a further proof of the effect attributable to vegetation moisture in reducing the reliability of the radar measurements, the noise level was lowest along the highly reflective concrete surface channels, which indicated no deformation prior to the failure (Figure 21).

Figure 21: (a) Cumulative Deformation Map for a Concrete Surface Channel From November 14, 2018, to January 25, 2019, and (b) Corresponding Time Series of Deformation

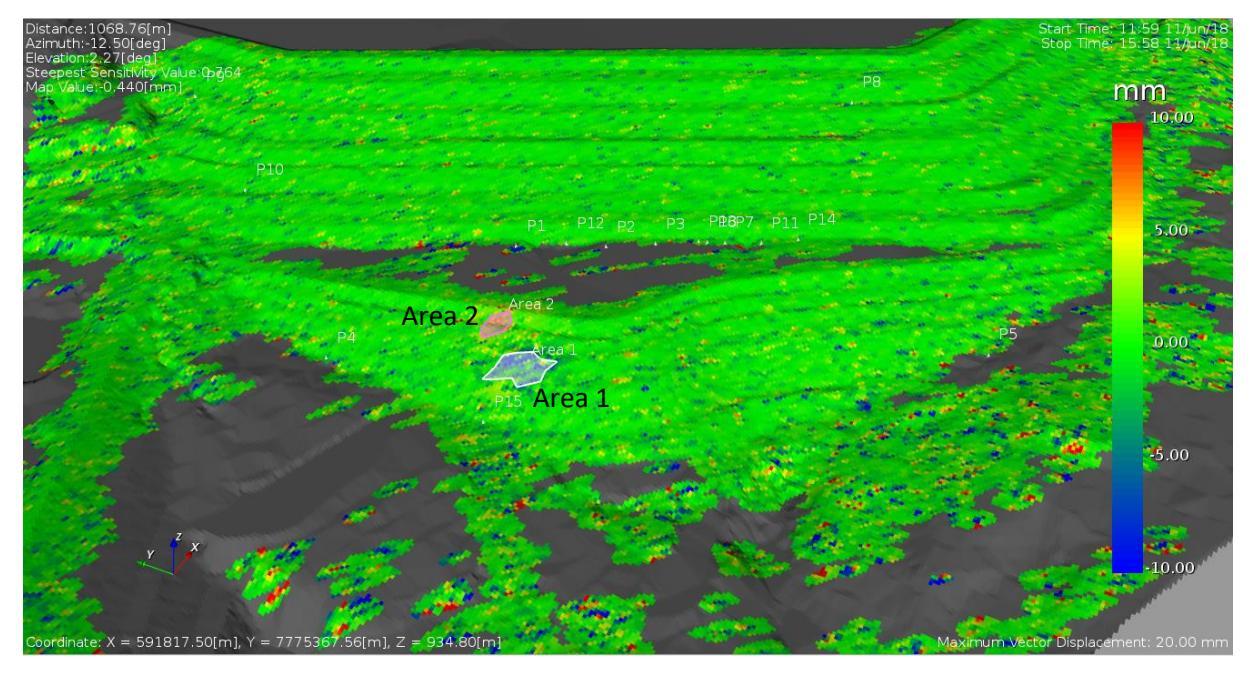
Because these deformations were rapid and occurred in a relatively short period of time, the detected deformations are considered reliable. Notably, the ground based radar did not detect any fast deformations of the type detected in connection with DHP 15 in the months prior to the failure, including during the last radar scan immediately before the visible failure of the dam.

Figure 26: Cumulative Deformation Map from June 11, 2018 11:59 am, to June 11, 2018 3:58 pm

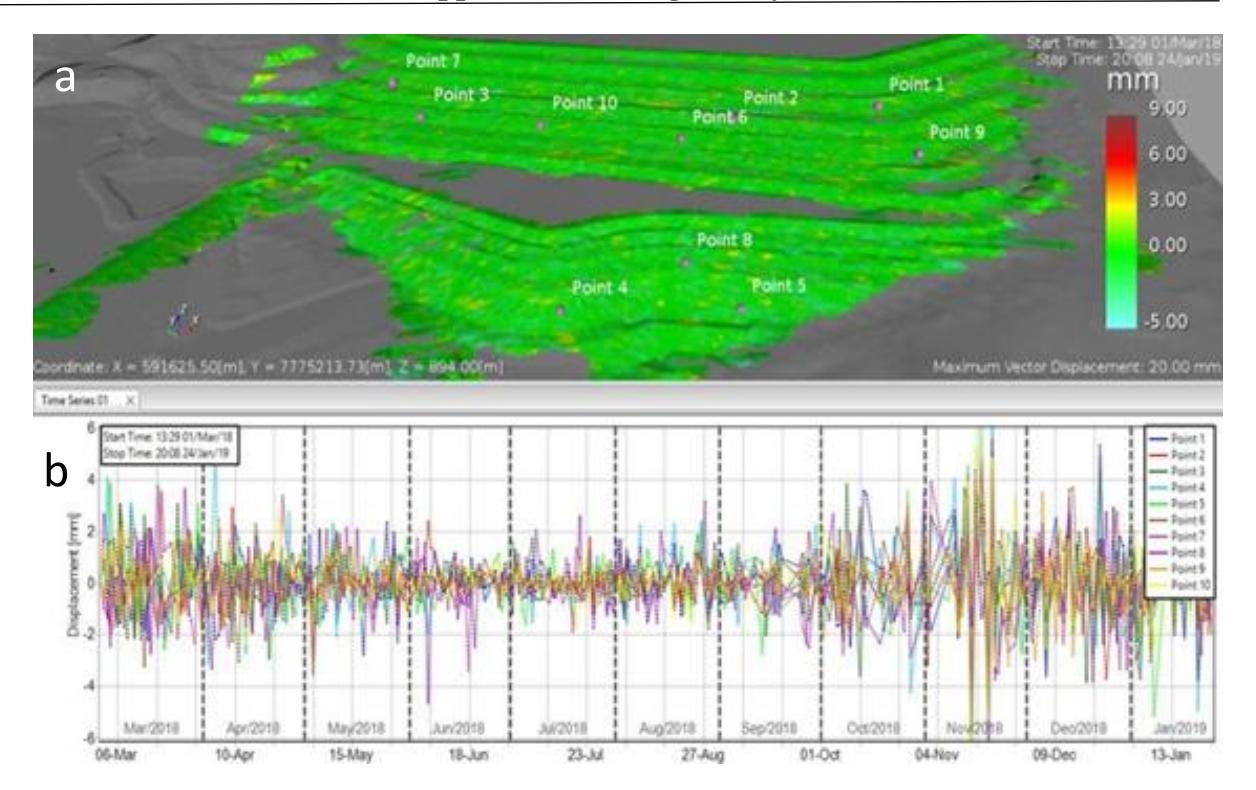
The "slow movement" analysis did not detect any significant deformation along the radar line of sight above the radar noise or the radar minimum detectable velocity (corresponding to 3 mm/month or 36 mm/day, according to the radar manufacturer IDS Georadar) (Figure 28). In January 2019, a signal slightly above the detectable limit was reported in the lower part of the dam toward the left abutment (Figure 29). However, at 3 mm to 4 mm, this is too close to the minimum detectable velocity to be confirmed as actual deformation. In addition, as noted above, the purported deformations reported by the radar do not correlate with those reported by satellite InSAR.

Figure 28: (a) "Slow Movement" Cumulative Deformation Map From March 1, 2018, to January 24, 2019, and (b) Deformation Time Series of Selected Points (as Located on Cumulative Deformation Map)

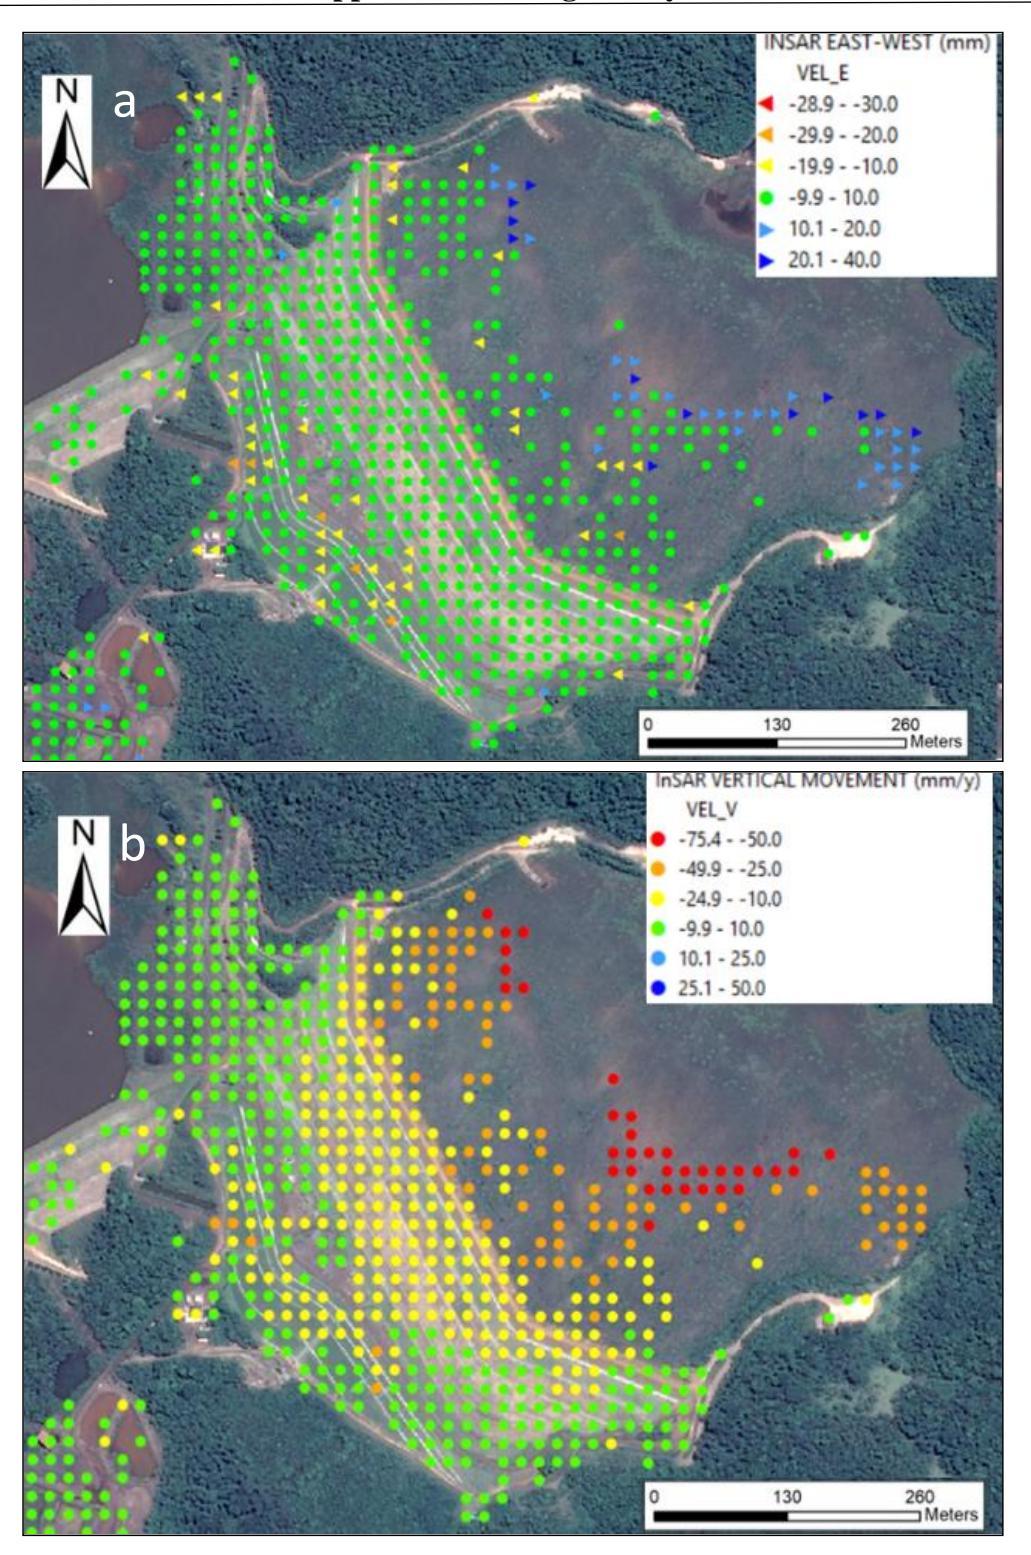
The noted deformations are compatible with: (i) vertical settlements, (ii) deformations with horizontal components toward the west (W), or (iii) deformations with both vertical and Westbound components. The InSAR data provided by the TerraSAR-X dataset along ascending geometries confirm the presence of deformations at the bottom of Dam I (Figure 32). When combining their line-of-sight measurements with those of Sentinel-1, as shown in Figure 33, it is possible to confirm the presence of deformations with both a vertical and a westward component at the bottom of Dam I (Figure 34).

Figure 34: Velocity Map from Decomposed InSAR TerraSAR-X – Sentinel-1 Data: (a) for E-W Components and (b) Vertical Components

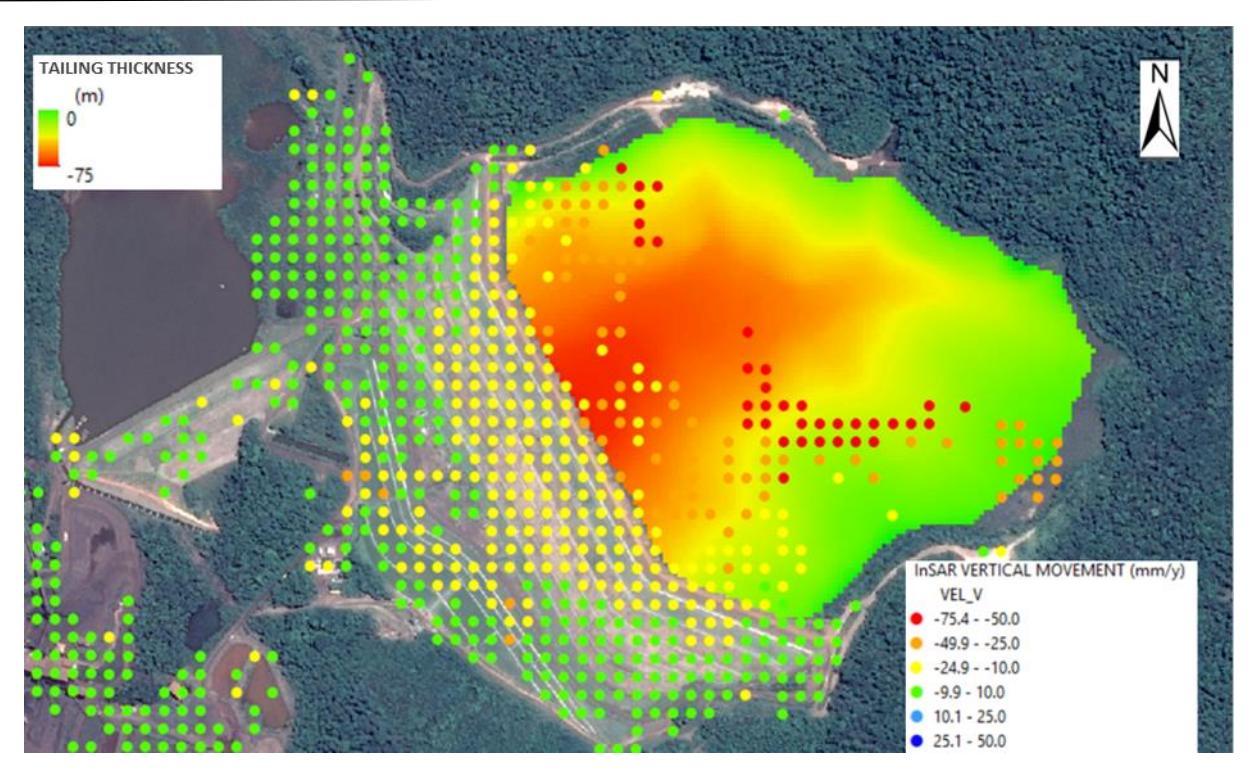
The maximum deformations measured in the tailings over the last year prior to the failure did not coincide with the maximum depth of tailings, but were located far from the crest of the dam. It is difficult to separate ongoing consolidation of the tailings from deformation of the dam, based on the time period of the InSAR data available. Ongoing consolidation would be expected to decrease with time, while deformation of the dam would be expected to accelerate towards the time of failure. Given that no acceleration is present here, it appears that the detected deformations are associated with the consolidation process.

Figure 39: Vertical Velocity Map From InSAR Visualized Over Thickness of Tailings

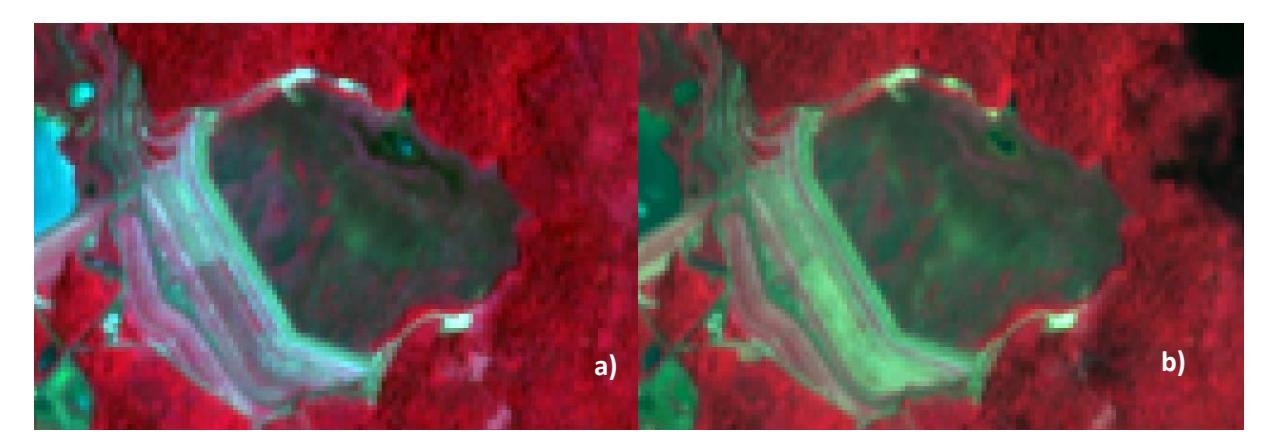
Figure 55: Comparison Between the S-2 Acquisitions on (a) January 7, 2019, and (b) after 10 days (January 17, 2019). Note the Shrinking of the Wet Area in the Northern Part of Dam I

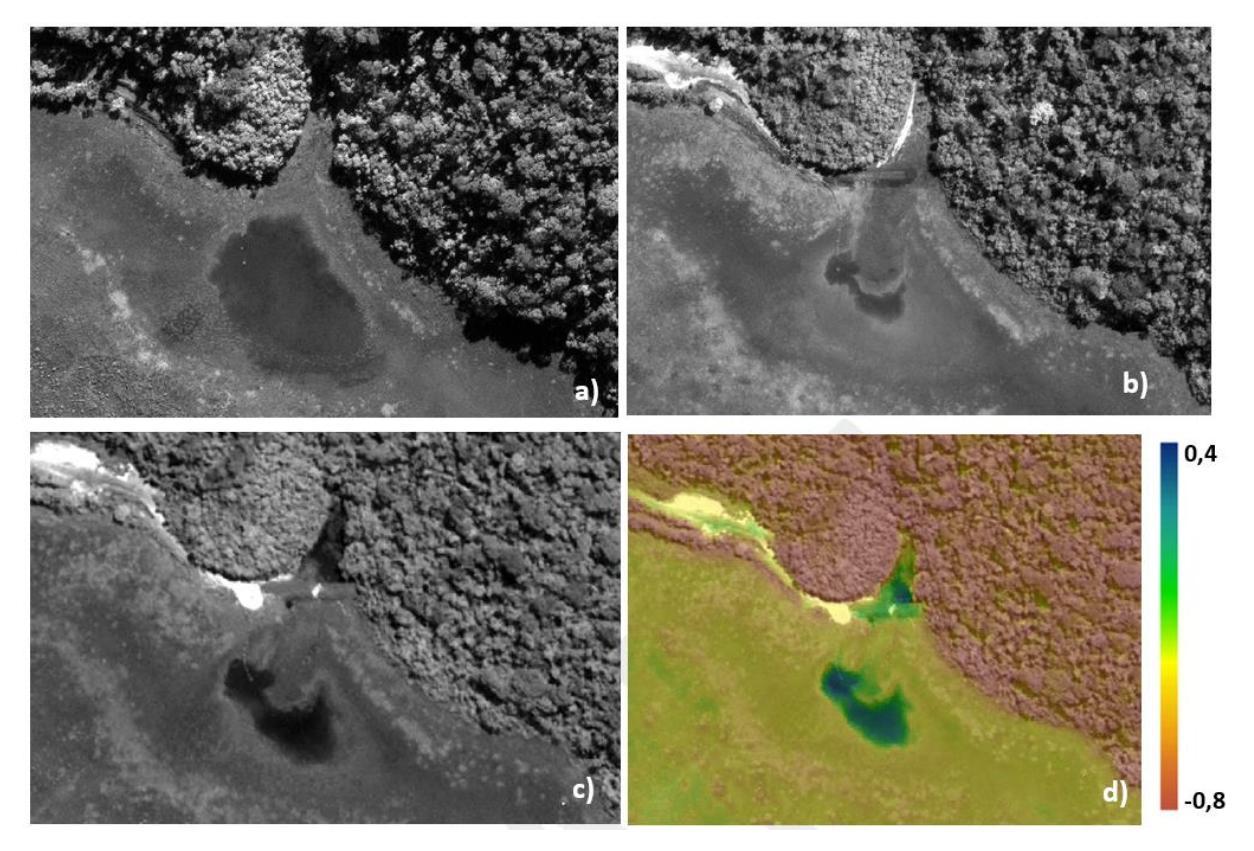
Figure 57: Possible Damming of Main Dam I Inlet by an Earth Berm. (a) Area in June 2018;
(b) Starting of Inlet Damming in September 2018; (c) Dam is Complete in January 2019; and
(d) Water Concentrates Upstream, Confirmed by NWVI Index

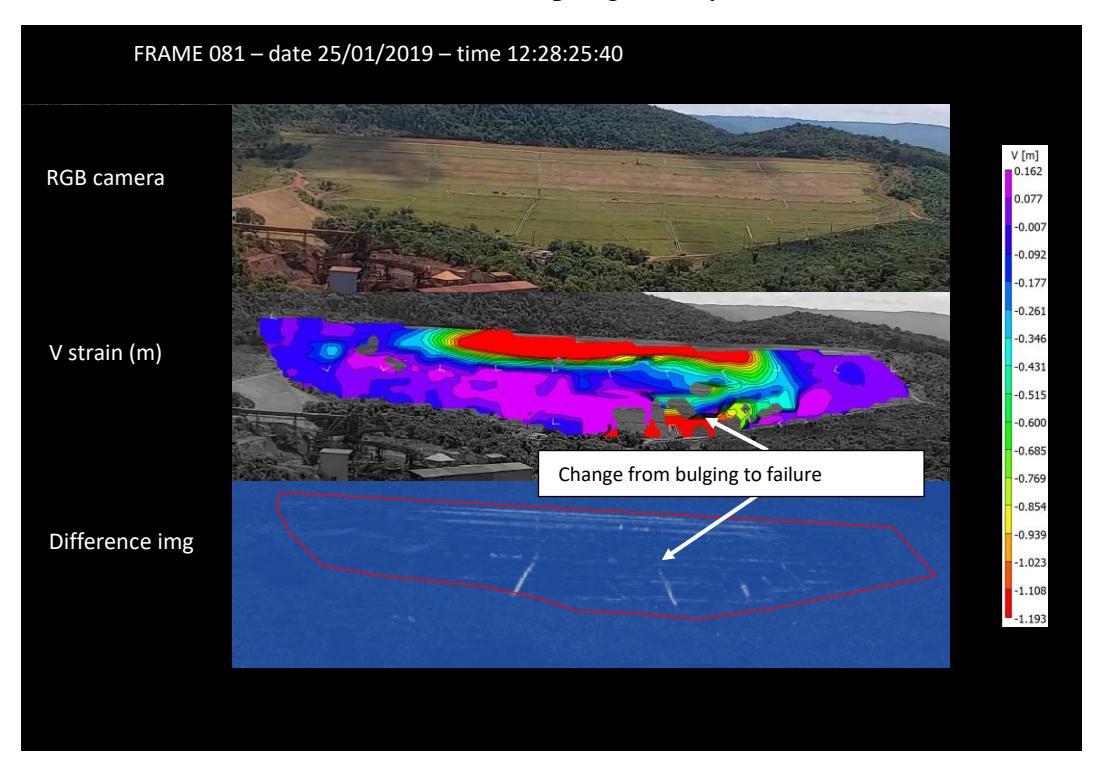
Figure 76: Change from Predominantly Bulging to Predominantly Vertical Collapse of the Central-right Part of the Dam Face

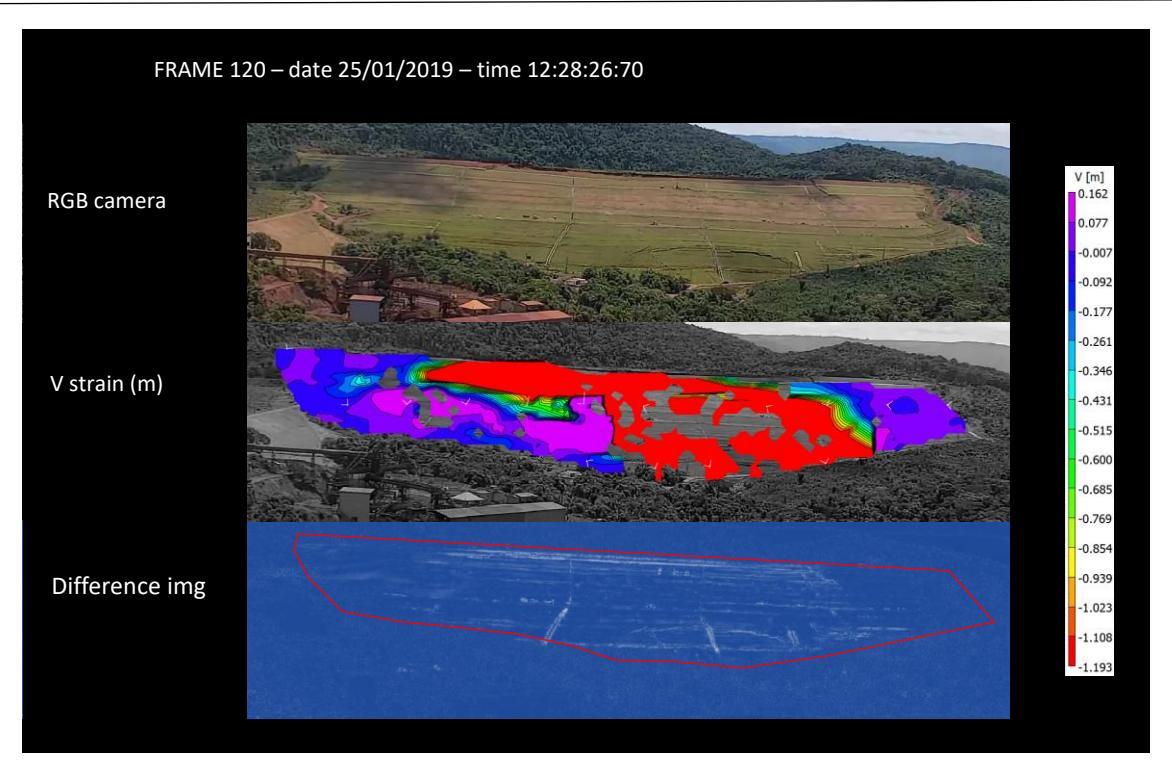
Figure 77: At Frame 120, Two Failure Zones Join and General Dam Failure Starts

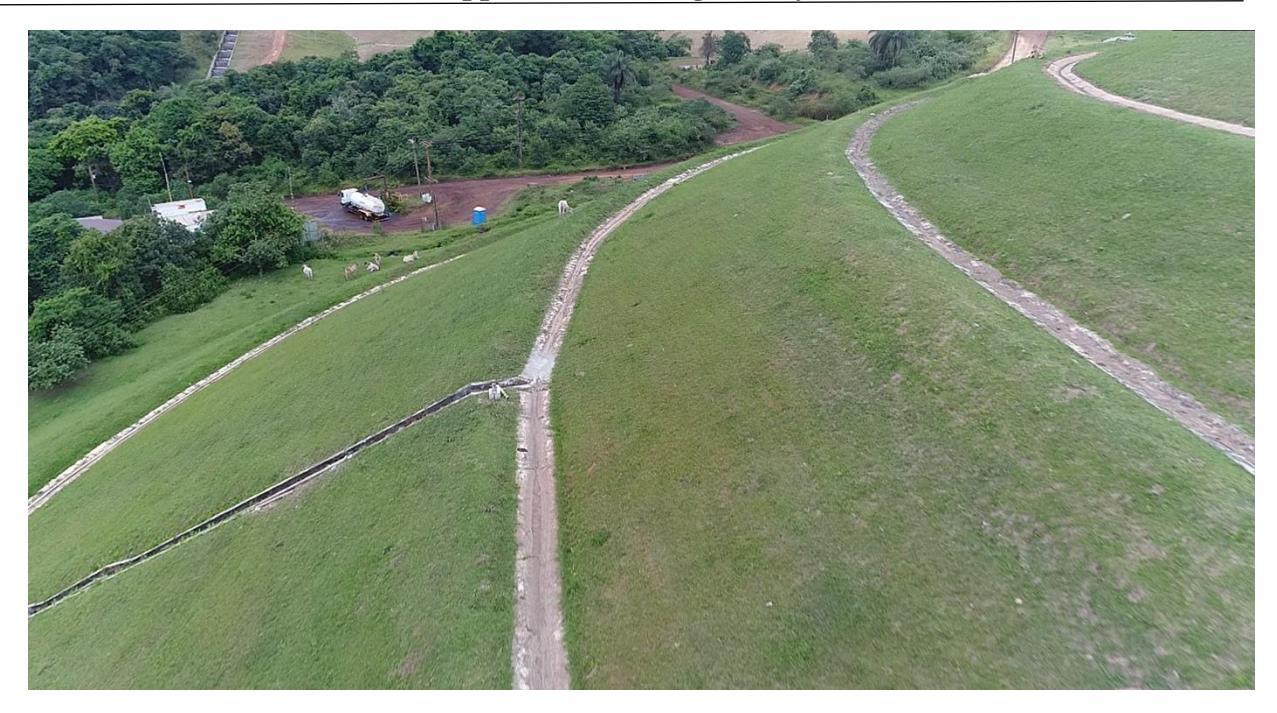
Figure 82: Drone Footage at 06:50 of Video DJI_0143.mov Showing Greener Vegetation in Lower Part of Dam Compared to Central and Upper Parts
