Report of the Expert Panel on the Technical Causes of the Failure of Feijão Dam I
Addendum to Appendix F

Addendum to Appendix F

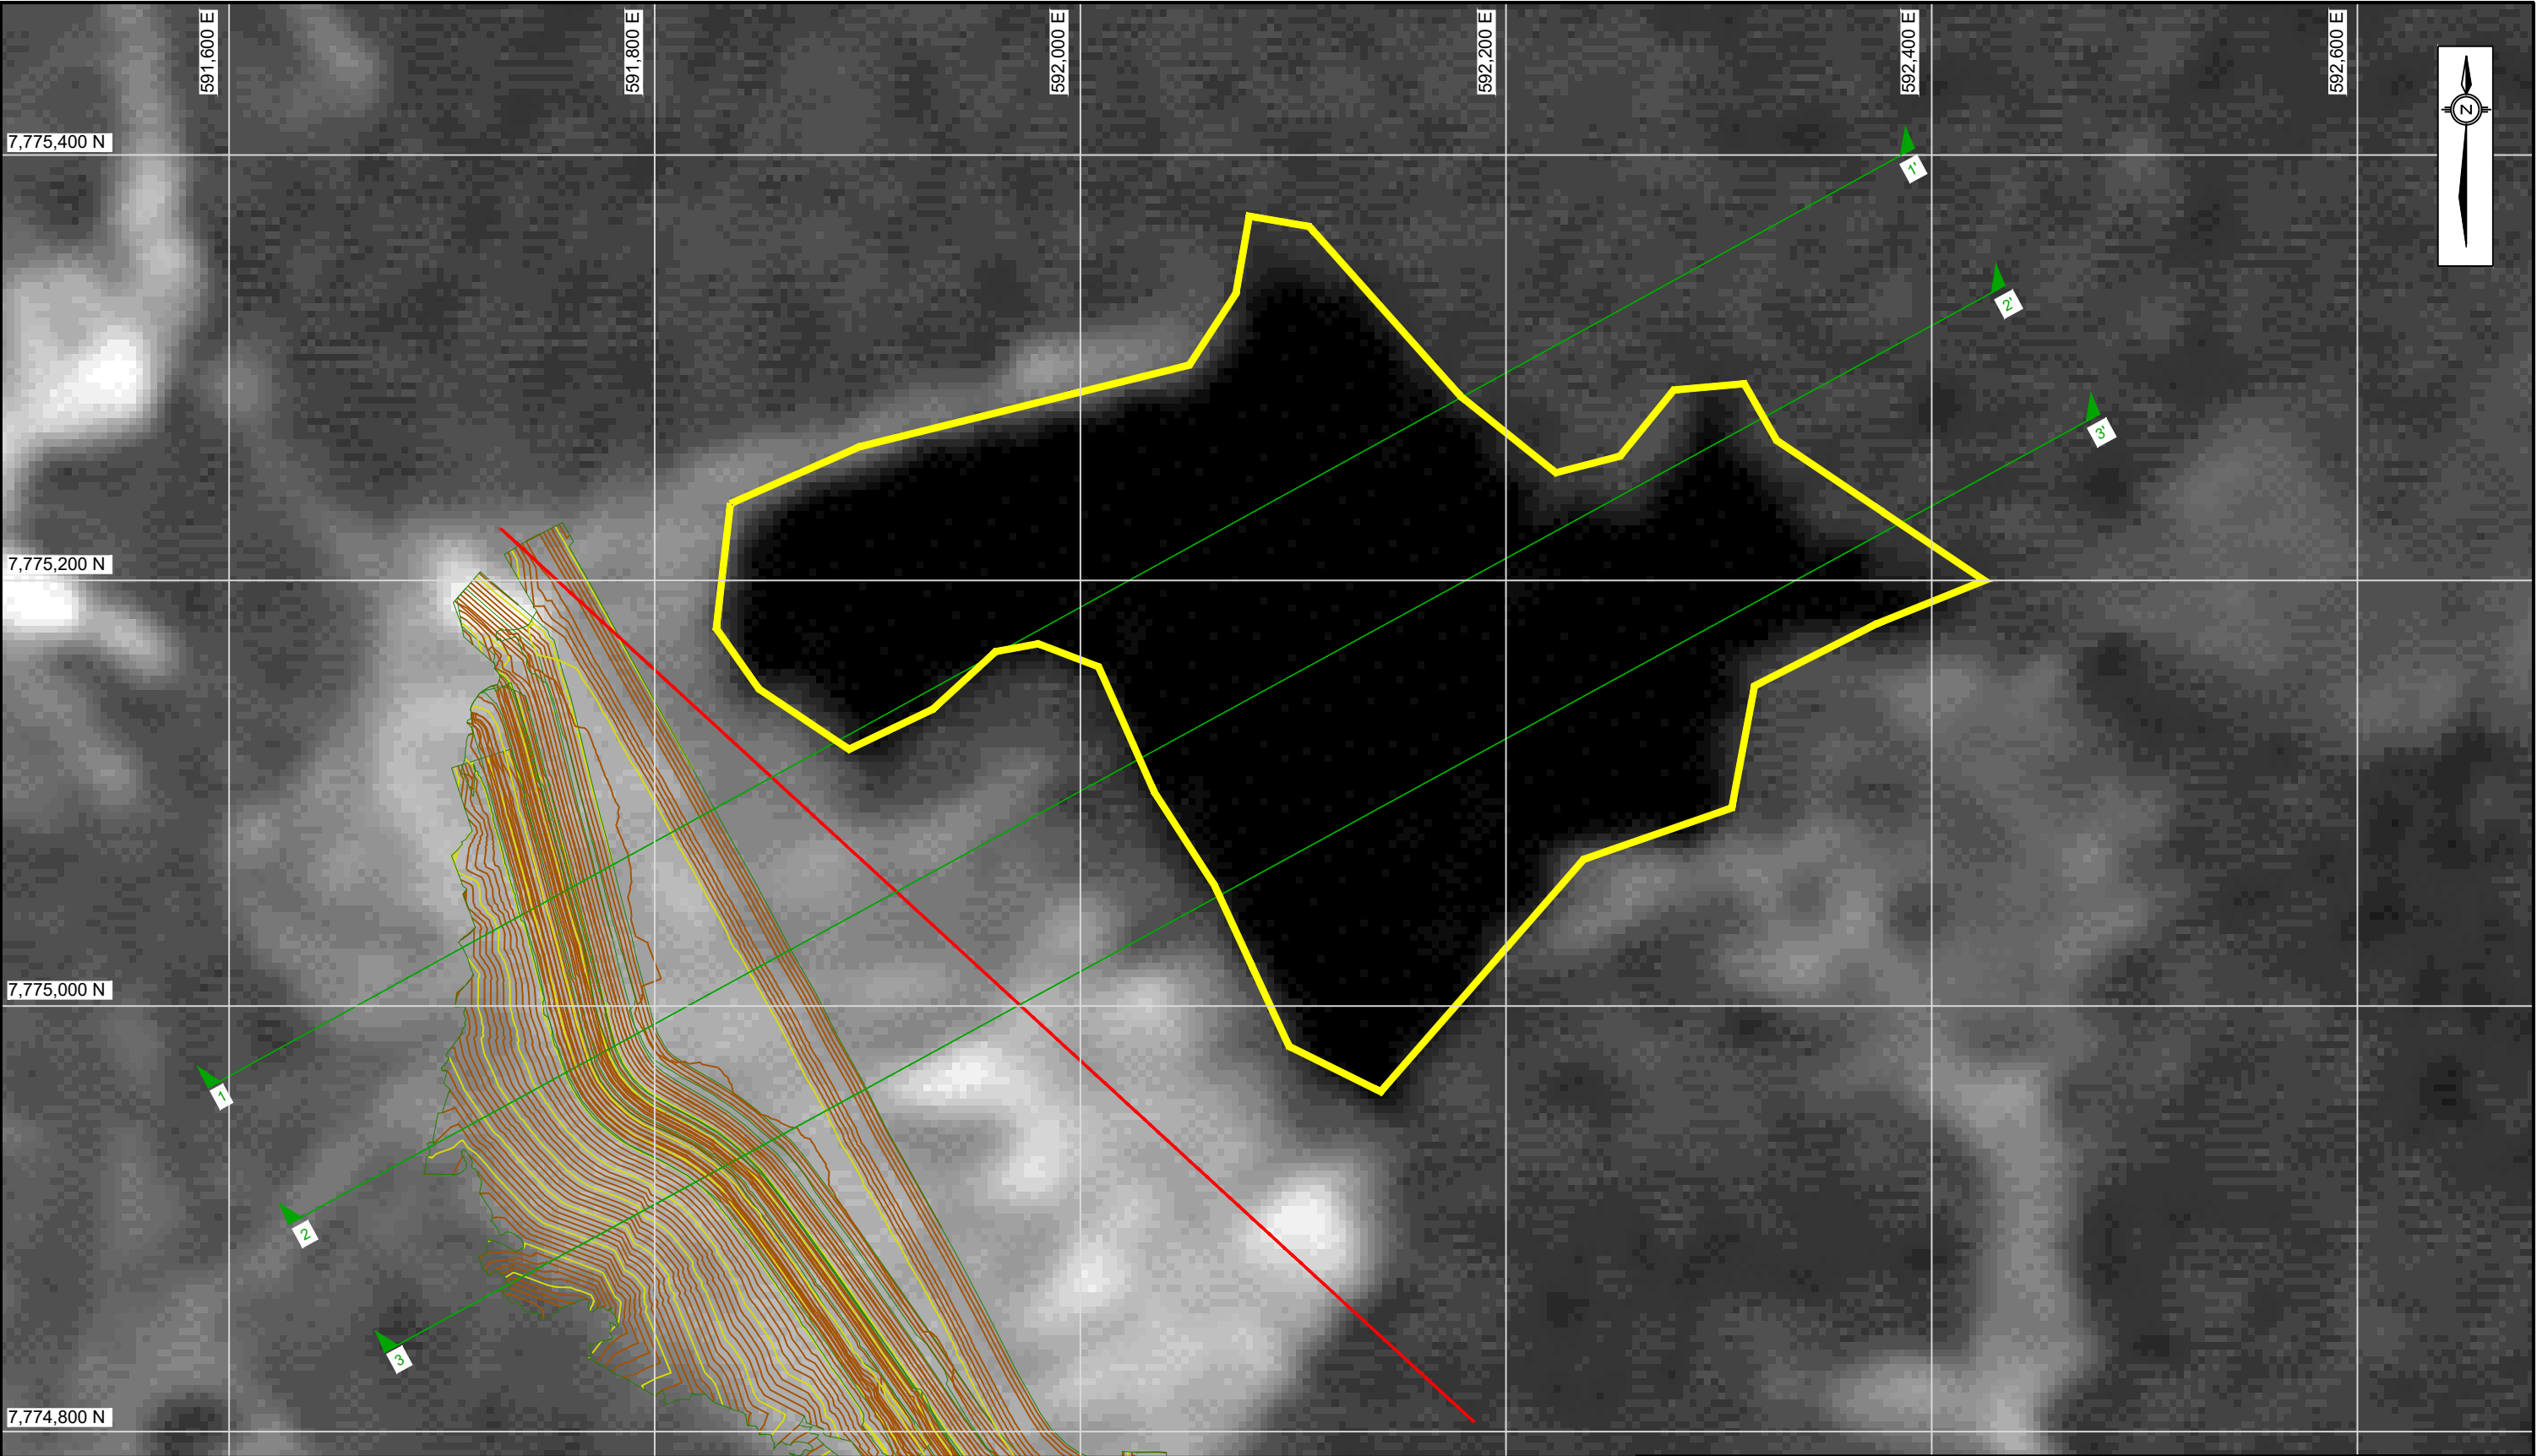
CLIENT	
PROJECT	
REPORT OF THE EXPERT PANEL ON THE TECHNICAL CAUSES OF THE FAILURE OF FEIJÃO DAM 1- SUPPLEMENTAL ASSESSMENT	
TITLE	
SATELLITE IMAGES JULY 28, 1997 (S) RAISE #9 DAM CREST EL. 905 m	
SCALE	PROJECT No.
1:3,000	A03355A02
FIG. No.	
FIGURE I-78

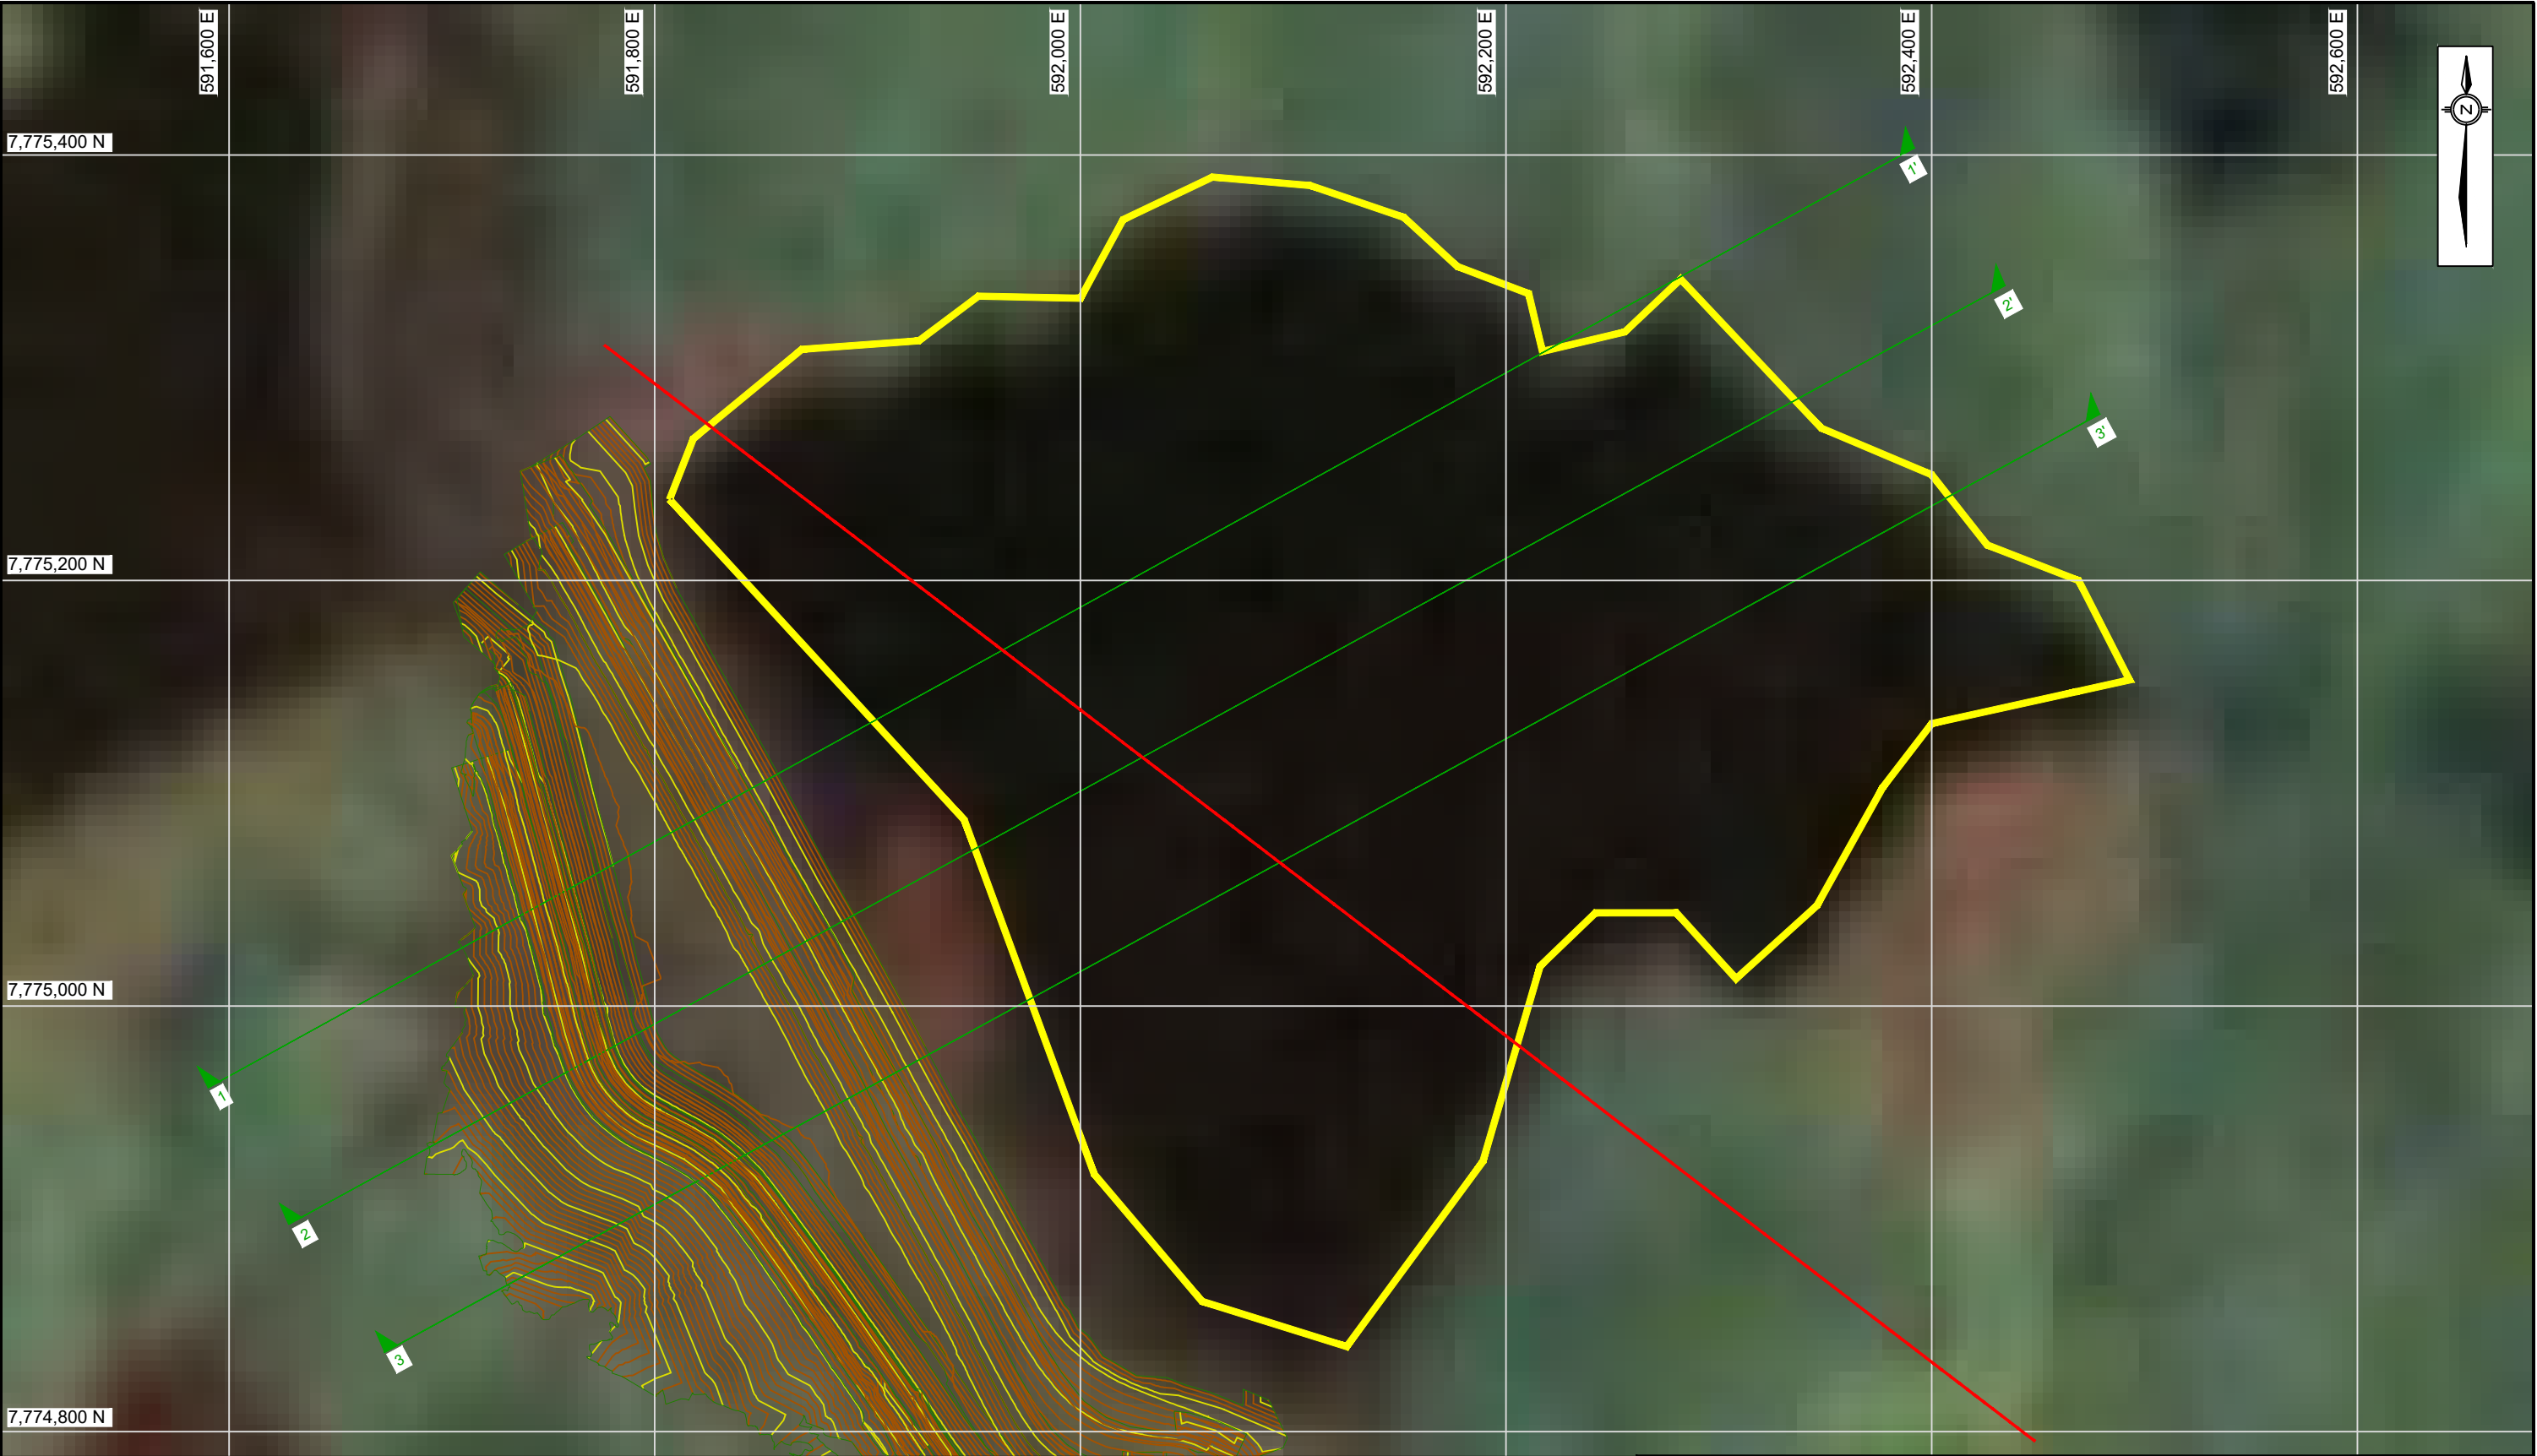
CLIENT	
PROJECT	
REPORT OF THE EXPERT PANEL ON THE TECHNICAL CAUSES OF THE FAILURE OF FEIJÃO DAM 1- SUPPLEMENTAL ASSESSMENT	
TITLE	
SATELLITE IMAGES JULY 26, 2002 (S) RAISE #11 DAM CREST EL. 916.5 m	
SCALE	PROJECT No.
1:3,000	A03355A02
FIG. No.	
FIGURE I-94

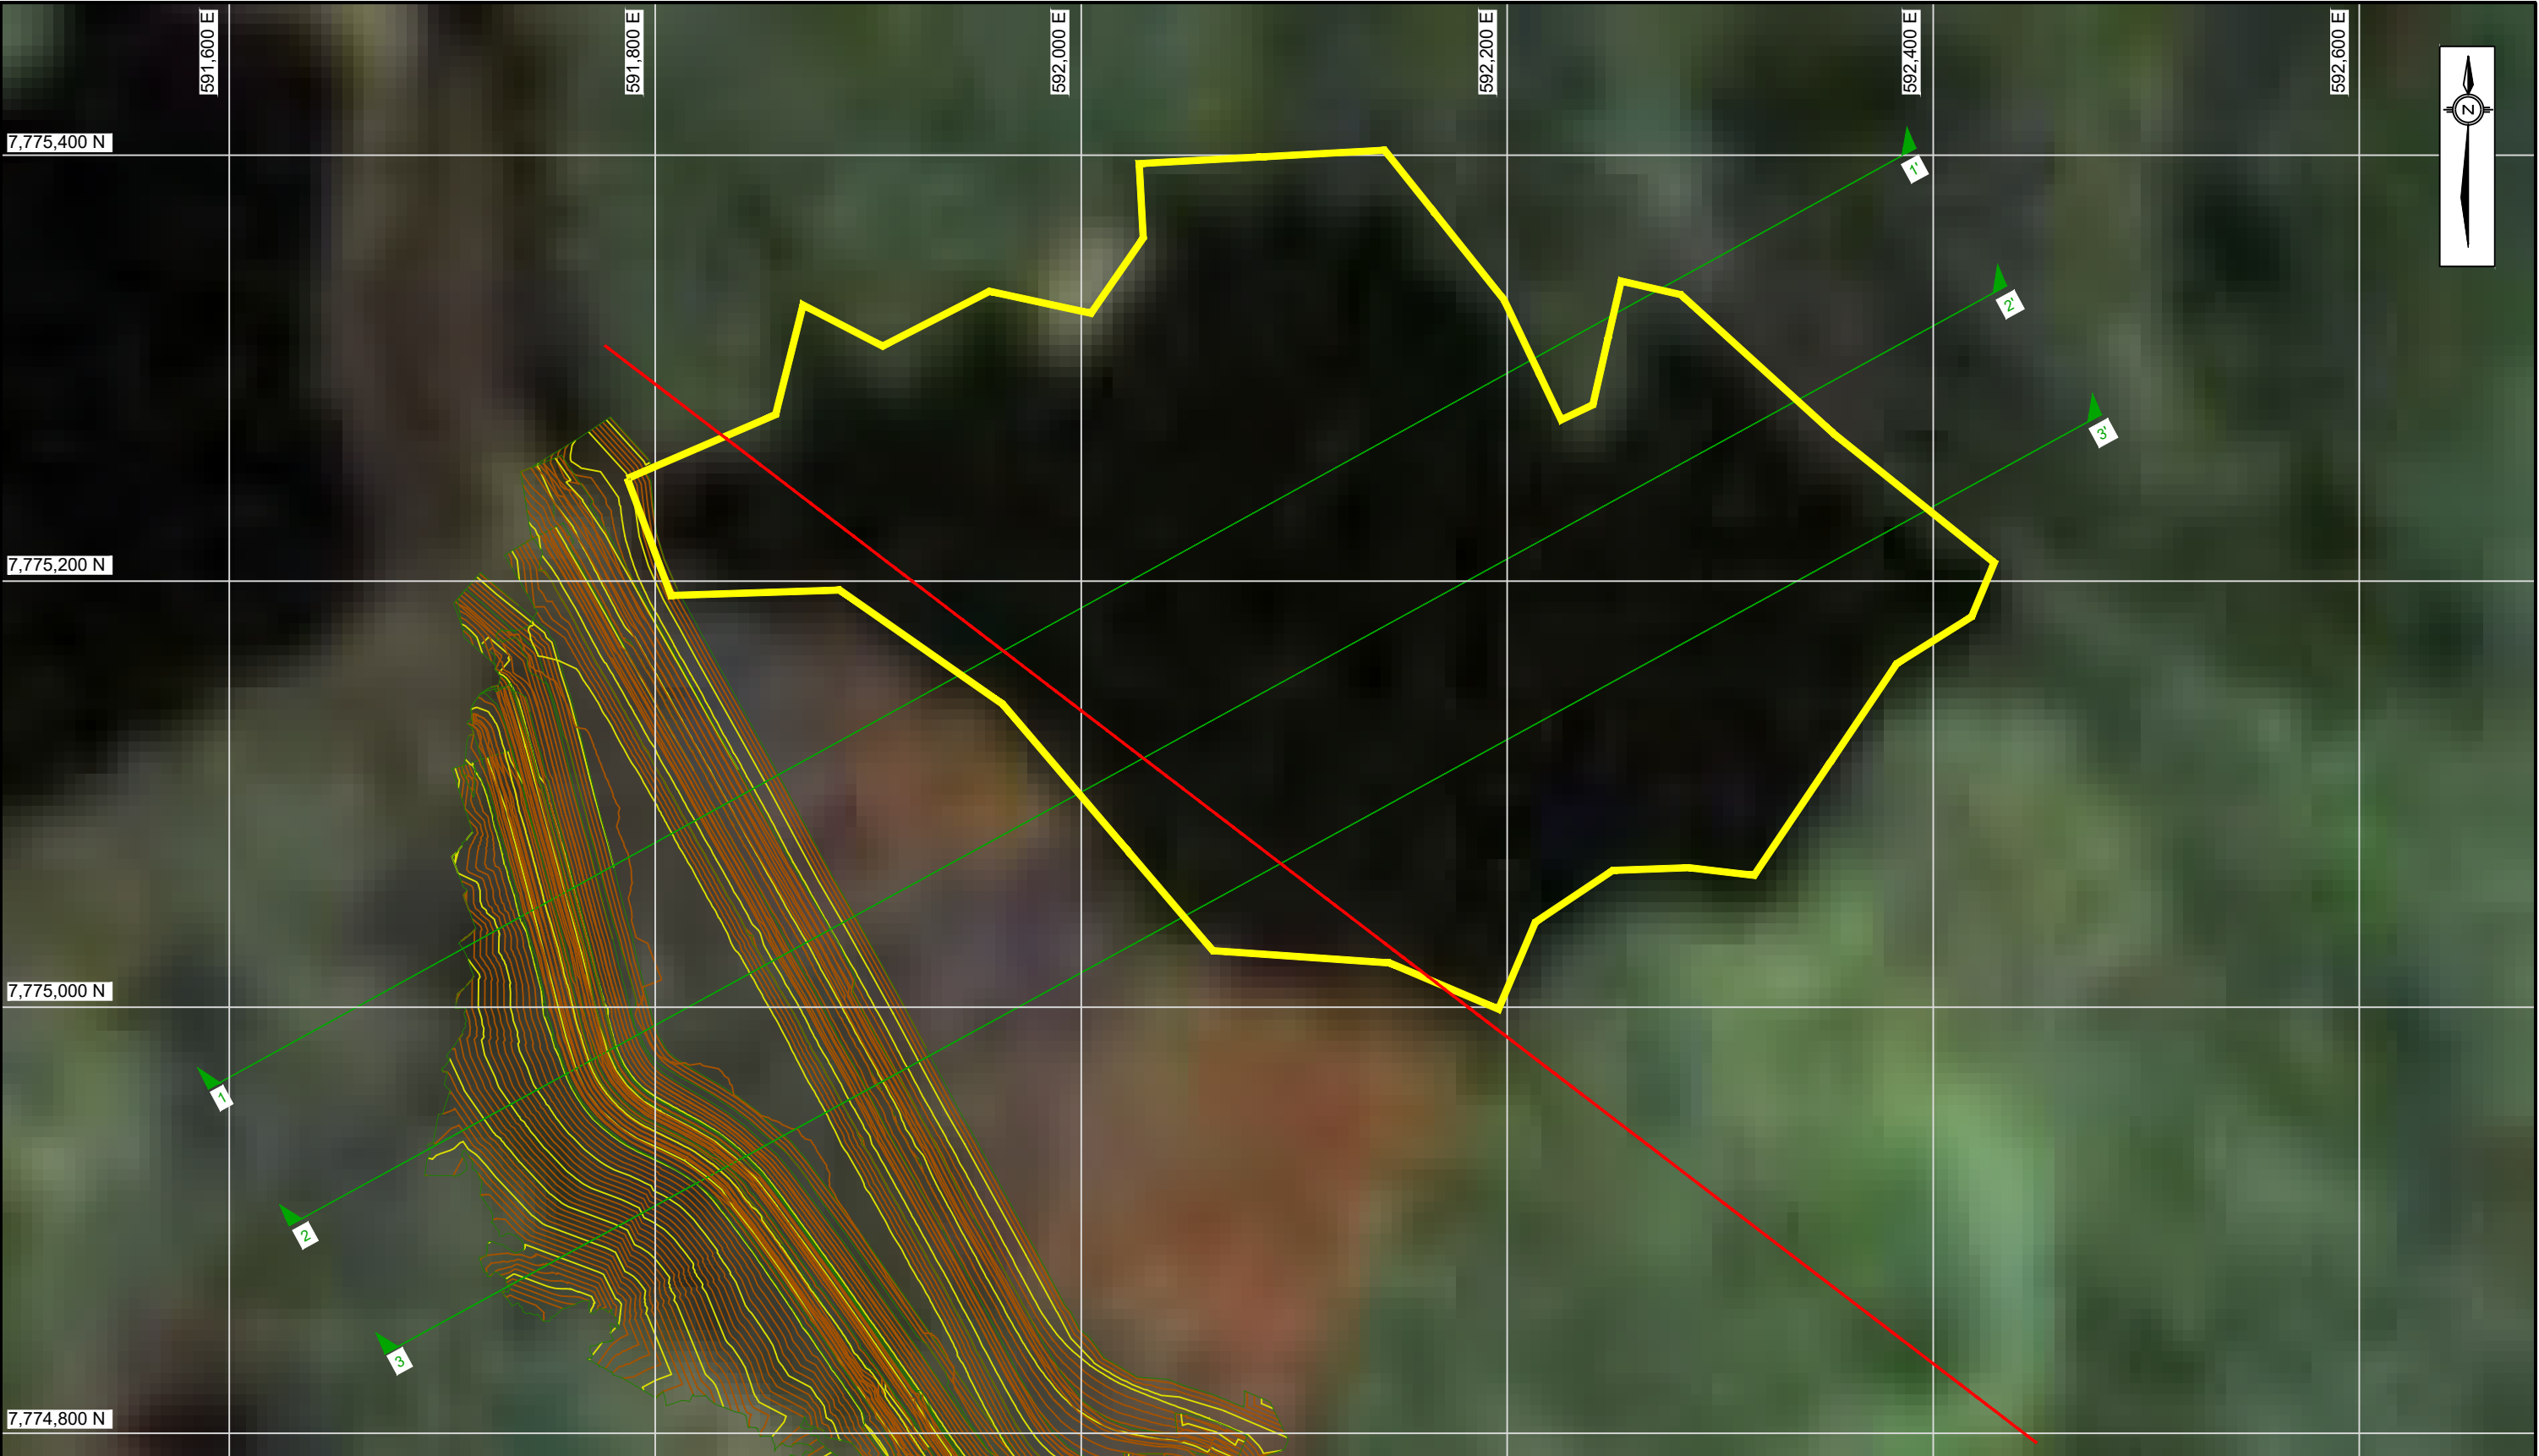
SCALE 1:3,000	PROJECT No. A03355A02	FIG. No. FIGURE I-95
------------------	--------------------------	-------------------------

TITLE
**SATELLITE IMAGES
JANUARY 10, 2003
RAISE #11
DAM CREST EL. 916.5 m**
