History of Construction

December 2019

Report of the Expert Panel on the Technical Causes of the Failure of Feijão Dam I
Appendix A – History of Construction

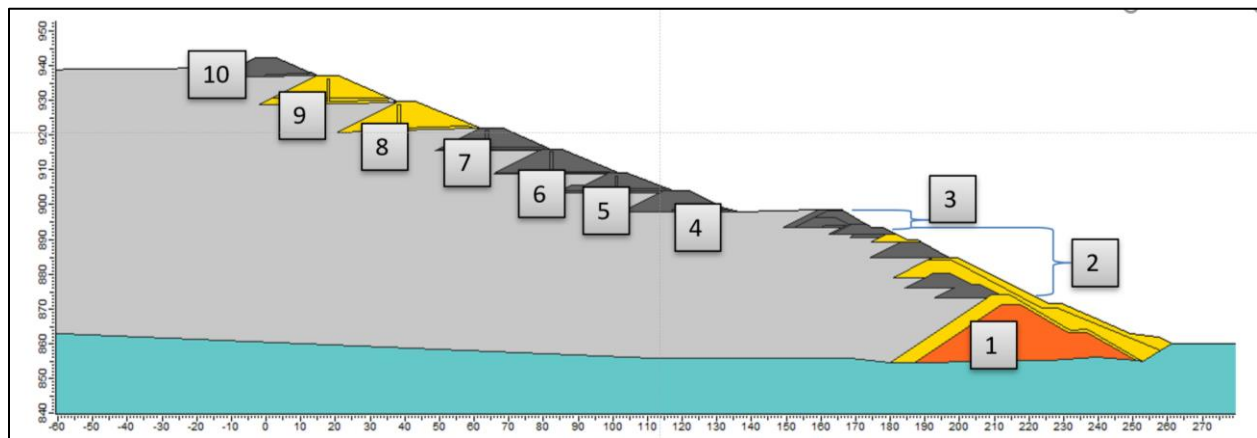
Figure 3: Dam I Cross-section Showing Raisings and Stages of Construction¹²

identified in Table 1, and the raisings and stages for Dam I are illustrated in the cross-sectional view in Figure 3.

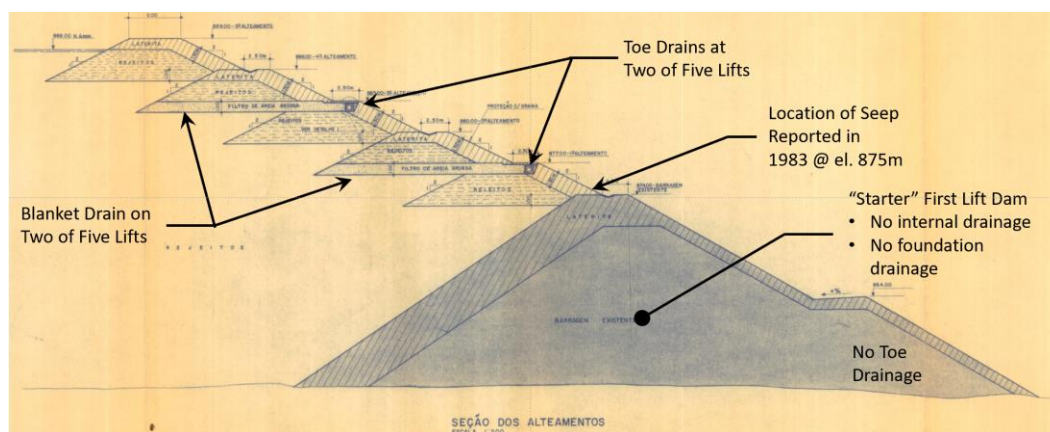
Figure 8: Second Raising Cross-section (Initial Design)³⁶

The initial Second Raising design described a series of five stages, each having a height of 3 m, to raise the dam to a crest elevation of 889 m msl using the upstream construction method.³⁹ The design cross-section is shown in Figure 8. The design includes stages constructed of compacted coarse tailings, covering of the downstream slope with a 1.5-m thick layer of compacted laterite, and inclusion of horizontal drainage blankets in two of the stages (see internal drainage discussion in Section 5.3.2.2). The design approach addressed the surface water drainage system and decants, the dam itself, and the use of tailings to construct the raising. The design discusses the importance of the formation of the beach to the stability of the dam and the function of the beach in the formation of materials suitable for use in the future stages of dam construction.⁴⁰

The initial Second Raising design is shown above in Figure 8. The design called for dam upstream and downstream slopes of 2H:1V. Downstream slopes were designed having a 1.5 m-

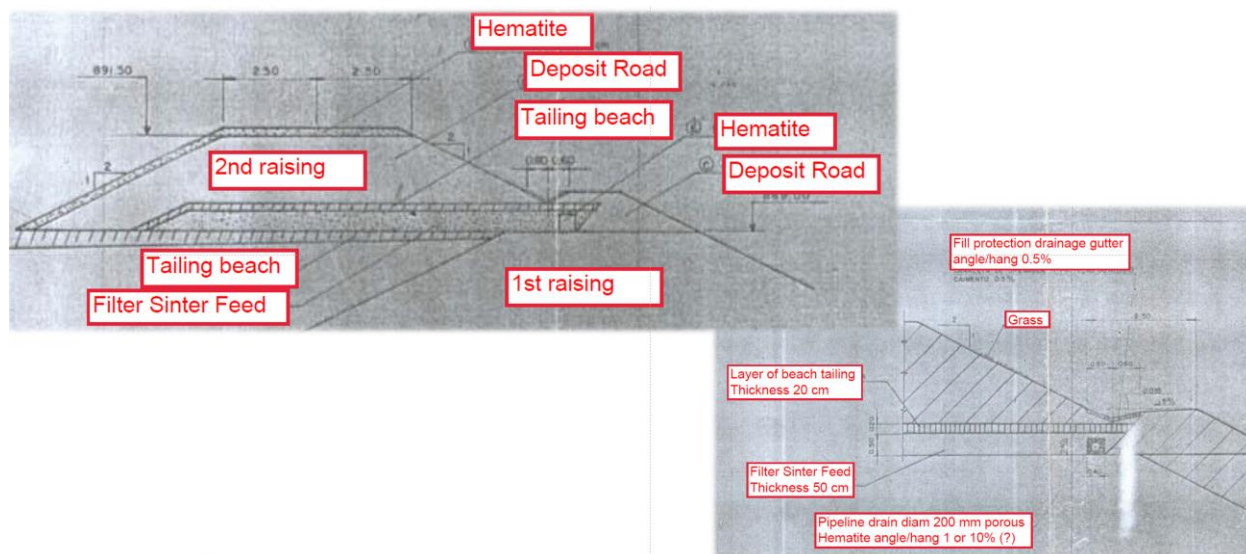
Figure 10: Second Raising Internal Drainage Detail (Stage 2)⁴³

Internal drainage for the Second Raising initial design was to consist of sinterfeed or crushed stone horizontal filters (“drainage blankets”) at the base of the second and fourth of the five planned Second Raising stages.⁴² A cross-section of the Second Raising, second step (also referred to in Table 1 as the “Stage 3 berm”), and the drainage blanket are shown in Figure 10. The filter was designed to reduce the hydrostatic pressure behind Dam I. In Figure 10, within the 50-cm (i.e., about 18-inch) thick sinterfeed layer, a longitudinal pipe that slopes towards the abutments was specified. This pipe appears to discharge at intervals to the surface channels on the dam, but this is not clear in the design documents that are available. These discharge pipes appear to correlate to flow meter devices, which were used to measure flows from the drains (see Section 7 of Appendix C for discussion of drain flow instruments and measurements), although the available documents do not provide a clear correlation between these pipes and the location of any specific drain flow measurement device.

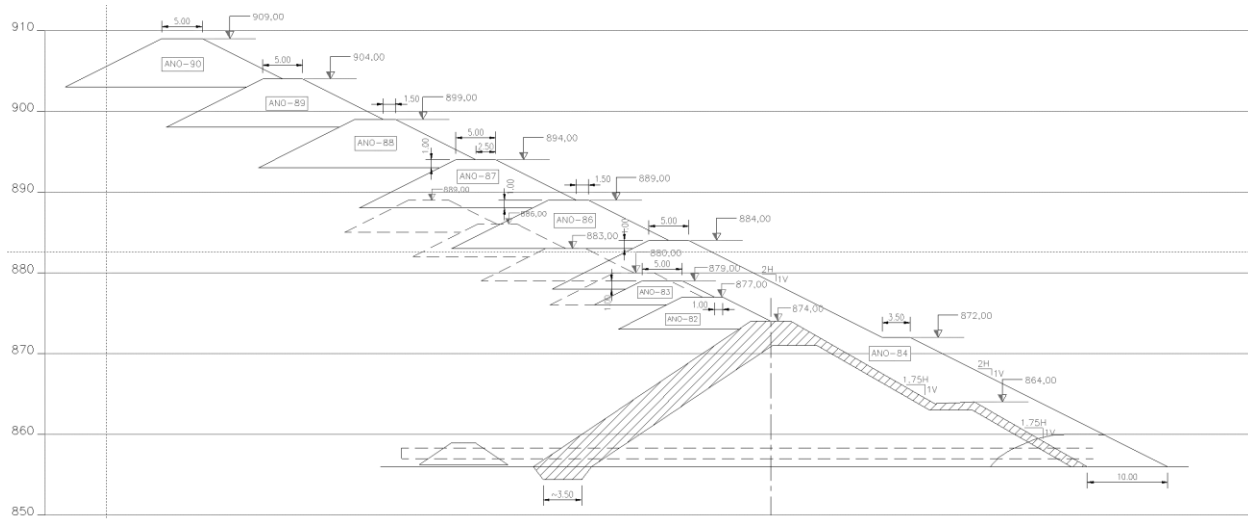
Figure 12: Revised As-Designed Second Raising Stages⁶³

raise the dam crest to El. 909 m msl using the upstream method.⁶¹ The approach is illustrated in Figure 12. The design called for a drainage blanket at the base of each of the five stages above the centerline stage (i.e., above Stage 4). Although the concept and importance of the beach was discussed in the initial design of the Second Raising,⁶² it was not discussed in any of the revised Second Raising design documents.

The layout of the as-designed revised Second Raising is shown in Figure 12 above. The geometry of the stages called for a compacted soil slope having a grade of 2H:1V on the downstream side and, apparently, a similar slope on the upstream side. A channel was apparently intended between stage berms to manage surface water. The geometry of the centerline stage is shown as extending over the downstream side of all lower stages and having a top elevation of 884 m msl. The subsequent five stages were planned to be approximately 5 m high to raise the dam to El. 909 m msl using tailings from the beach. A 1.5-m thick compacted laterite facing was planned on the downstream slopes of the revised design Second Raising berms with slopes of 2H:1V to protect the dam from erosion.

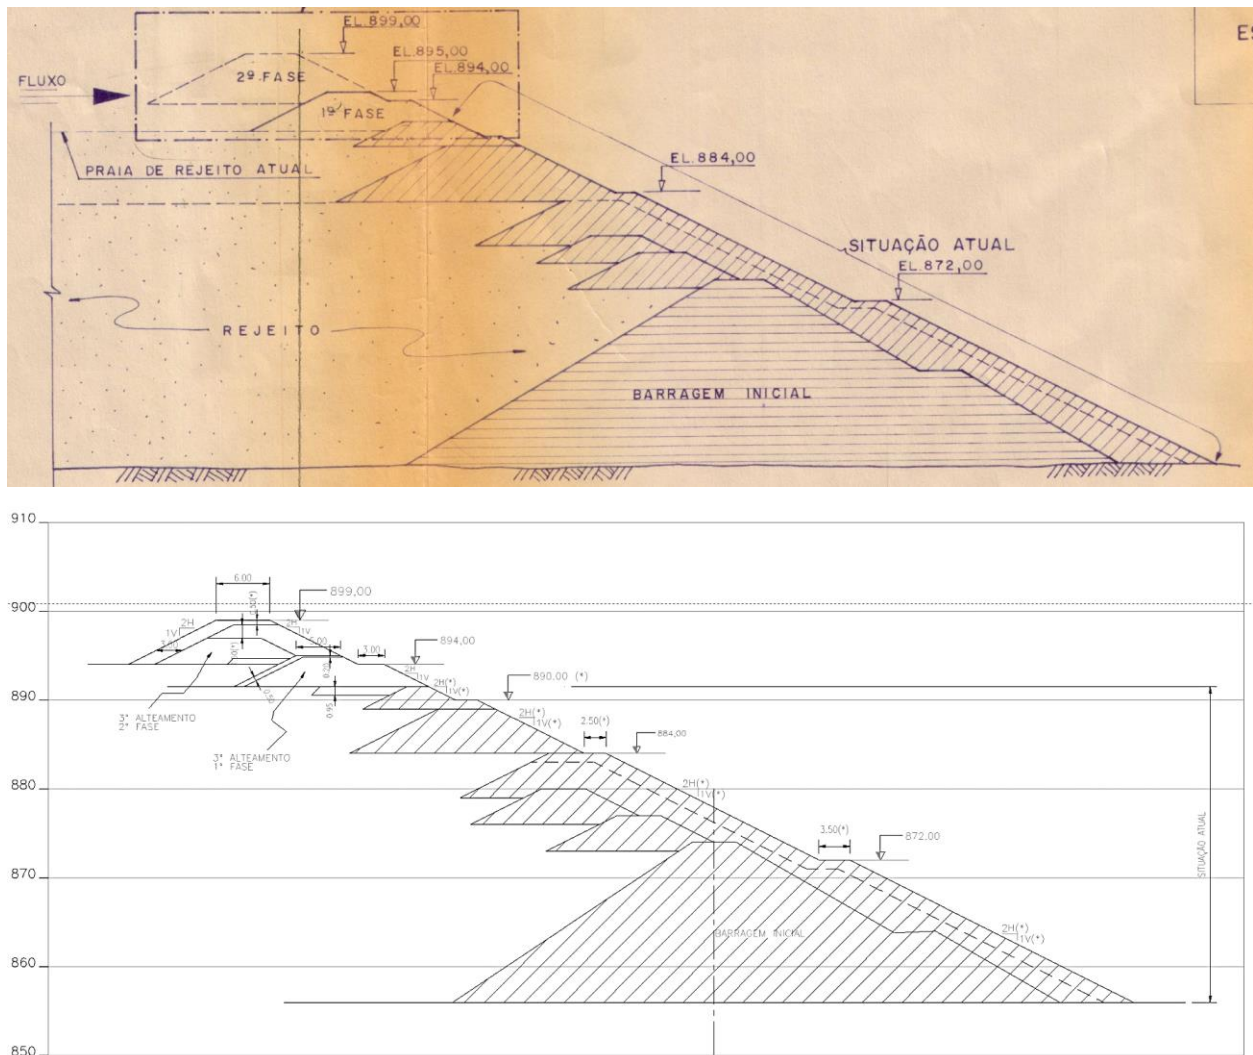
Figure 13: As-Constructed Second Raising Stages⁷²

Actual construction of the Second Raising revised design was, as was the case for the initial design, substantially different from that intended by the design. The as-constructed configuration of the revised Second Raising is illustrated in Figure 13; the centerline raising (Stage 4) was constructed in 1984, generally as planned in the design. The next stage, Stage 5, was constructed in 1986 with a planned height of 5 m but included an apparent “buttress” over the entire downstream face of the dam; this feature is not discussed in any of the available documents, and so its purpose, construction detail, and drainage considerations (if any) are not known. The third and final stage of the Second Raising revised design (Stage 6) was constructed in 1990 and was only 2.5 m high instead of 5 m high.⁷⁰

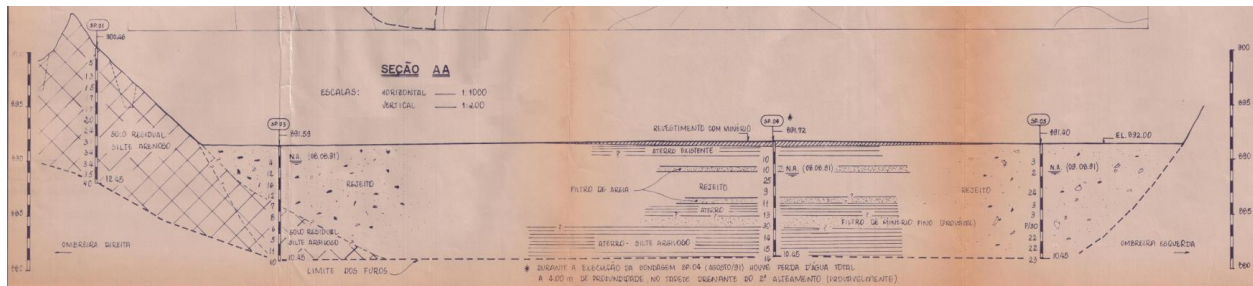
Figure 14: Third Raising Geotechnical Investigation⁷⁴

The design report includes the results of boreholes that were performed for the Third Raising. Figure 14 shows that the boreholes were performed before the first stage of the Third Raising (Stage 7). SPT blow counts indicate variable penetration resistance with depth which could signal variable material types or variable levels of compaction of the material. On the left and right abutments (i.e., boreholes SP-05 and SP-03), only tailings were encountered above the depth of exiting ground. Borehole SP-04, which was advanced through the crest of the Stage 6 berm (i.e., the fifth berm of the Second Raising) near the center of the dam, reportedly encountered layers of tailings and “fill” material used to construct the underlying berm stages. The report also indicates that the borehole encountered layers of drainage blanket material (i.e., “filtro de areia” and “filtro de minerio fina”) and that water loss occurred at the depth of the drainage blanket during drilling, suggesting that the drainage blankets shown in the design drawings for the Second Raising were installed. No further information is available regarding the material encountered in the boreholes.

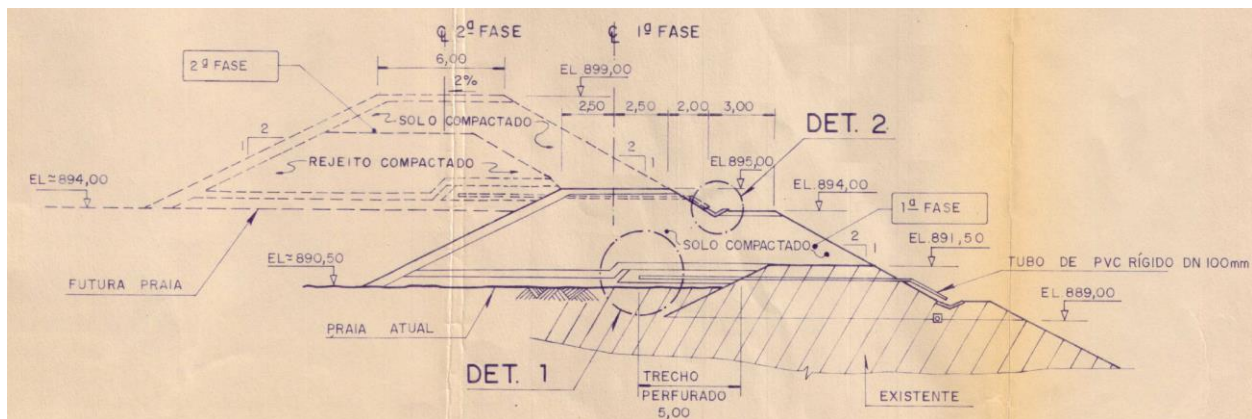
Figure 15: Third Raising Design Cross-section⁷⁸

In Figure 15, both Phases 1 and 2 were designed having upstream and downstream slopes with grades of 2H:1V, with all (Phase 1) or part (Phase 2) of the upstream portion constructed using clay. A 3-m berm was planned at the bottom of the downstream slope where a drainage channel

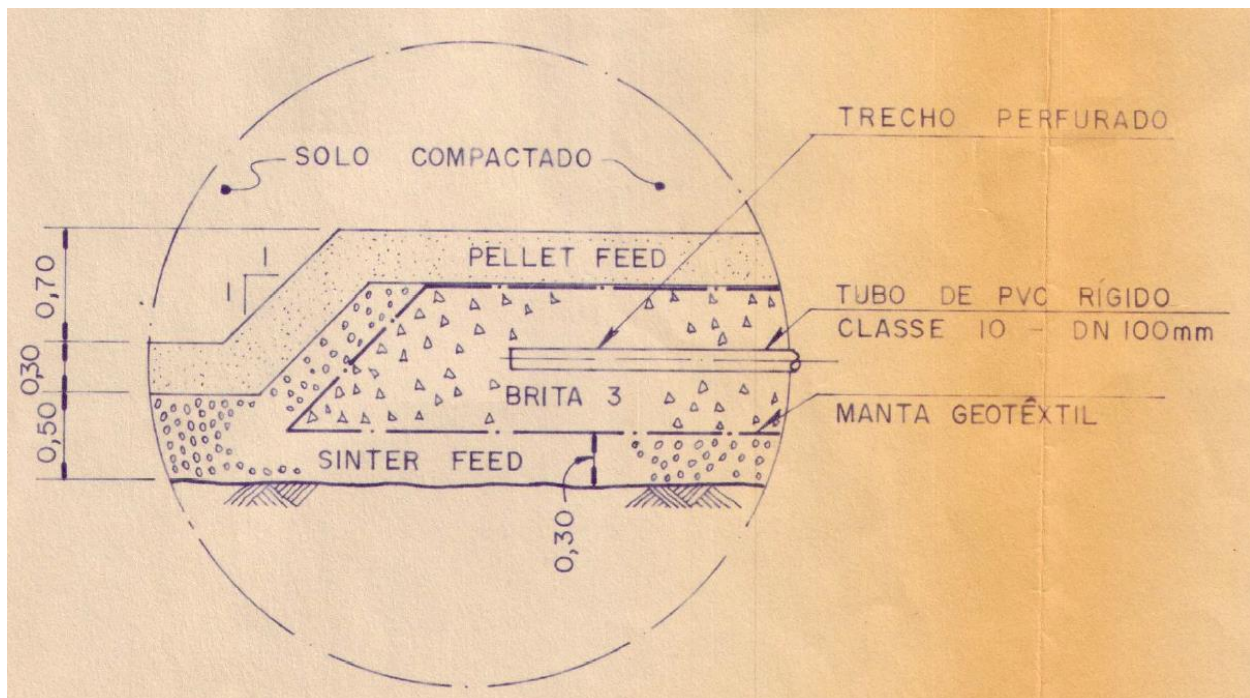
Figure 16: Third Raising Design Drainage Layer⁸¹

The Third Raising stages were designed with internal drainage features to control seepage. The design detail is shown in Figure 16 and included a 1.5-m thick drainage layer at the base of the stages constructed using a pellet feed transition layer underlain by a continuous gravel toe drain of sinterfeed wrapped in a geotextile (“Bidim OP-20”) that discharged water directly to the drainage channel on the downstream slope of the dam. Drainage from the drain layer was to be routed from the toe drainage to the discharge channel using rigid 100-mm diameter polyvinyl chloride (“PVC”) pipes installed every 50 m along the length of the beach. These PVC pipes were planned to be perforated along the section embedded in the drainage layer.⁸⁰

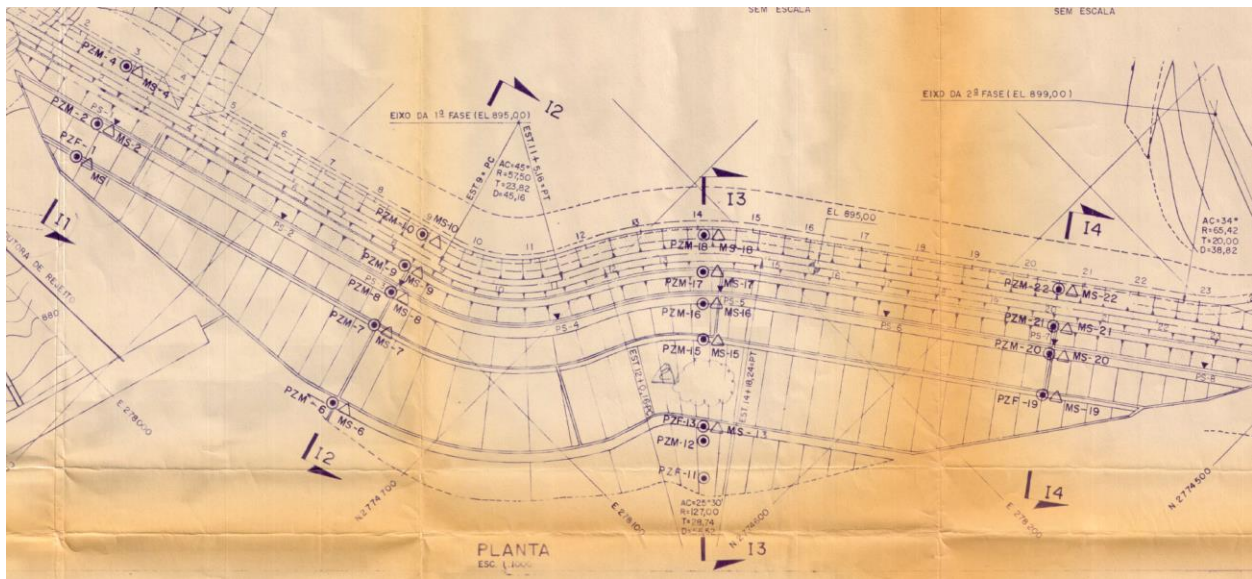
Figure 17: Third Raising Instrumentation Plan⁹⁰

The instrumentation system was designed to monitor excess pore water pressures, dam movement, and internal drainage efficiency. The design document mentions, in particular, that the purpose of the piezometers is “...to monitor the development of interstitial pressures and to establish the current phreatic surface and its evolution as a function of future raisings...” and that the sub-horizontal drains “...together with data from the adjacent piezometers will allow an assessment to be made of the behavior and performance of the internal drainage system of the dam.”⁹¹ A stability and hydrology report for the Fifth Raising references their installation.⁹²

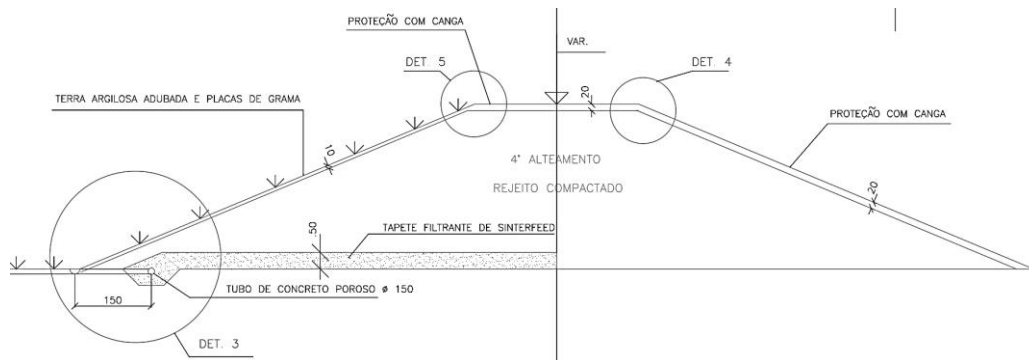
Figure 18: Typical Cross-section of the Fourth Raising Berm⁹⁹

The technical specifications mention that this filter layer should be constructed using the tailings from the beach formed by the Third Raising.¹⁰⁰

Materials for construction are discussed in the engineering report and the technical specifications,¹⁰¹ and also on the drawings (as illustrated above in Figure 18).

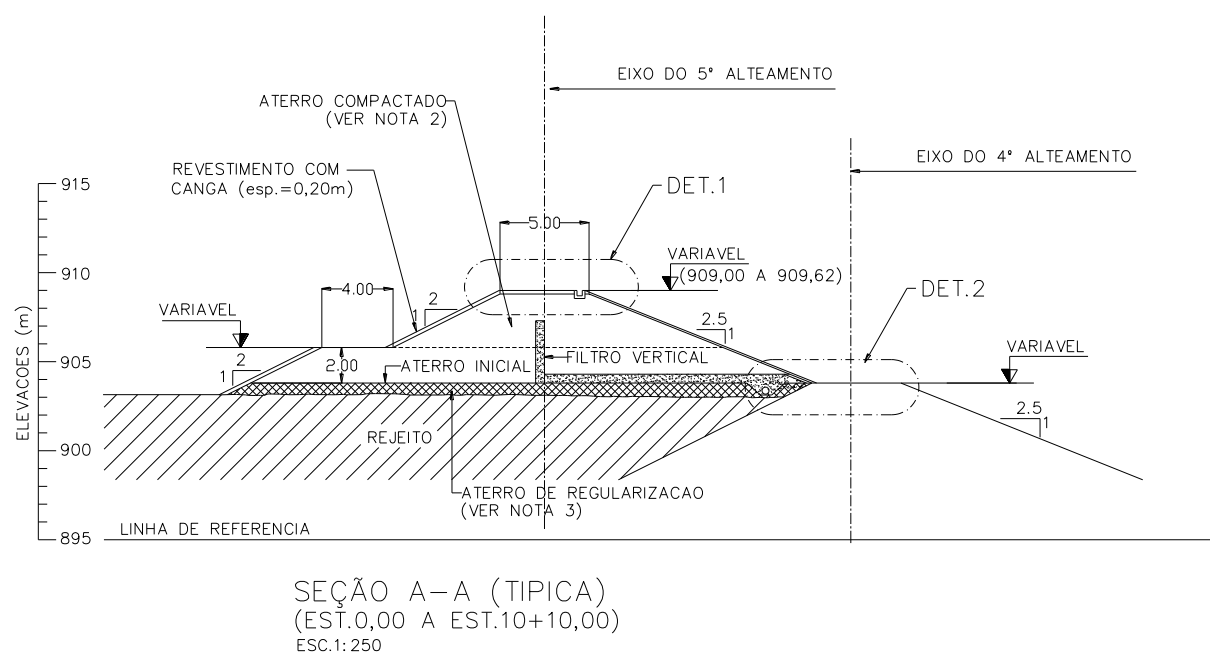
Figure 20: Typical Cross-section from Station 0,00 – 10+10,00¹²⁵

The Fifth Raising design consisted of one stage that was to be constructed directly adjacent to the Fourth Raising and parallel to its alignment. An initial 4-m wide by 2-m high berm (Figure 20) was designed on a 210 m section starting at the right abutment of the Fourth Raising to mitigate the soft saturated conditions described in Section 5.6.1. This berm raised the right section of the Fifth Raising 2 m higher than the left.¹²⁴

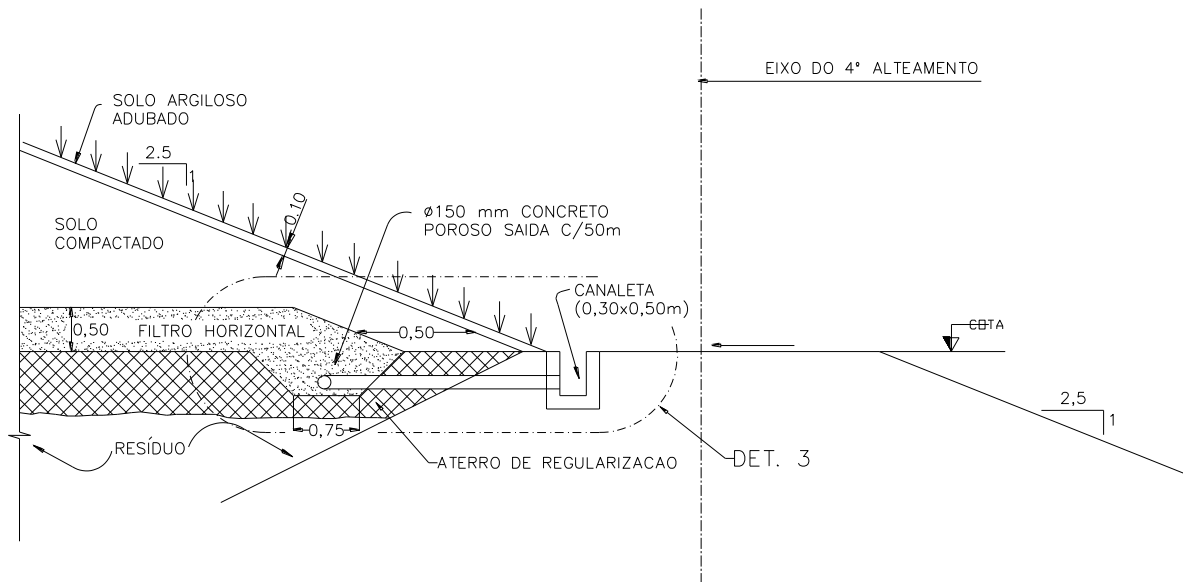
Figure 22: Typical Detail of Drainage Outfall¹³¹

Horizontal perforated PVC pipes 150 mm in diameter were planned every 50 m along the Fifth Raising alignment, placed perpendicular to the alignment. The drainage system was designed to outflow into a reinforced concrete channel at the toe of the raising (Figure 22).

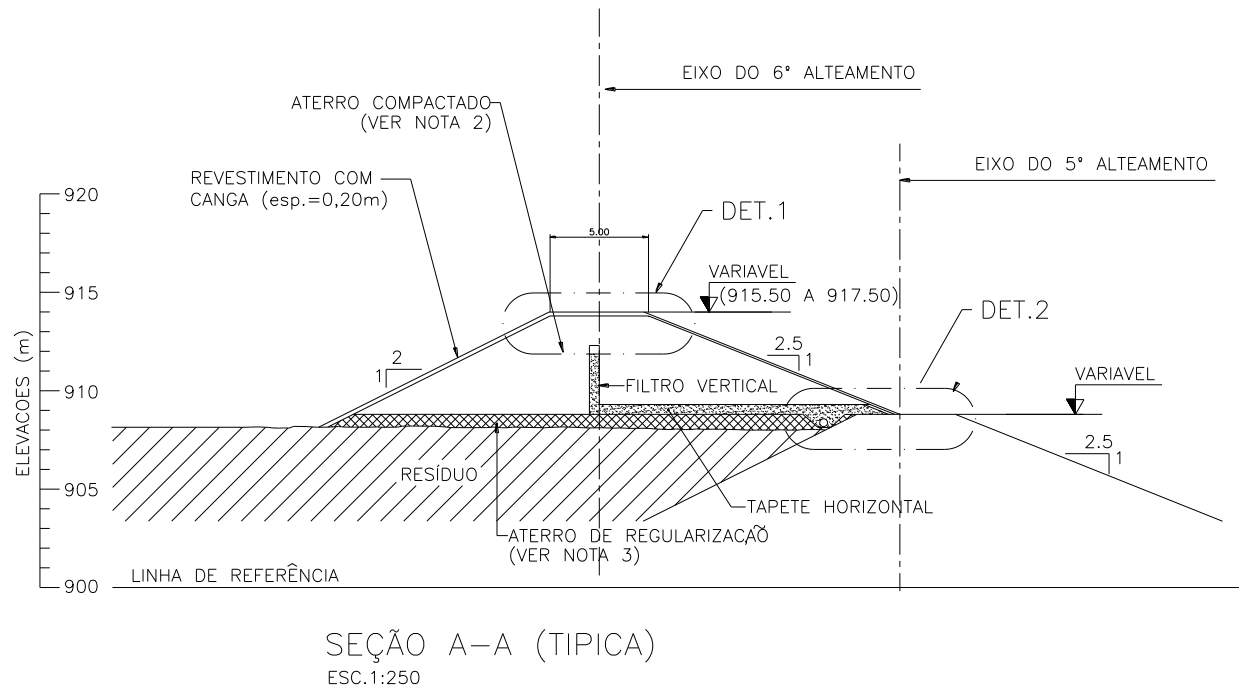
Figure 23: Typical Cross-section of the Sixth Raising¹⁵¹

The Sixth Raising was planned to be 6.5 m high with a 5-m-wide crest. A crest elevation of 916.5 m msl was specified. Upstream and downstream slopes were constructed at 2H:1V and 2.5H:1V, respectively, as shown in Figure 23.

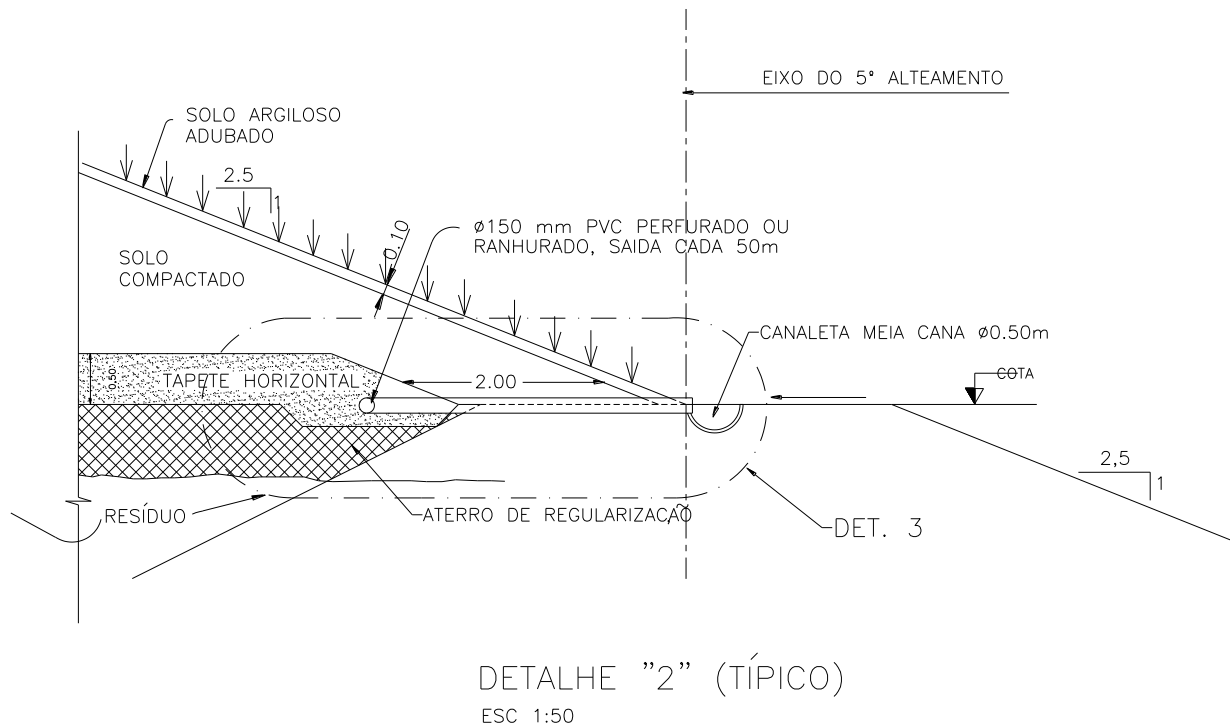
Figure 24: Internal Drainage and Surface Water Management Detail ¹⁵⁶

Horizontal perforated PVC pipes with a 150-mm diameter were planned every 50 m, which would be placed perpendicular to the Fifth Raising and direct water into a reinforced concrete trough at the toe of the raising (Figure 24).¹⁵⁵

The perimeter surface water drainage system was designed to route overflow to Dam VI, similar to the Fourth and Fifth Raisings (Figure 24). The design report describes in detail the hydrology studies performed to assess the conditions that the surface water system was designed to manage. The report uses the 1,000-year return frequency storm (i.e., peak flow, $Q_1 = 1.458 \text{ m}^3/\text{s}$) as the basis of design, as well as an assumed flowrate from the pumping of tailings into the reservoir (i.e., $Q_2 = 0.222 \text{ m}^3/\text{s}$) resulting in a total peak flow (Q) of $1.680 \text{ m}^3/\text{s}$.¹⁵⁷

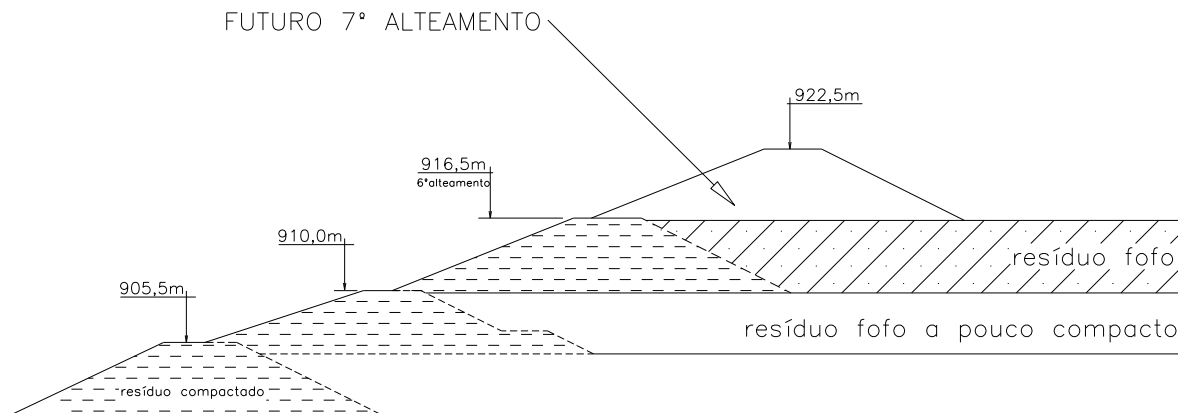
Figure 25: Typical Cross-section of the Seventh Raising ¹⁶⁹

The Seventh Raising was designed as a single 6-m stage from El. 916.5 m msl to 922.5 m msl (Figure 25). The top elevation of the right abutment (i.e., El. 921.5 m msl) of the raising was specified to be 2 m lower than the left abutment (i.e., El. 923.5 m msl).¹⁶⁸

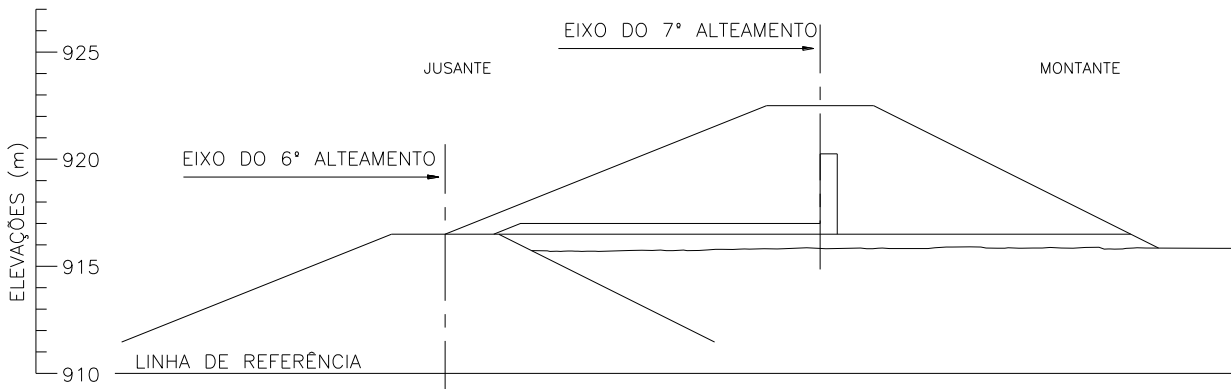
Figure 26: Seventh Raising Drainage Features¹⁷⁵

Design drawings indicate a vertical filter (0.8-m thick) and horizontal filter (0.5-m thick) made of sinterfeed constructed in an L shape (Figure 26). The outflow system connects to perforated PVC pipes, which run to perimeter drainage channels similar to the Sixth Raising. The design drawings and report do not describe the required parameters of the drainage layer materials. No filtration calculations are provided in the report to assess the ability of the compacted soil layer to be filtered by the sinterfeed.

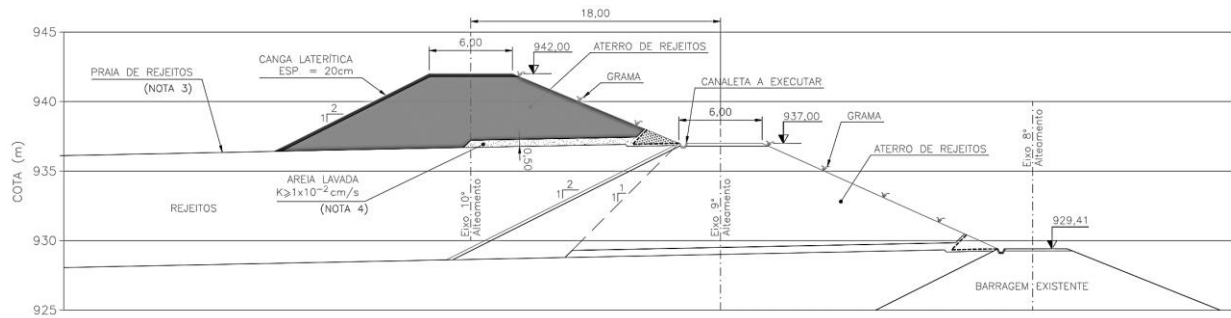
Figure 27: Ninth and Tenth Raisings As-Designed²⁰¹

The design approach for the Ninth and Tenth Raisings is illustrated on Figure 27 and called for upstream construction. The raisings were designed to be constructed of tailings, overlain with a layer of lateritic gravel along the crest of the dam and upstream slope, and vegetation on the downstream slope.

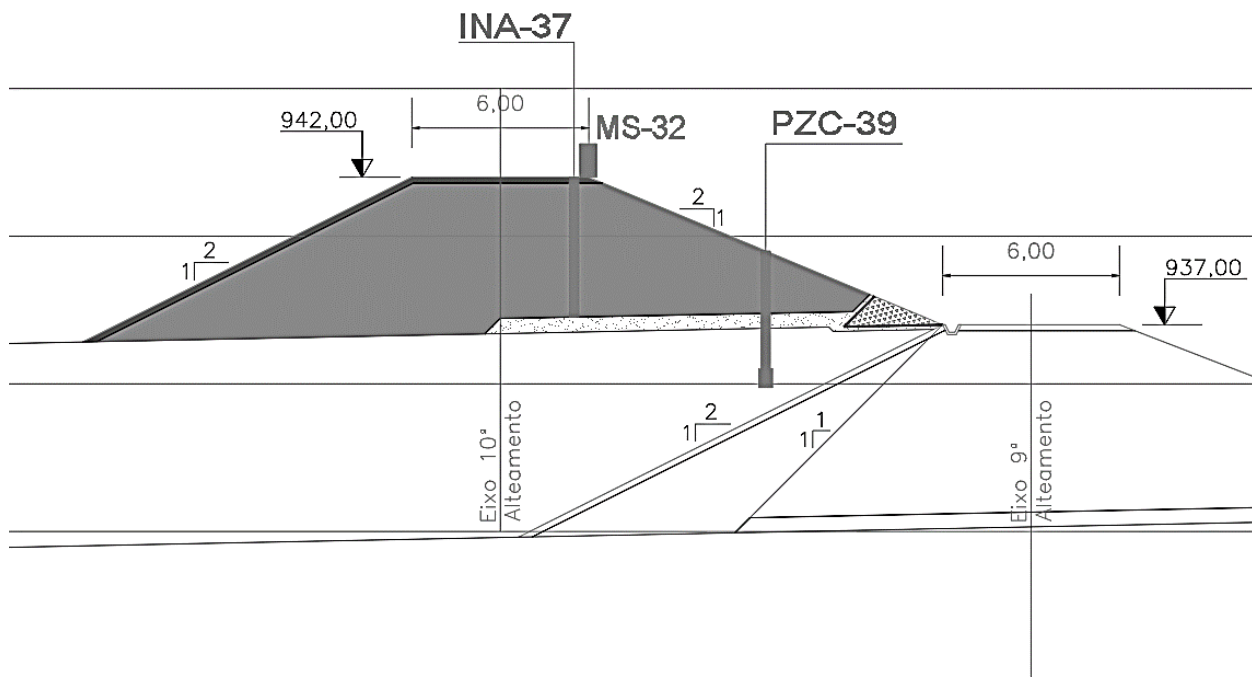
Figure 28: Ninth and Tenth Raising Piezometer and Water-Level Indicator Installation Plan²¹⁶

- open Casagrande-type piezometers, to be installed soon after the raising was constructed at depths of about 5 m and within the tailings beneath the downstream toe of the Tenth Raising berm (e.g., PZC-39 in Figure 28);
- water-level indicators, to be installed after the raising was constructed within the drainage blanket material (e.g., INA-37 in Figure 28) to monitor for the presence of water under pressure within this layer;
- surface-control markers, installed at the crest of the berm; and
- water-level gauges within the decant pond.²¹⁵

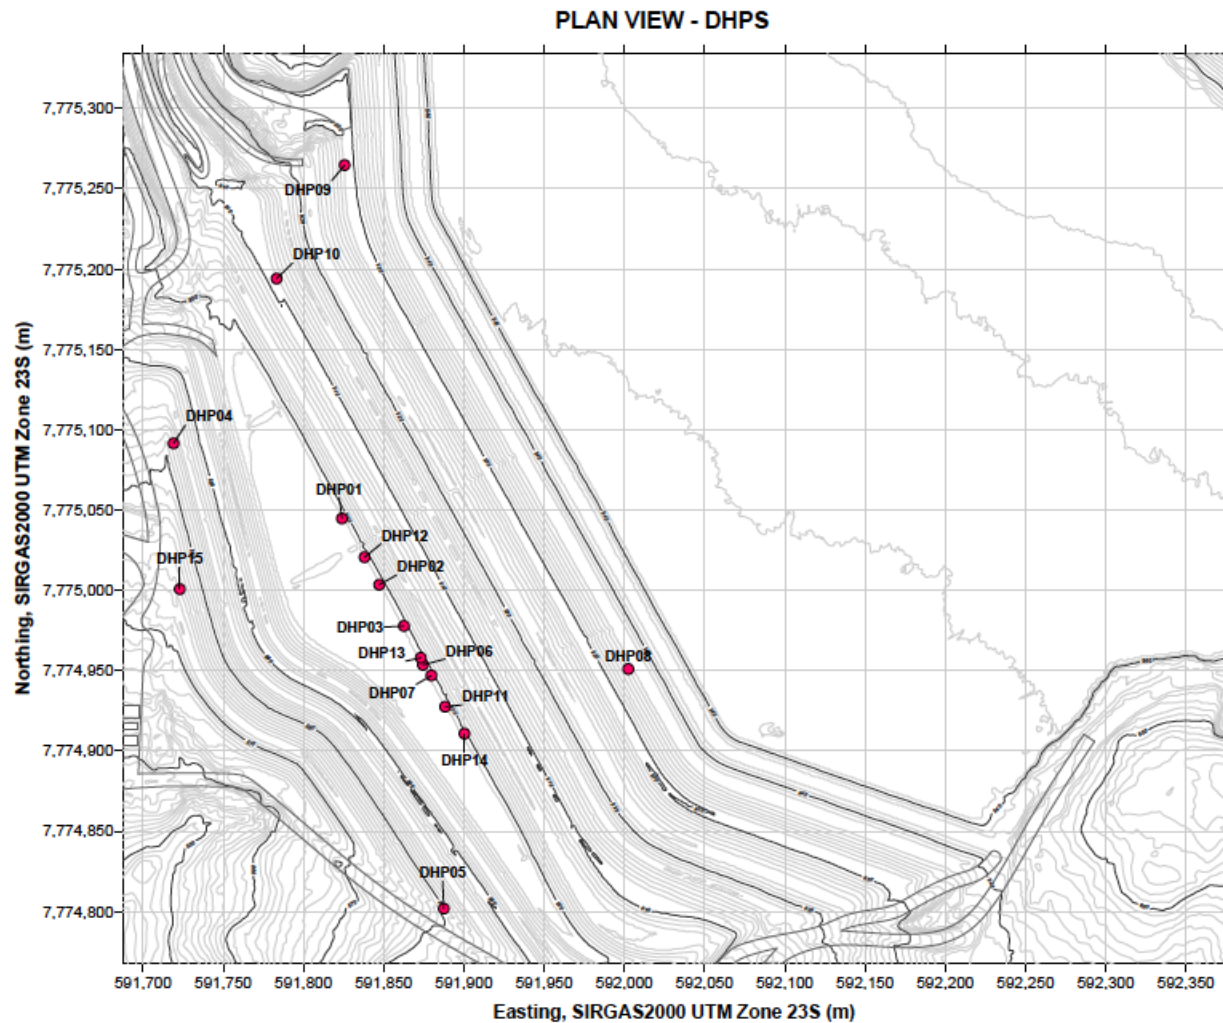
Figure 32: DHP Locations²⁴⁷

Installation of DHPs began in February 2018. By June 2018, 14 DHPs had been installed (DHP 01 through DHP 14).²⁴⁶ Figure 32 shows the locations of the DHPs as installed.

An installation report for the DHPs describes the installation procedures and provides the logs for the 13 DHPs that were installed by the end of May 2018.²⁴⁸ The logs indicate that none of the DHPs reached the original design length of 100 m. The typical length of the installed DHPs was about 60 m and the maximum reported length was 81 m. Advancing the drilling through the berm was achieved with an air pressure of up to 600 kPa, with additional water pressure of up to 400 kPa applied in the tailings. The only reported issue with the installation of the first 14 DHPs

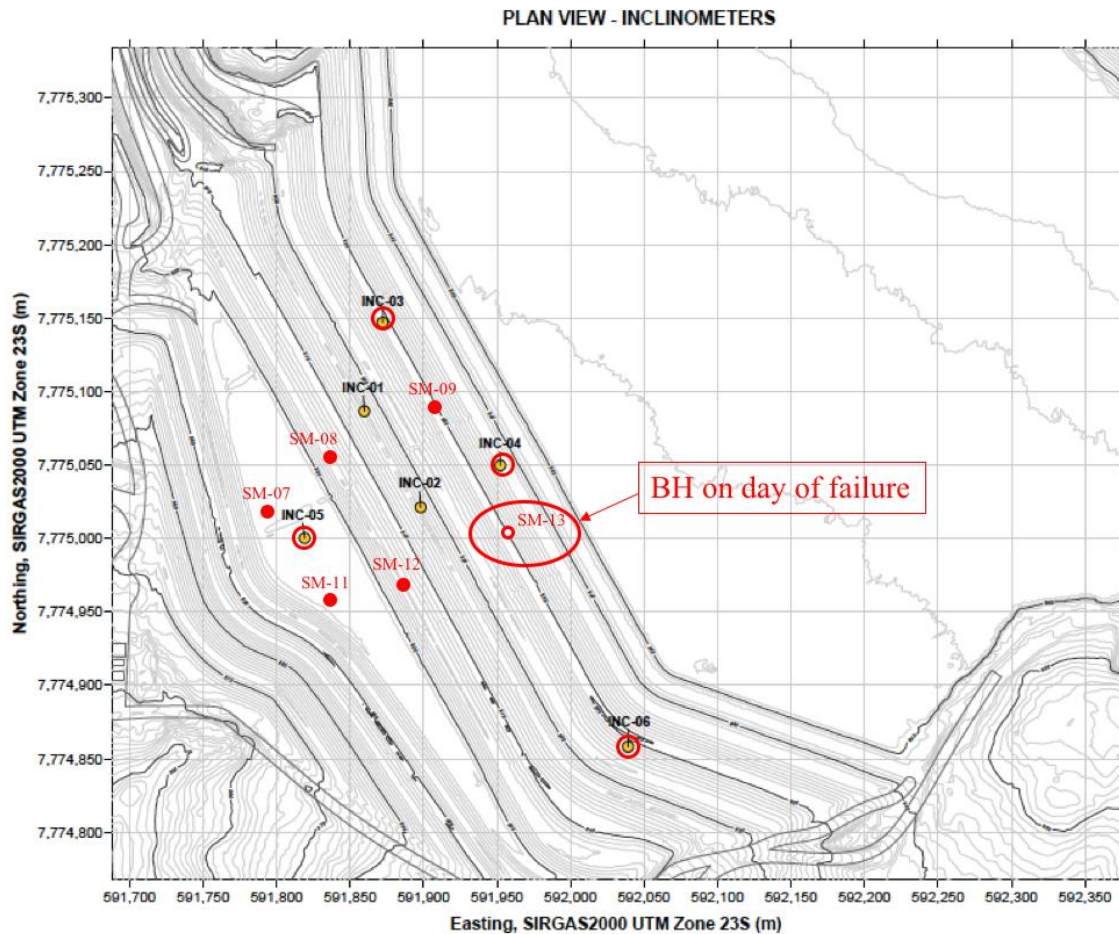
Figure 35: Boreholes on Dam I Between October, 2018 and the Failure²⁷²

Drilling of B1-SM-13 was in progress on the day of the failure. There is no drill log or other driller's report of the drilling that was performed on the day of the failure. However, drilling logs are available for all prior drilling days, including from the day before the failure. On the day prior to the failure, according to the drilling records,²⁷³ drilling was advanced to a depth of 65.5 m below the ground elevation of approximately 929 m msl to a bottom elevation of approximately 863.5 m msl. This was approximately the elevation of natural soils beneath the tailings. This is the depth and elevation at which the drilling likely started on the day of the failure. Also, records show that the drilling method was changed from percussion at shallow depths to rotary when the water level in the dam was reached; therefore, it is likely that drilling at B1-SM-13 was being performed using rotary methods on the day of the failure. This method involved recirculation of water in the borehole. At the time of the failure, the drillers had been
