Appendix D Image Analysis

December 2019

Report of the Expert Panel on the Technical Causes of the Failure of Feijão Dam I Appendix D – Image Analysis

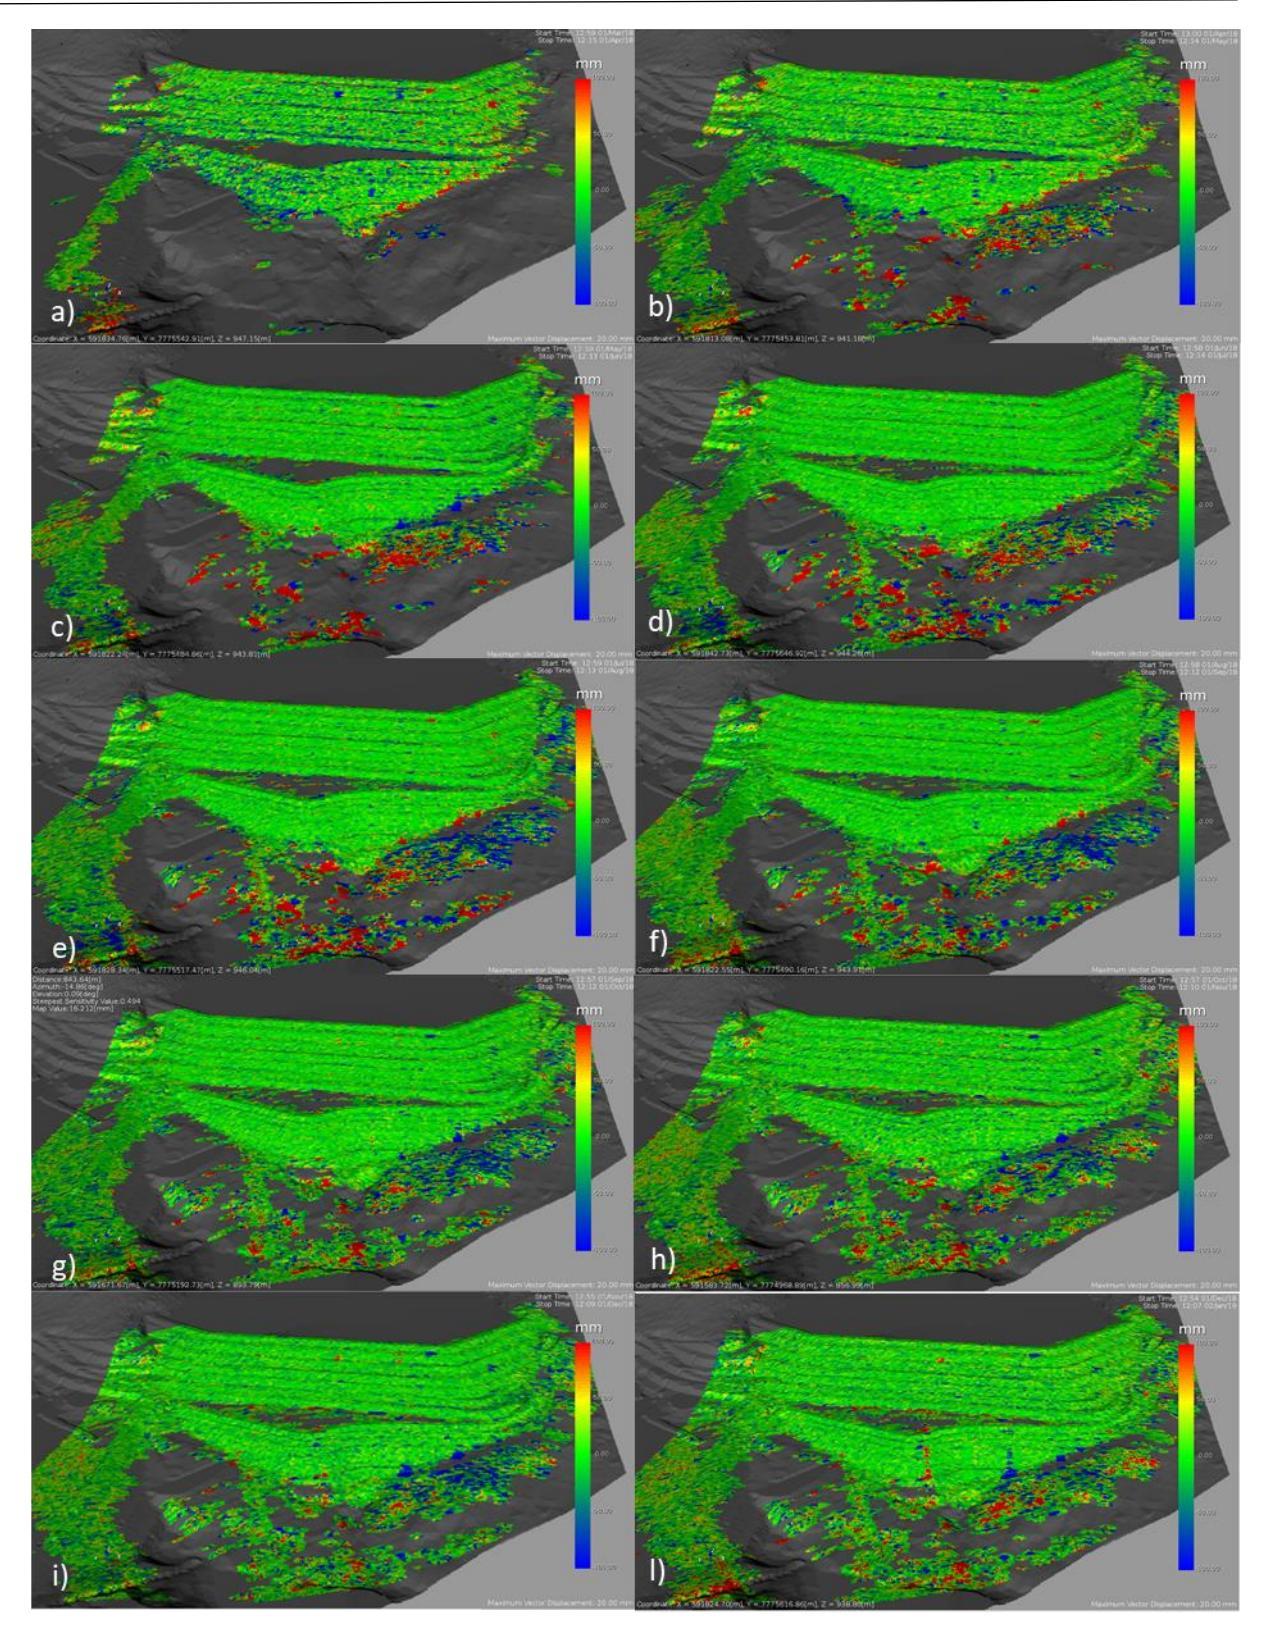
Figure 14: Monthly Cumulative Radar Deformation Maps (Image (a) Corresponds to March 2018 with Subsequent Lettered Images Following Chronologically up to December 2018)

The monthly cumulative deformation maps produced by the radar between March 2018 and the date of the failure appear to identify significant surface deformations in different sectors of the dam, especially during March and April 2018. The amount of reported deformation from May to October 2018 is lower than that appearing in the maps for the period November 2018 to January 2019. The highest amount and the largest number of areas of the purported deformations appear in the March to April 2018 maps.

The reported deformations have both negative and positive signs, indicating deformations away from and toward the radar, respectively (Figure 14 and Figure 15). The amount of the purported deformation is significant (ranging from 200 to 700 mm in March 2018 and from 100 to 380 mm in April 2018) and above the noise level established by the radar manufacturer (i.e., 0.3 mm/h).

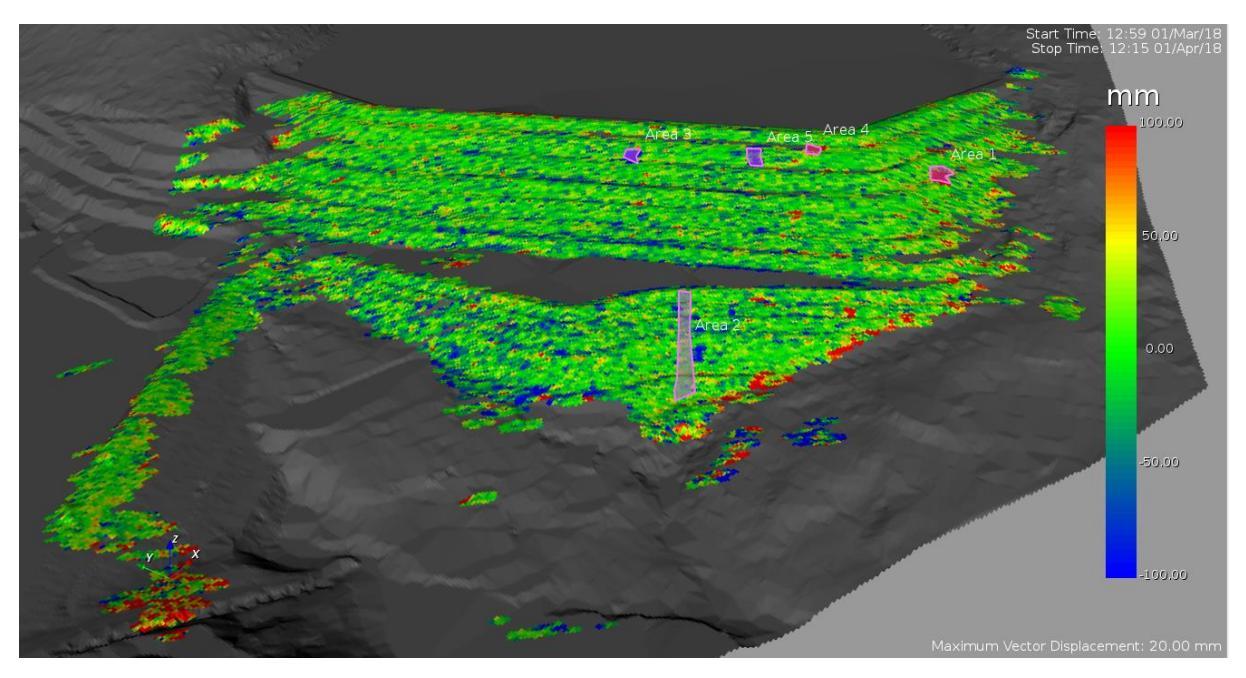
Figure 16: Monthly Cumulative Deformation Map From March 1, 2018, to April 1, 2018

A re-evaluation of the ground-based radar data reveals that long-term deformations were not occurring as reported. For example, in April 2018, the ground-based radar purported to show large, new, and ongoing surface deformations of hundreds of millimeters in specific areas. However, the radar signal shown in the monthly deformation maps for March and April 2018 is not attributable to actual deformation, but is likely the result of cumulative noise induced by: (i) the presence of vegetation on the face of the dam, (ii) changes in moisture of the vegetation/soil, and (iii) cumulative residual atmospheric artifacts not properly compensated for between each consecutive radar scan (Figure 16 and Figure 17). This was confirmed by photographs taken at the time.

The two largest areas where deformations were reported by the ground-based radar (Areas 3 and 5 of Figure 16) show them directed away from the radar. Such a direction of deformation is not compatible with any reasonable failure mechanism, considering the geometry of the radar line-of-sight and the geometry of the dam (Figure 18).

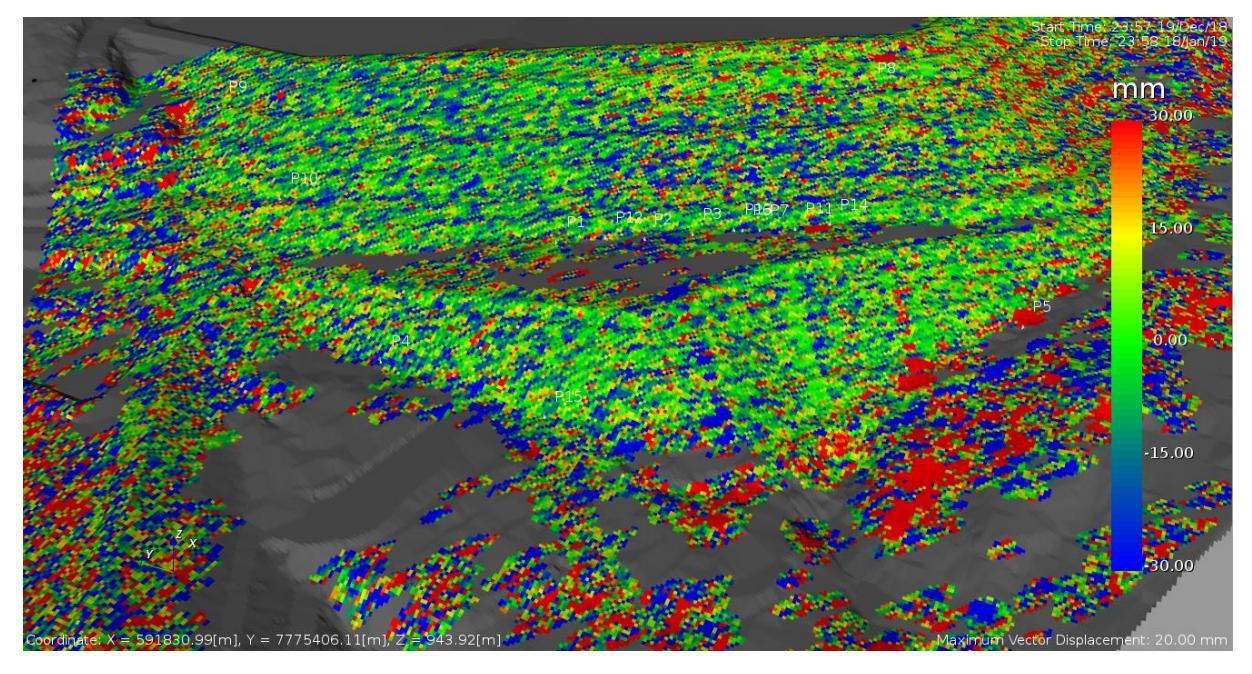
Figure 19: Monthly Cumulative Deformation Map From December 19, 2018 to January 19, 2019

There also were reports by the ground-based radar of large deformations occurring on the dam during the period from December 2018 up to and including January 18, 2019. The review of the radar data does not identify any deformations above the radar noise level either in the monthly cumulative deformation map from December 19, 2018 to January 19, 2019 (Figure 19), or in the daily cumulative deformation map from January 18 to January 19, 2019 (Figure 20). The radar signal visible in those

deformation maps is interpreted as noise induced by vegetation and soil moisture and not actual deformations.

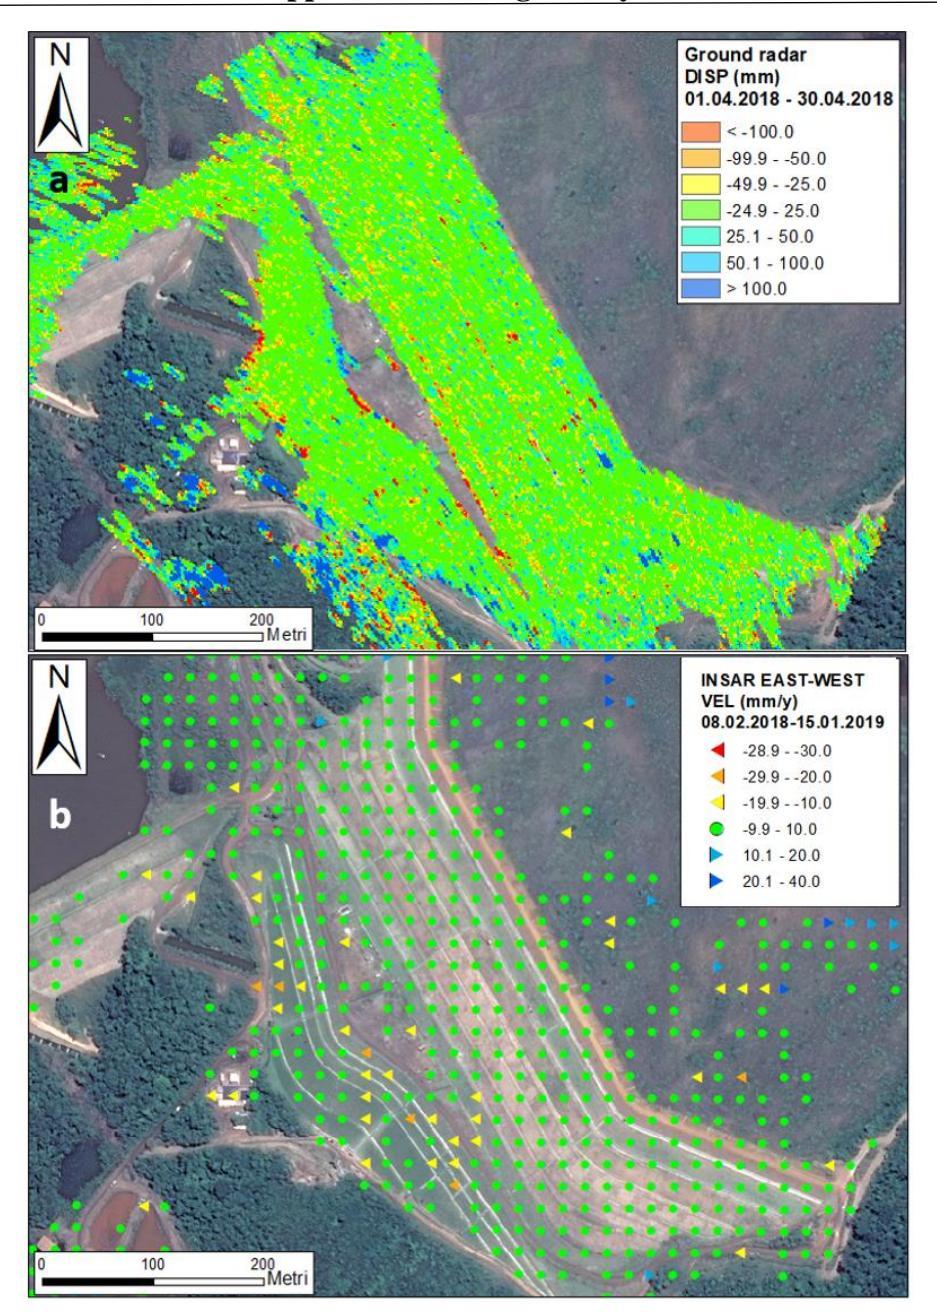
Figure 22: Comparison Between (a) Cumulative Deformation Map From Radar in April 2018 and (b) the E-W Velocity Map Obtained Via InSAR From February 8, 2018, to January 15, 2019

The deformations indicated by the ground-based radar also are not confirmed after a review and analysis of more sensitive satellite data from that same time frame (discussed further below), corroborating this conclusion. Deformations of such intensity as indicated by the monthly deformation maps, if accurate, would have been noted in the InSAR data by a lack of measurement points in correlating areas of the map. However, the InSAR data in those areas reveal good coverage of measurement points (Figure 22 through Figure 25).

InSAR data identified deformations on the dam but with a different spatial distribution, having a different geometry (mainly vertical on top of the dam, with a significant horizontal component towards west at the bottom of the dam for InSAR) and with a different range of values (10 millimeters per year (mm/y) to 30 mm/y for InSAR versus 200 mm to 700 mm for the ground-based radar) when compared to those reported by the ground-based radar.

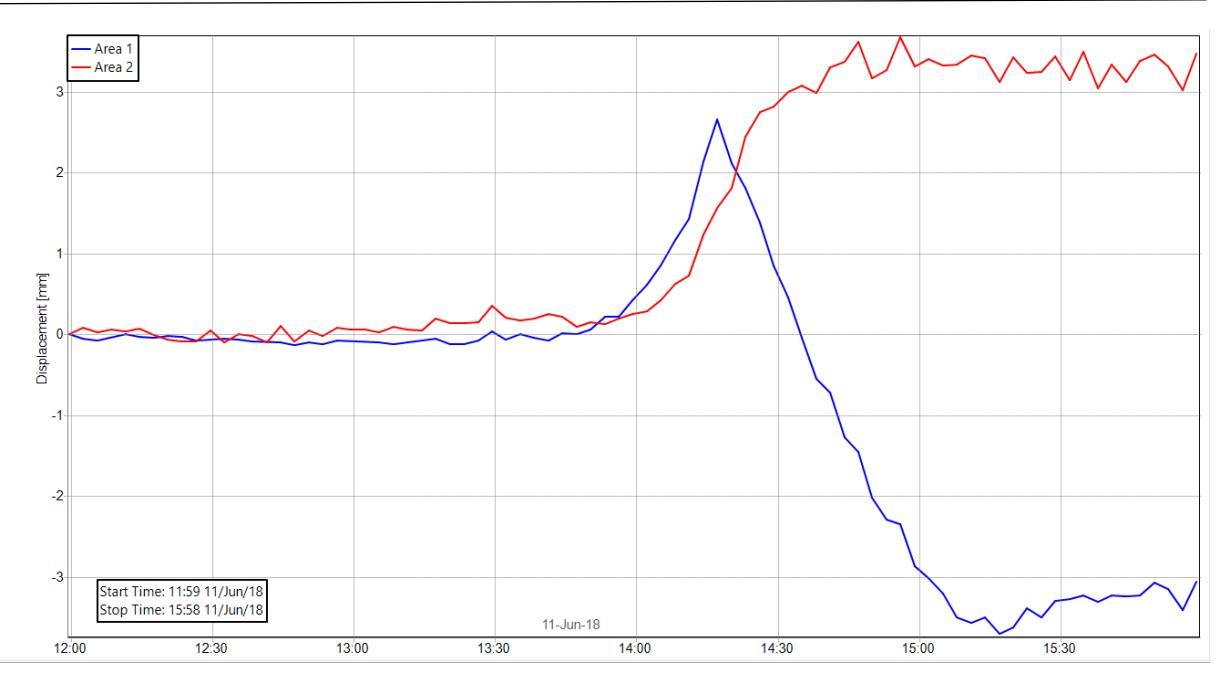
Figure 27: Time Series of Average Deformation of Area 1 and Area 2 from June 11, 2018 11:59 am, to June 11, 2018 3:58 pm

Small, rapid deformations were recorded by the radar on June 11, 2018 in two areas, Area 1 of around 400 m², and Area 2 of around 135 m², located in the central part of dam, respectively at a distance around 35 m and 55 m from DHP 15 (Figure 26). In Area 1 positive deformations (towards the radar) started at 1:53 pm, reaching a maximum value in the area of 6.4 mm and an average value of 2.4 mm. From 2:17 pm negative deformations (away from the radar) were measured by the radar until 3:16 pm, with a maximum value of 14.1 mm and an average value in the area of 3.9 mm (Figure 27). Those deformations are compatible with an initial bulging in the area potentially associated with the injection of water and air in the dam during drilling, followed by a contracting process of the dam surface induced by the dissipation of pressure in the ground. In Area 2 the radar recorded only positive deformations (towards the radar) starting at 1:53 pm and ending at 2:46 pm, with a maximum value in the area of 3.6 mm (Figure 27).

Because these deformations were rapid and occurred in a relatively short period of time, the detected deformations are considered reliable. Notably, the ground based radar did not detect any fast deformations of the type detected in connection with DHP 15 in the months prior to the failure, including during the last radar scan immediately before the visible failure of the dam.

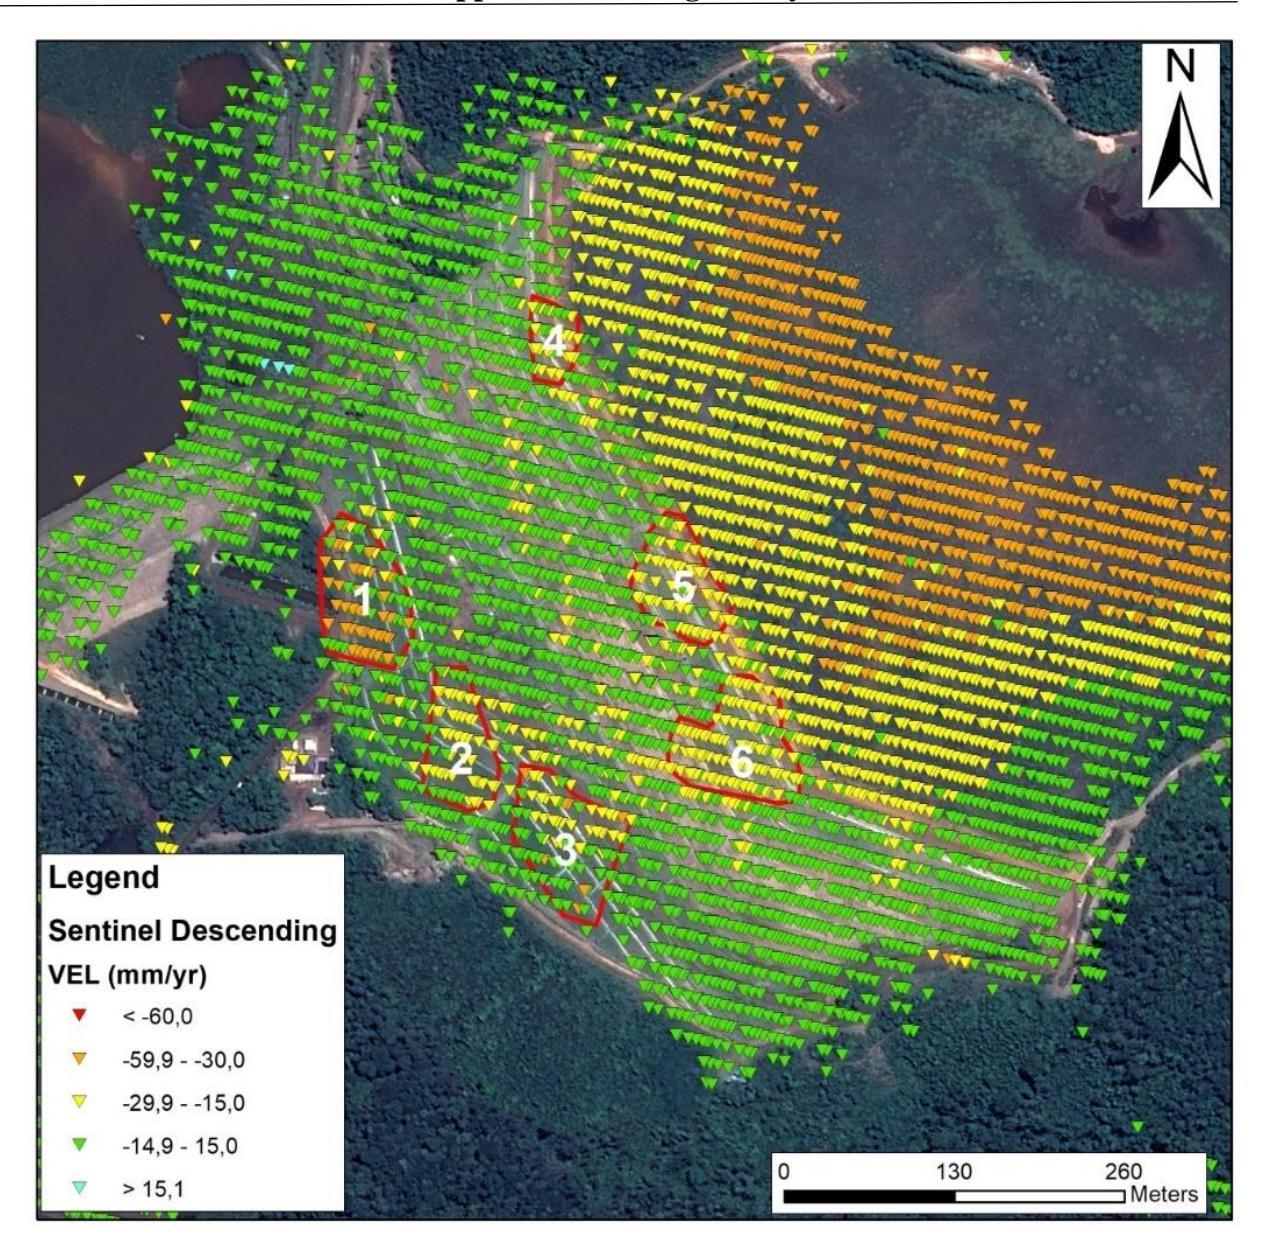
Figure 31: Velocity Map from InSAR Sentinel-1 Dataset From January 3, 2018, to January 22, 2019 (Polygons of Moving Sectors of Dam I are Identified in Red)

Line-of-sight deformations away from the satellite were detected at the bottom of the dam in three different areas, with vertical and E-W components. The three moving areas at the bottom of the dam show average velocities during the analyzed period ranging between 17 mm/y and 35 mm/y along the descending line-of-sight (Figure 31).

The noted deformations are compatible with: (i) vertical settlements, (ii) deformations with horizontal components toward the west (W), or (iii) deformations with both vertical and Westbound components. The InSAR data provided by the TerraSAR-X dataset along ascending geometries confirm the presence of deformations at the bottom of Dam I (Figure 32). When combining their line-of-sight measurements with those of Sentinel-1, as shown in Figure 33, it is possible to confirm the presence of deformations with both a vertical and a westward component at the bottom of Dam I (Figure 34).

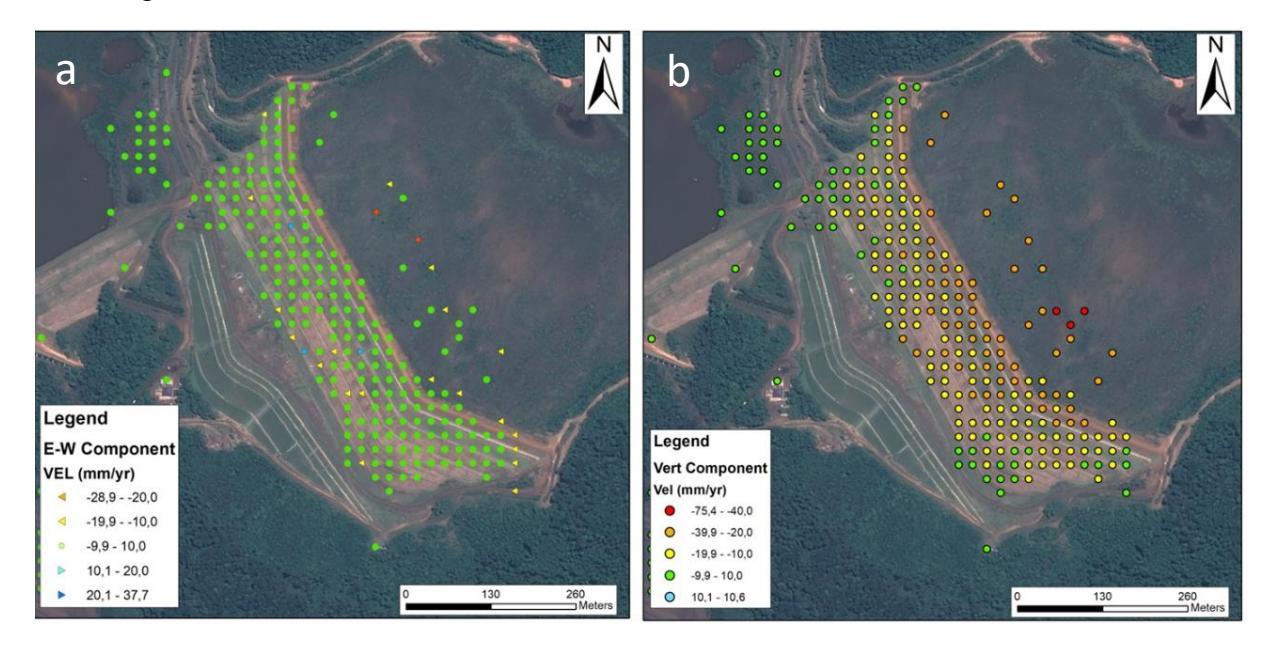
Figure 35: Velocity Map from Decomposed InSAR CosmoSkyMed Datasets for (a) E-W Components and (b) Vertical Components

In the lower part of the dam the deformations measured by InSAR were mostly less than 10 mm/year, but included areas where the horizontal deformations ranged from 10 to 30 mm/year in the 12 months prior to the failure. It was not possible to confirm the horizontal deformations detected by the Sentinel-TerraSAR-X combined datasets in this sector of Dam I through the ascending and

descending CosmoSkyMed datasets because of the lack of measurement points in the lower part of the dam (Figure 35).

On the top of the dam, deformations with mainly vertical components and some minor horizontal components (close to the level of the noise in the data) were detected by all InSAR datasets (Figure 34 and Figure 35), with maximum velocities of 20 mm/y to 22 mm/y.

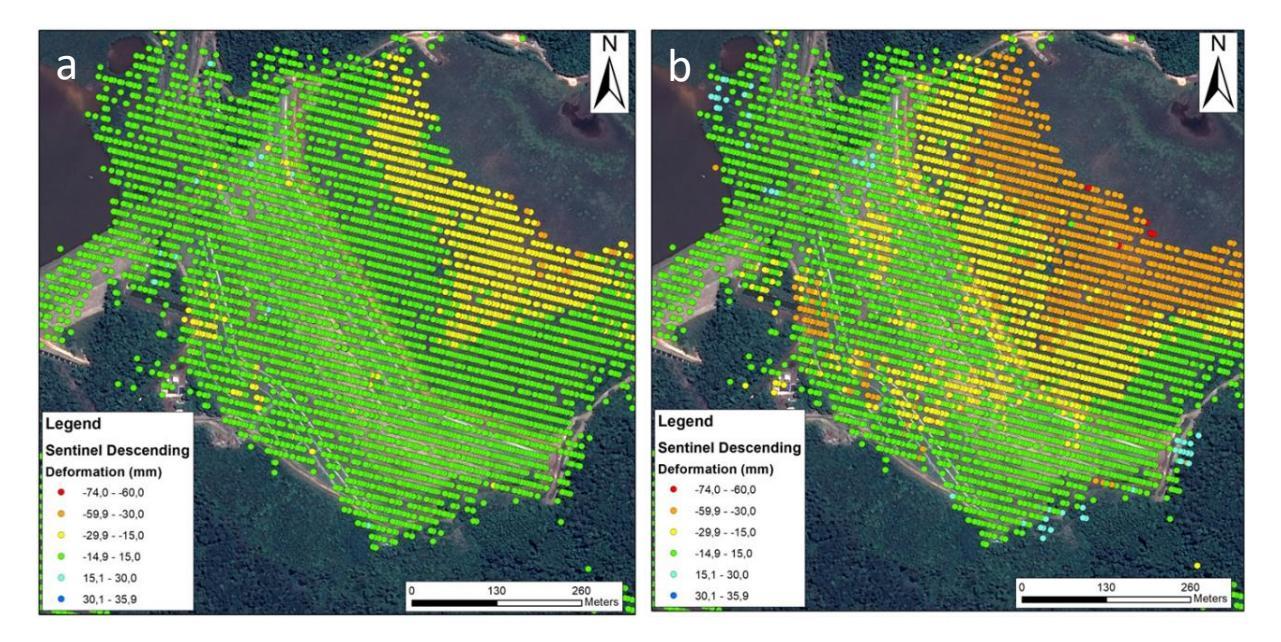
Figure 36: Comparison Between Cumulative Deformations Datasets Measured by Sentinel-1 (a) From January 3, 2018, to August 7, 2018 and (b) From January 3, 2018, to January 22, 2019

From Figure 36, it is evident that most of the deformations measured on Dam I occurred in the second part of the analyzed period (i.e., from August 2018 to January 2019).

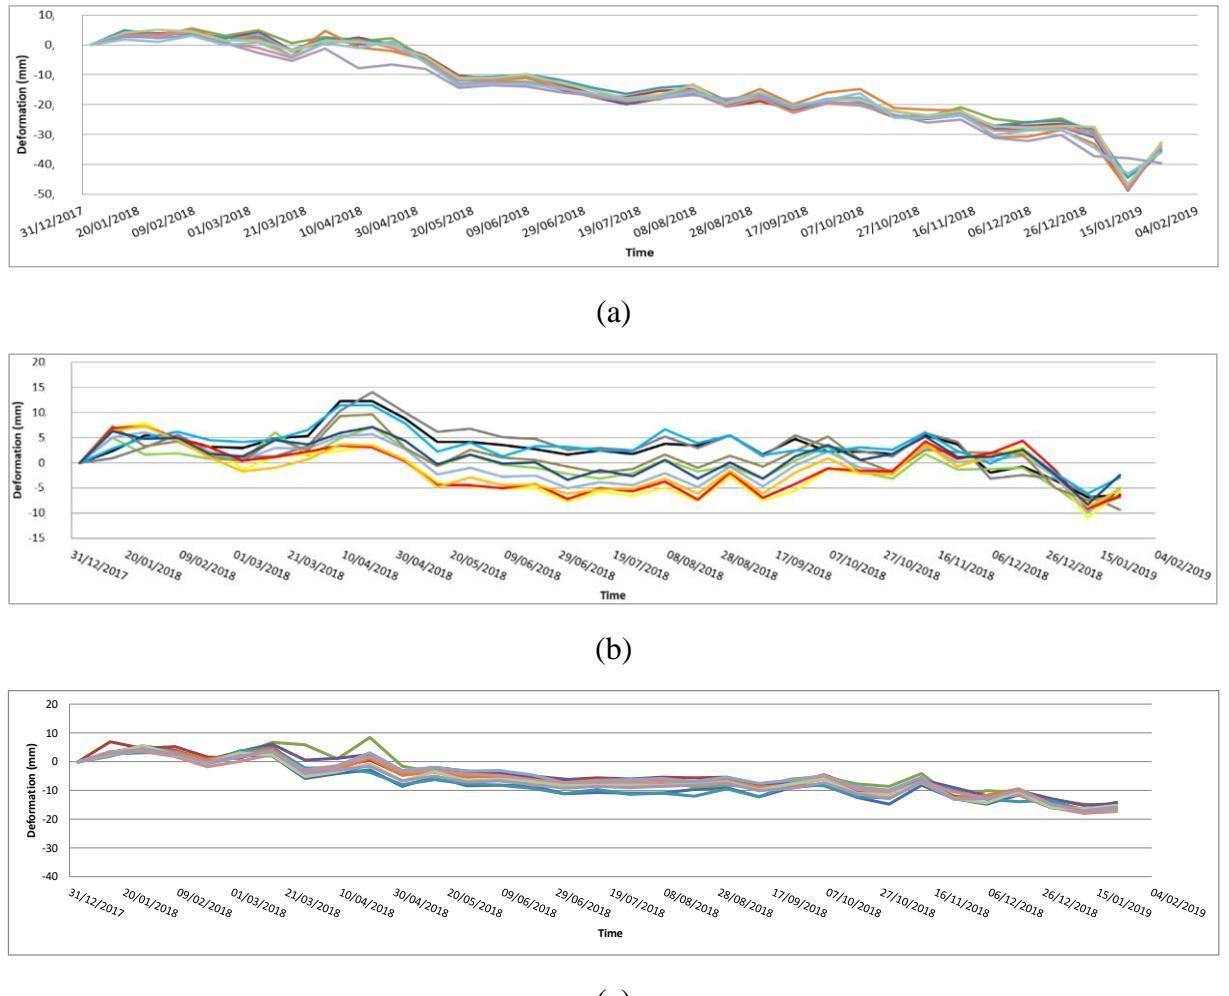
Figure 37: Deformation Time Series of InSAR Points for Sentinel-1 Data Located at Bottom of Dam I (From Figure 31) for: (a) Area 1, (b) Area 2, and (c) Area 3

By analyzing the temporal series of InSAR measurement points located at the bottom of the dam, deformations are first identified in late March to April 2018, with certain acceleration phases in October and November 2018. A final acceleration occurred from December 2018 to January 2019. These accelerations were observed for most of the InSAR points in this area (Figure 37).

Although deformations increased slightly from September to October 2018, none of the points showed a clear progressive acceleration of deformation prior to the failure that would be potentially useful to empirically predict the time of failure (e.g., using the inverse of velocity with time).

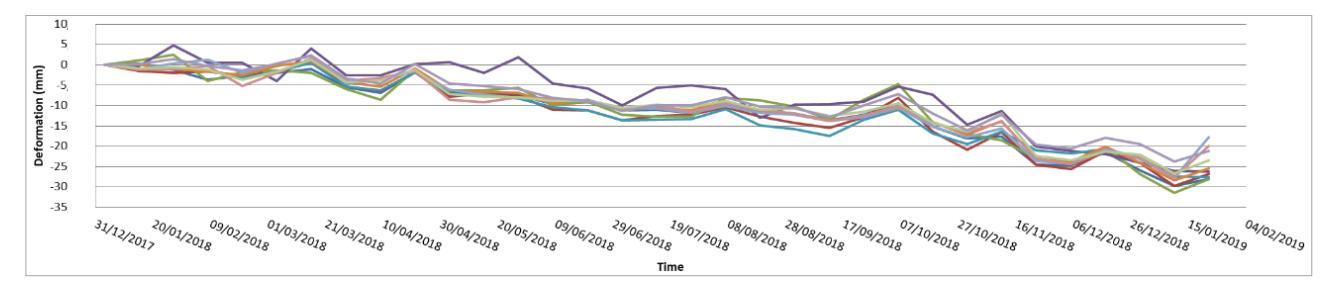
Figure 38: Deformation Time Series of InSAR Points for Sentinel-1 Dataset Located at Top of Dam I Belonging to Area 5 of Figure 31

The measured deformations on the upper part of the dam are linear, with no evident accelerations apart from an increase of velocity from October 2018 and a second velocity increase from the middle of December 2018 until the acquisition of January 10, 2019 of the Sentinel-1 descending dataset (Figure 38). The last two acquisitions of the Sentinel-1 prior to the failure (January 10, 2019 and January 22, 2019) did not indicate any evident acceleration, but confirmed that the deformation

reported by the ground based radar on January 18, 2019 (discussed above) was not an actual deformation.

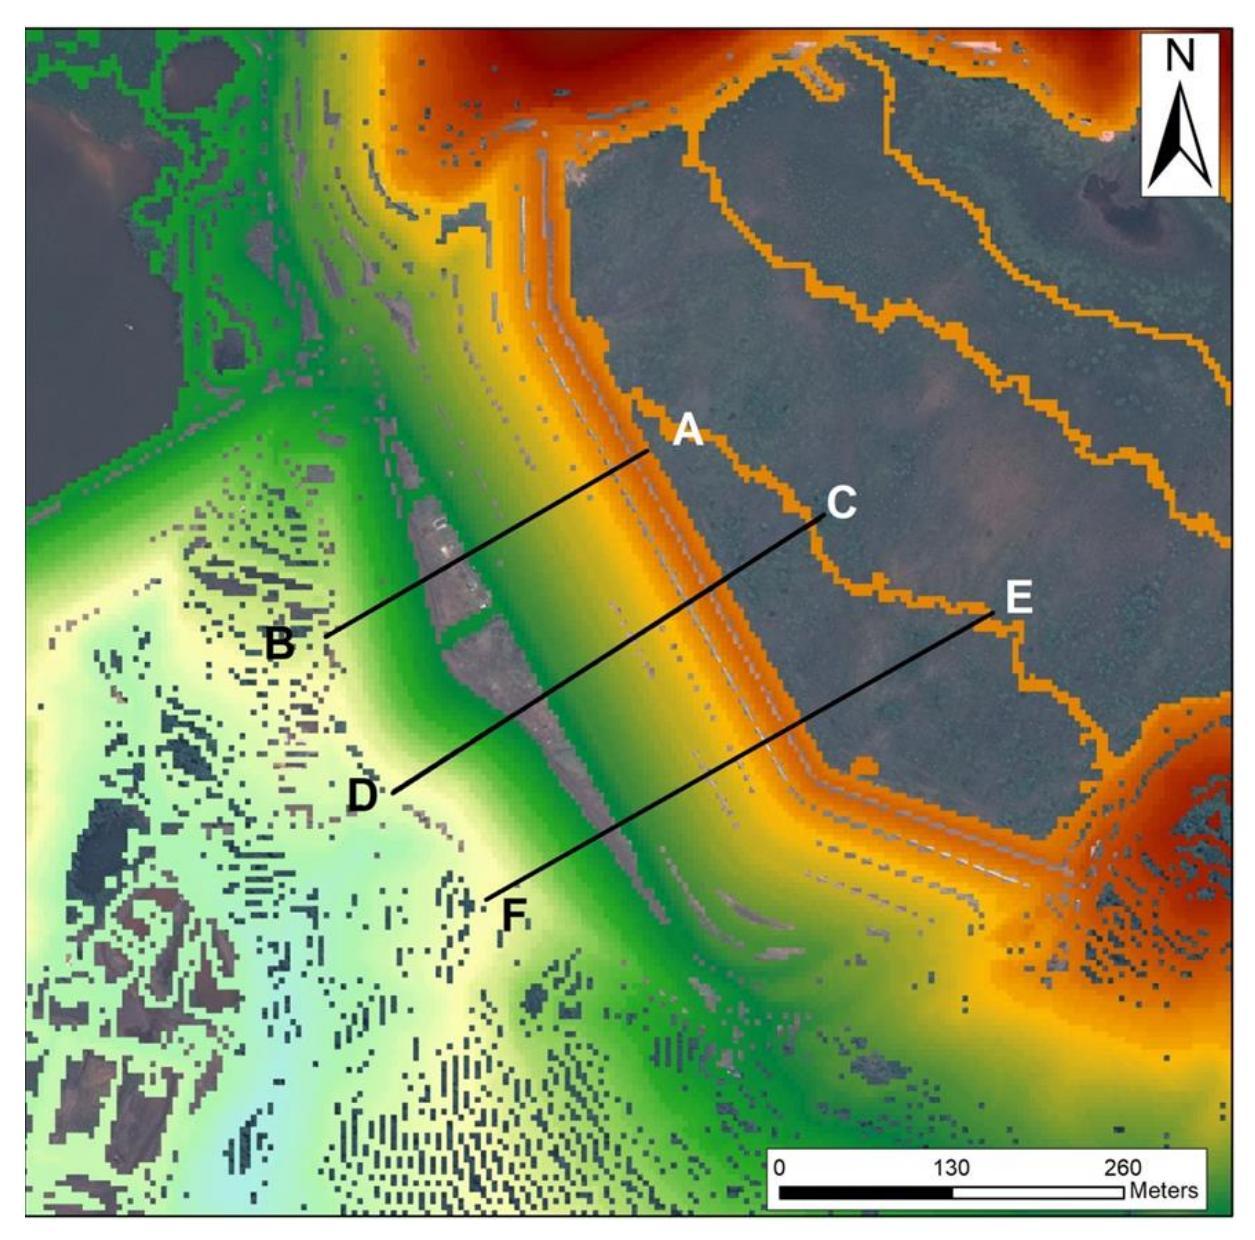
Figure 40: Topography of Dam I Before Failure Showing Locations of Three Cross-sections

To obtain a better understanding of the geometry of the deformations indicated by the satellite InSAR datasets, three cross-sections through the dam were drawn on the pre-failure topography (Figure 40), and the deformation vectors were measured using InSAR by combining the ascending and descending line-of-sight data, as visualized in Figure 41 through Figure 43. The deformation vectors inferred from InSAR do not include the N-S component, since the line-of-sight of both ascending and descending orbits is almost perpendicular to that direction which, considering the direction of the cross-sections, could introduce a bias in the direction of the vectors.

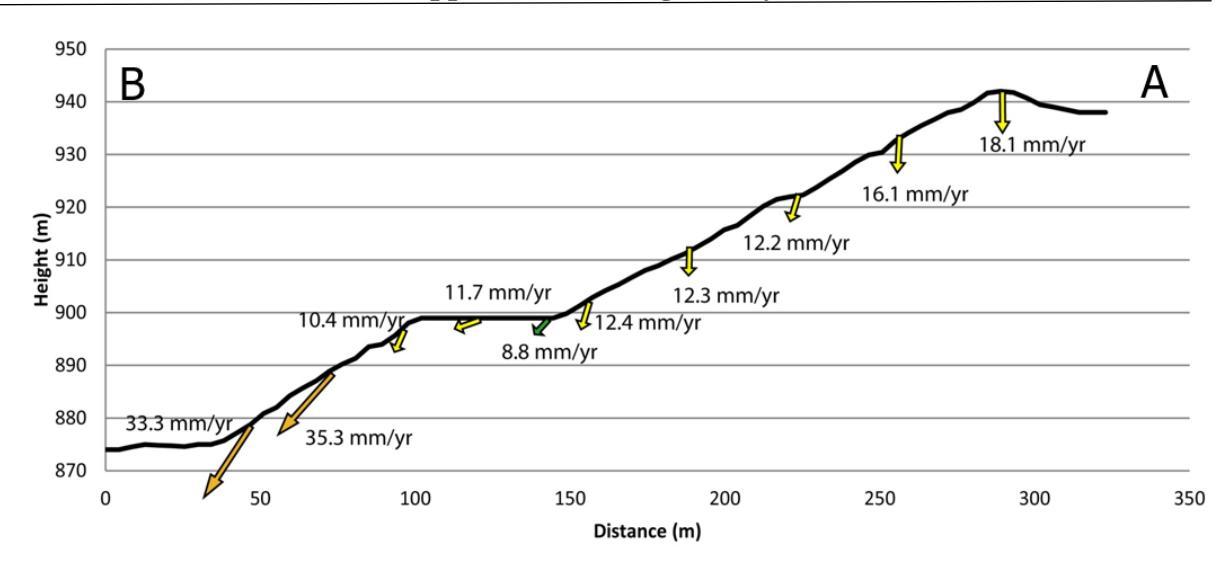
Figure 41: Cross-section AB Showing the Deformation Vectors Obtained From InSAR TerraSAR-X-Sentinel-1 Data

In all cross-sections, the deformation of the dam's crest is mainly vertical, while towards the toe of the dam the vectors dip towards the West and their inclination gradually increases up to a maximum angle of $\sim 60^{\circ}$ from the vertical, as shown in cross-section EF (Figure 43).

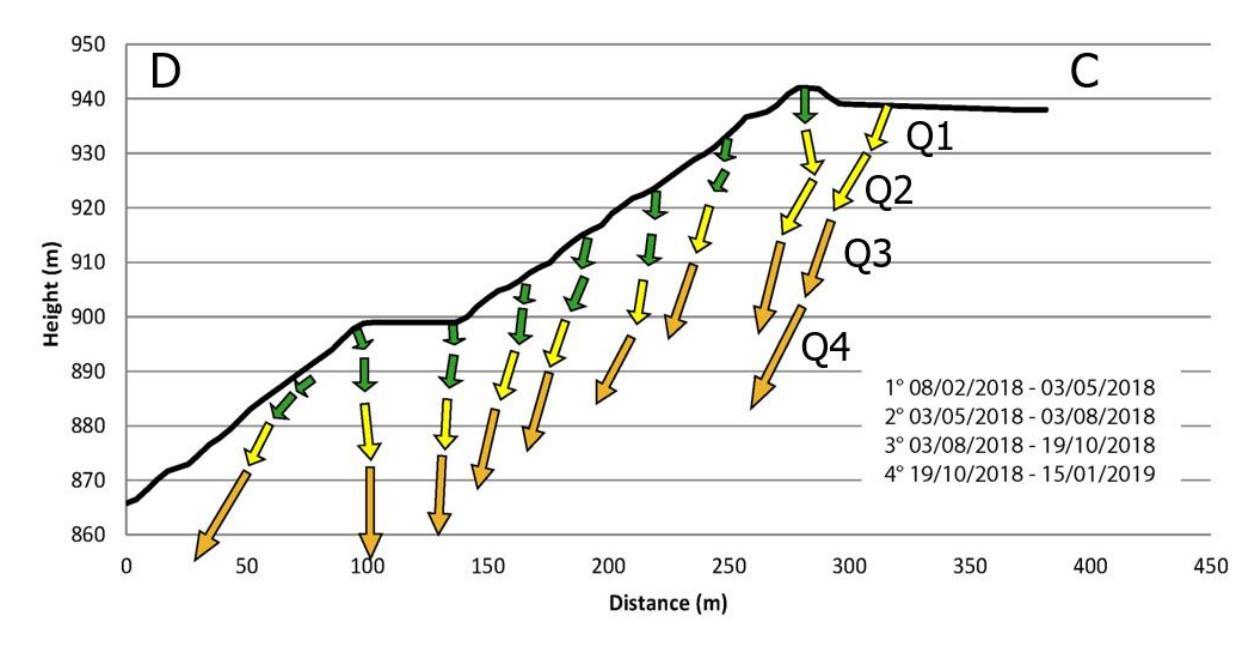
Figure 44: Cross-section EF Showing Deformation Vectors Obtained From InSAR TerraSAR-X-Sentinel-1 Data for Different Sub-periods of the Entire Time Span Covered by Datasets

By analyzing the cumulative deformation obtained from the InSAR data along the cross-sections divided into four temporal subsets of the entire period covered by the data, it is possible to visualize the temporal evolution of the deformations with an increase in the cumulative deformation more evident in the last three months (Figure 44).

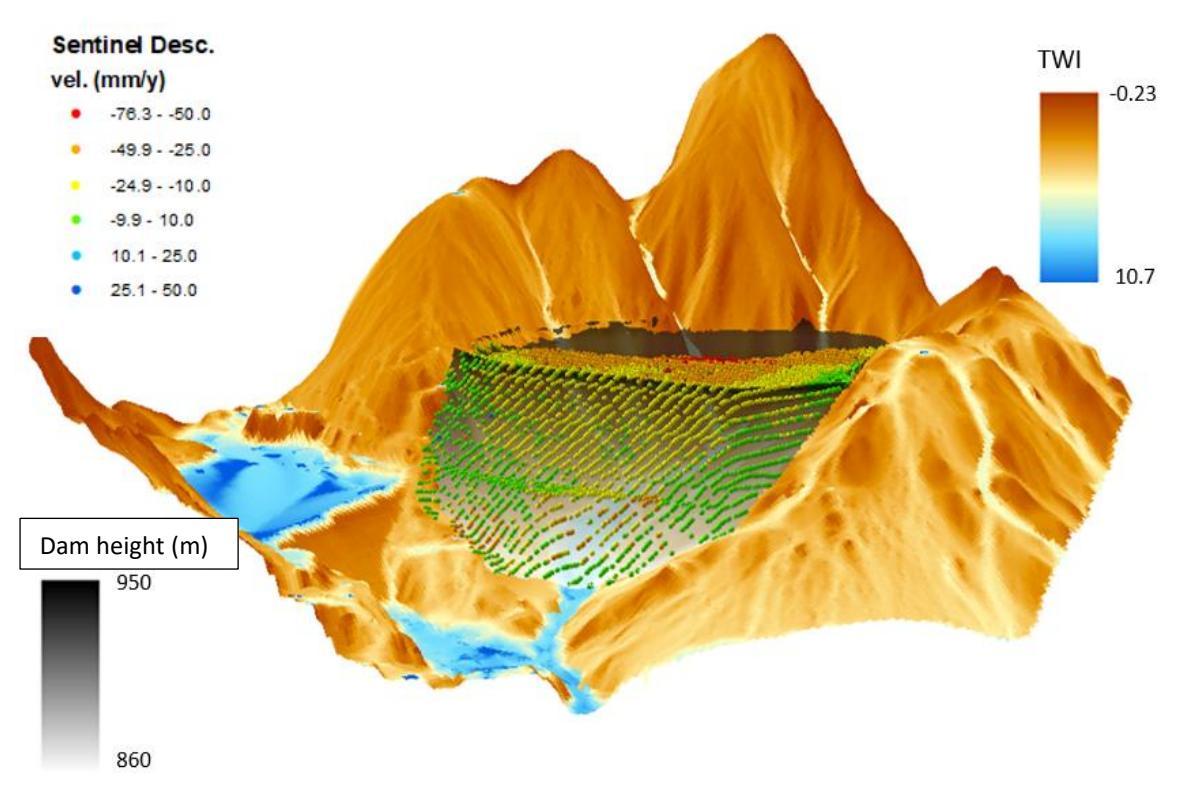
Figure 45: 3D View of Satellite InSAR Data Visualized Over Dam and TWI

InSAR data have been compared to TWI. TWI was calculated based on the pre-dam topography to estimate the water flow before dam construction. High values of TWI indicate that water is accumulating. The spatial distribution of the TWI values in the analyzed area shows that the flow accumulation obtained by calculating the TWI with the original topography is concentrated at the southern part of the toe of the dam where the dam face is exposed to the SW. By comparing the TWI values with the InSAR data (Figure 45), it is possible to observe that most of the deformations

identified by the InSAR analysis prior to failure at the bottom of the dam are located in the same sector of the pre-dam topography where the highest values of TWI were identified.

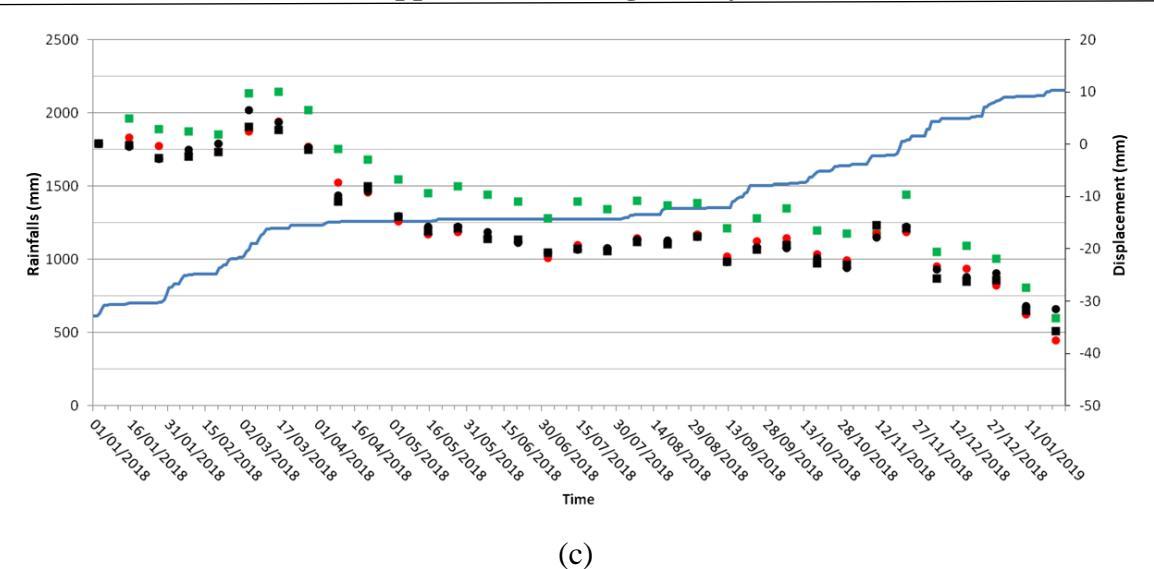
Figure 46: Comparison Between: (a) InSAR Data and Daily Rainfall, (b) InSAR and Monthly Rainfall, and (c) InSAR and Cumulative Rainfall for Points Located at Toe of Dam I

In particular, most of the points at the bottom (Figure 46) and on the crest of the dam (Figure 47) show that where rainfall was low from May to September 2018, there was limited deformation. During the period beginning October 2018 when rainfall increased, accelerations are recorded. The

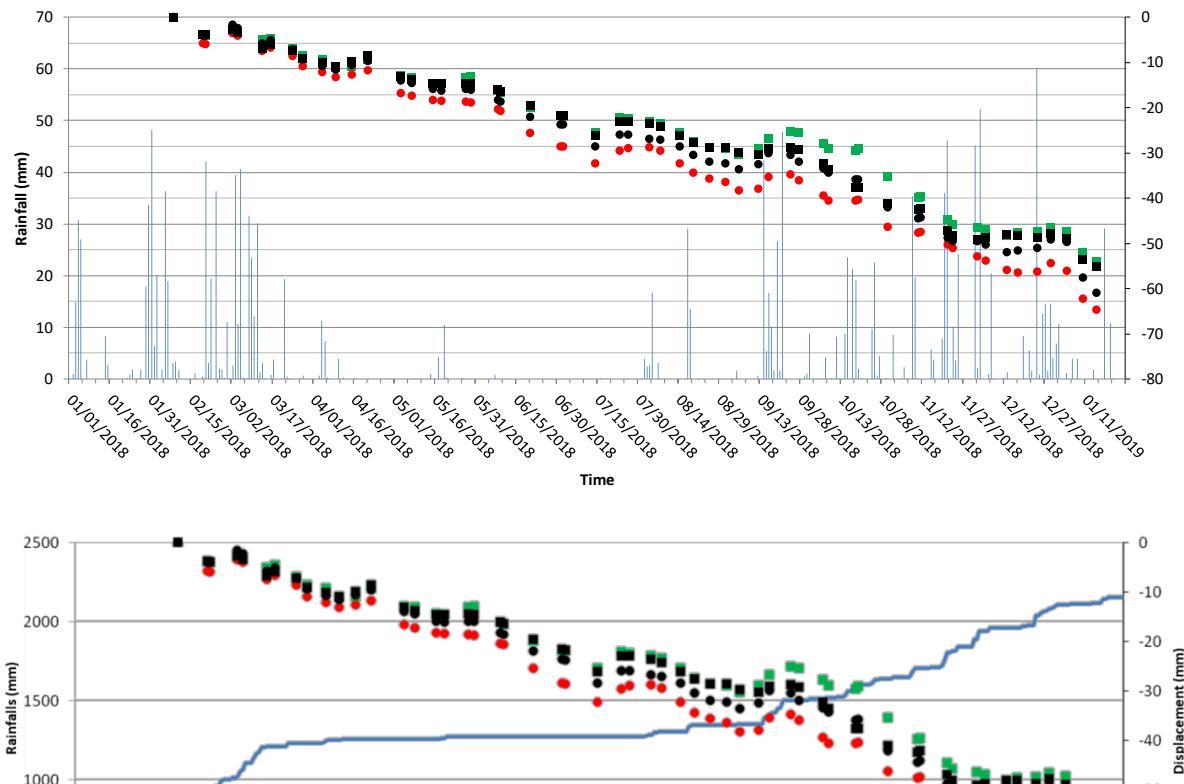
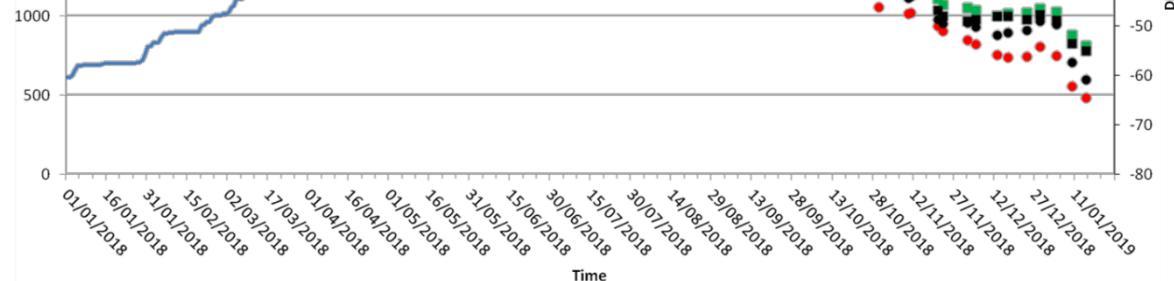
Figure 48: Comparison Between: (a) InSAR Data and Daily Rainfall, and (b) InSAR and Cumulative Rainfall for Points Located Within Tailings

deformations in the tailings are less correlated with rainfalls than those on the dam, showing an almost linear trend with a few slight acceleration periods only partially associated with rainfall events (Figure 48).

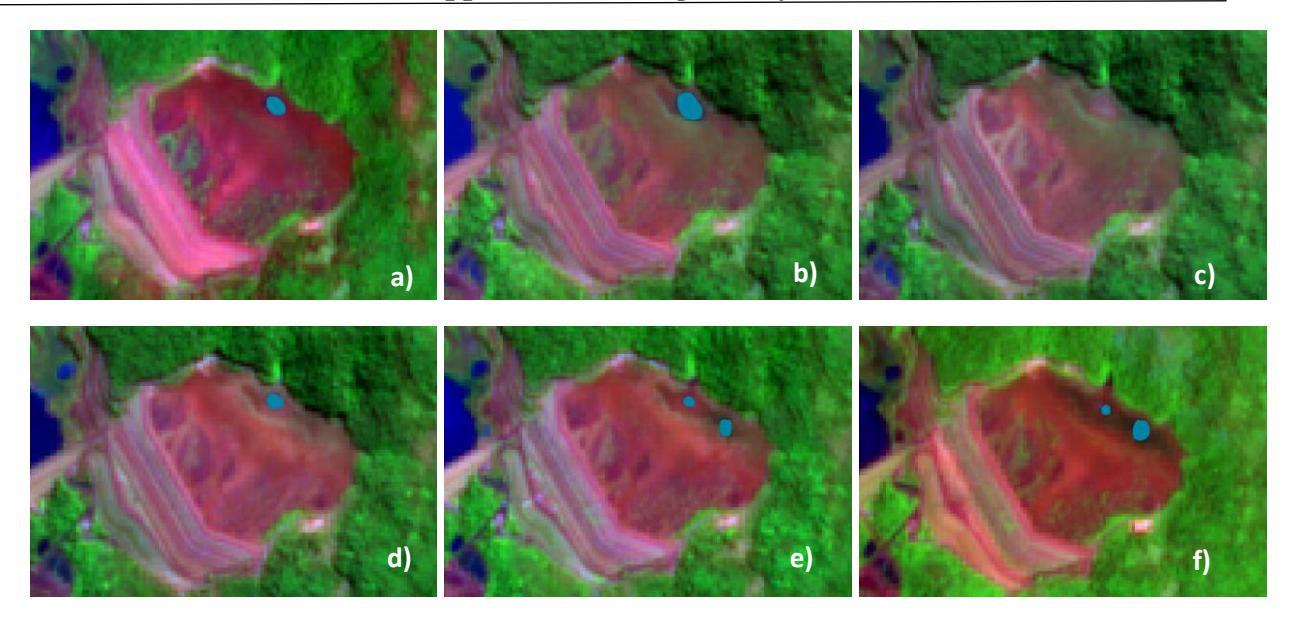
Figure 49: Dynamics of Pond (Depicted in Blue) on Dam I in S-2: (a) January 22, 2018, (b) June 1, 2018, (c) July 21, 2018, (d) August 15, 2018, (e) September 23, 2018, and (f) December 18, 2019

- From January to June 2018: the pond was detected in all the images (Figure 49a-b), located almost in the same position near the stream inlet from the catchment above. The NDWI dated April 27, 2018, clearly confirms the presence of a water body in the central part of the wet area (Figure 51). In Figure 51, the pond is the blue feature (water has the maximum value) in the central part of the wet area (coloured in green for the lower value of wetness index).

- In July 2018, the pond completely disappears, as the tailings surface dries (Figure 49c).
- In August 2018, the pond is again detectable (Figure 49d).

- The image in late September 2018 shows an extension of the pond and the presence of a second pond on the south-eastern (SE) part of the dam (Figure 49e).

- In October 2018, both ponds visible during September 2018 disappear.
- On December 18, 2018, the two ponds are again visible, and the whole tailings surface is wetter compared to late September 2018 (Figure 49f). In the corresponding NDWI and Moisture Index, the central pond is less evident than in April 2018, but the negative values in NDVI indicate the presence of water.

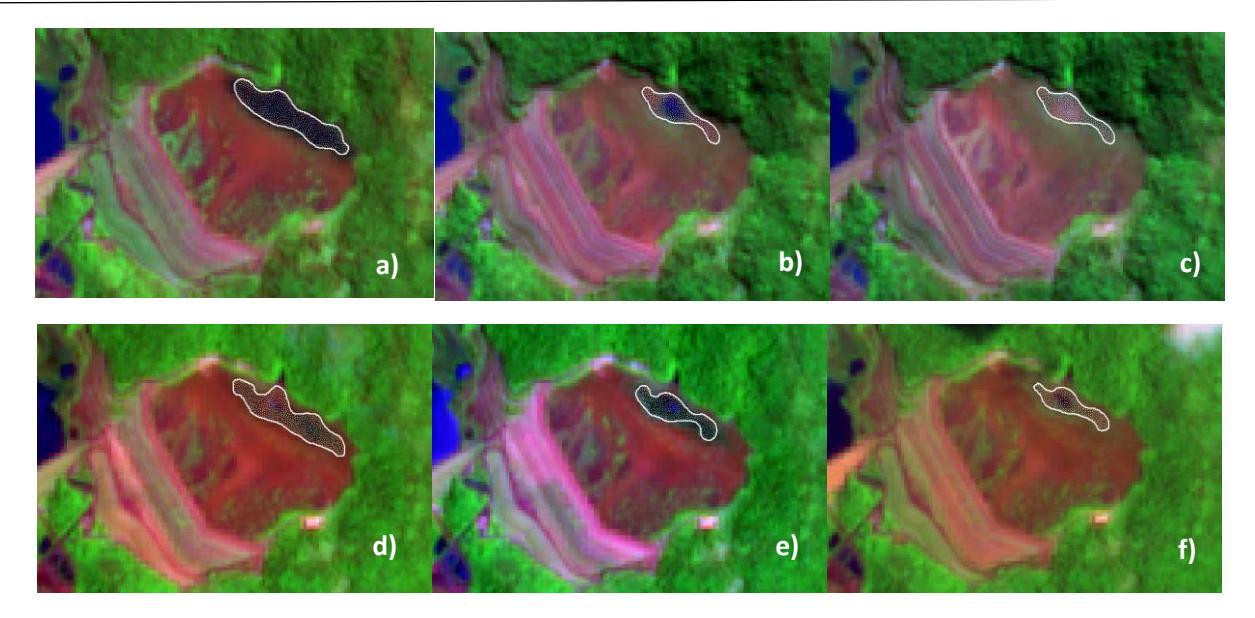
Figure 50: Dynamics of Wet Area (White Boundary) on Dam I in S-2: (a) March 13, 2018, (b) June 1, 2018, (c) July 21, 2018, (d) December 18, 2018, (e) January 7, 2019, and (f) January 22, 2019

A wet area was detected on the northern part of the tailings. The extent of the wet area has changed over the monitoring period, with the maximum in mid-March 2018 and then shrinking and remaining relatively constant in the following months (April to June 2018) (Figure 50a-b).

- In July 2018, the limits of the wet area on the tailings (Figure 50c) seem stable when compared to June 2018.
- August and September 2018 show an increase in the extent of the wet area on the tailings with respect to July 2018, but not to the extent seen in April to June 2018.
- In October 2018, a strong decrease in the extent of the wet area is observed, while December 2018 and January 2019 depict the wet area reaching almost its maximum spatial extension, especially on December 18, 2018, and January 7, 2019 (Figure 50d-e).
