Appendix D Image Analysis

December 2019

Report of the Expert Panel on the Technical Causes of the Failure of Feijão Dam I Appendix D – Image Analysis

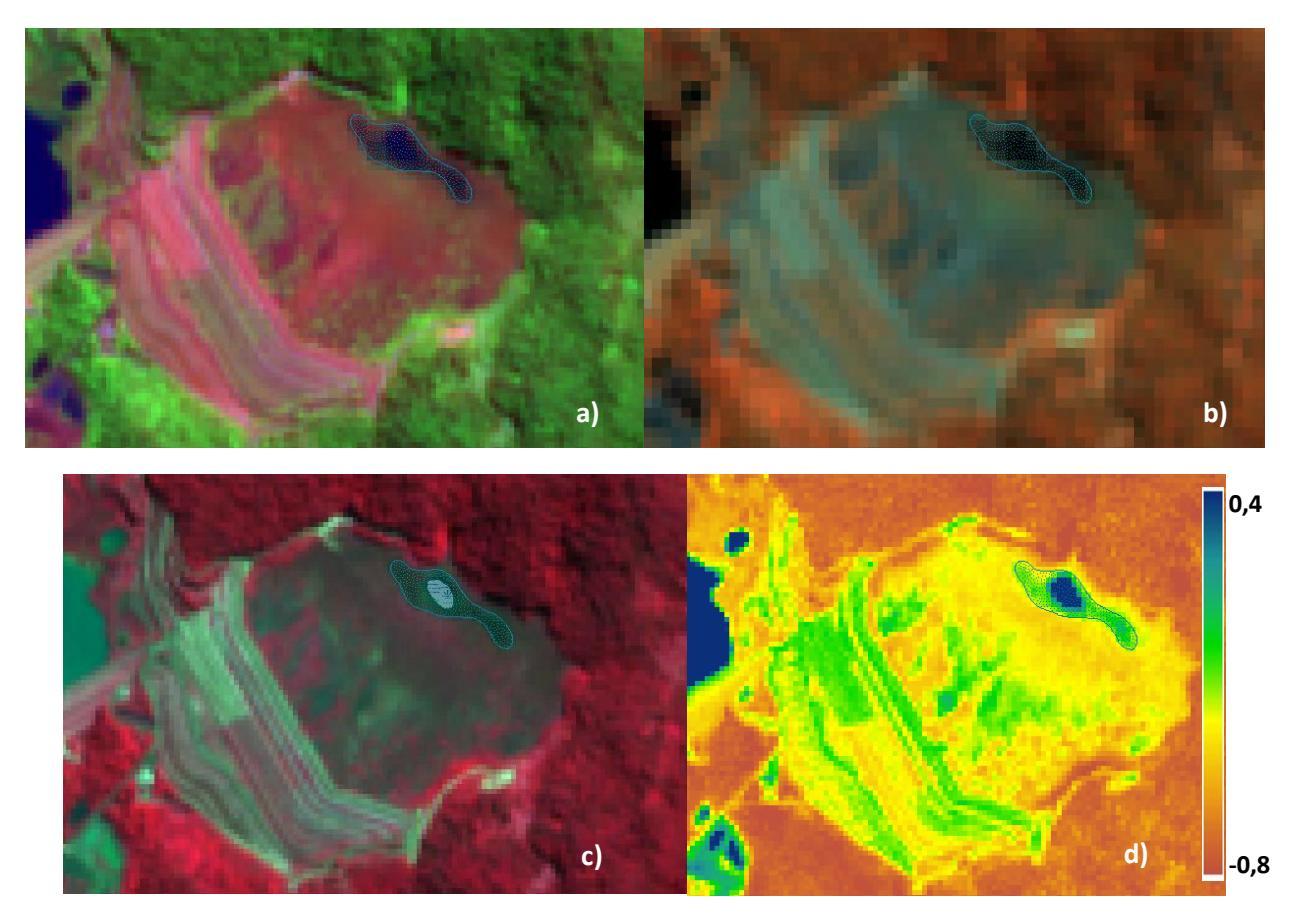
Figure 51: S-2 Data for April 27, 2018. Elaborations Used to Identify Wet Area and Pond Inside It. (a) RGB 12-8-3; (b) RGB 8a-11-12; (c) RGB 8-4-3; (d) NDWI Index

- From January to June 2018: the pond was detected in all the images (Figure 49a-b), located almost in the same position near the stream inlet from the catchment above. The NDWI dated April 27, 2018, clearly confirms the presence of a water body in the central part of the wet area (Figure 51). In Figure 51, the pond is the blue feature (water has the maximum value) in the central part of the wet area (coloured in green for the lower value of wetness index).

- In March 2018, the dam face and tailings show high signal responses associated with vegetation presence.
- In April 2018, the dam face vegetation seems to have been cut (straight line between vegetated (southern part) and not vegetated (northern part) areas). In the tailings, the vegetation response is similar to the March 2018 image. The NDWI index highlights two distinct zones with relevant differences in moisture (probably due to vegetation) (Figure 51).

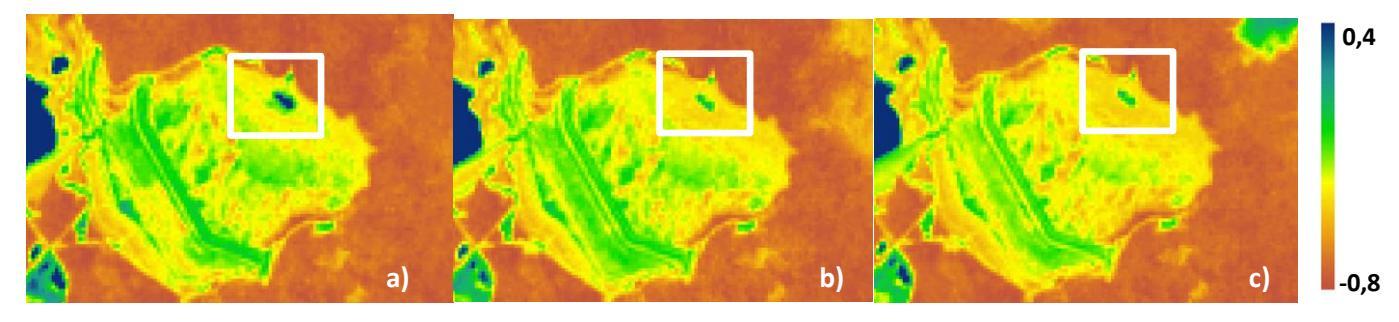
Figure 53: Comparison Between S-2 NDWI Elaborations That Show Progressive Decrease of Water Surface in Northern Part of Dam I for (a) January 7, 2019, (b) January 17, 2019, and (c) January 22, 2019

- On January 7, 2019, the pond surface seems to have further increased from December 2018, as confirmed by the NDWI and Moisture Index elaboration. Conversely, in the following 10 days (January 17, 2019), the pond is strongly reduced, and both NDWI and Moisture Index confirm the decreased moisture levels in the area. By January 22, 2019, in all composite images, the situation seems stationary and one pond near the stream inlet remains visible, as confirmed by the NDWI and Moisture Index elaborations (Figure 53).

The extent of the pond is at a maximum in the January 7, 2019, S-2 image and decreases over the next two weeks (S-2 image of January 17, 2019), apparently due to the lack of rainfall. From the same images, it is possible to note the shrinking of the wet area. This dynamic is confirmed by the S-2 NDWI elaborations that show the progressive decrease of the water surface in the northern part of Dam I in January 2019 (Figure 53).

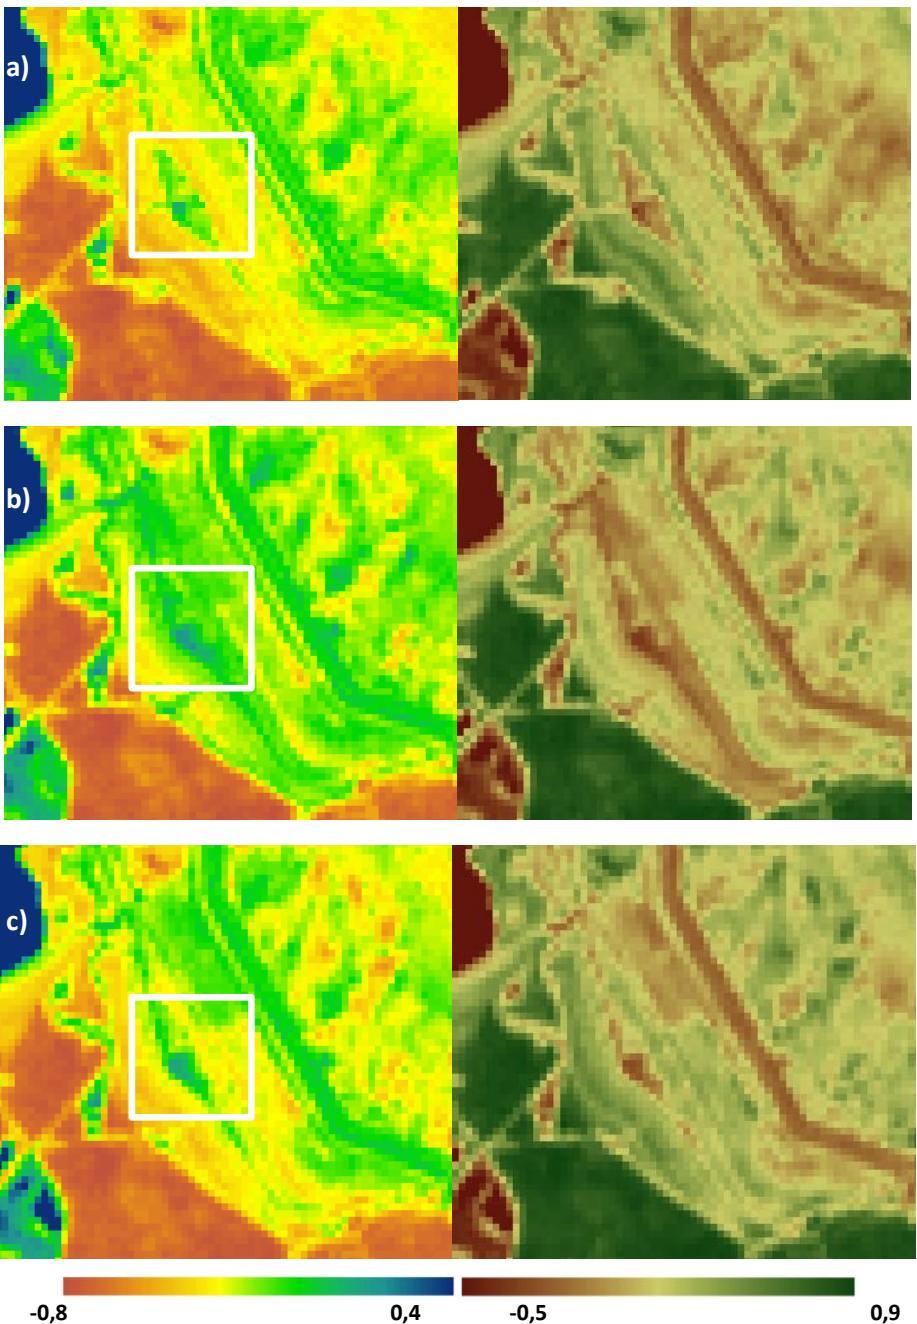
Figure 54: Comparison Between S-2 NDWI and NDVI Elaborations Showing Moisture Content in Setback Area of Dam from December 2018 to early January 2019 With Respect to Values of October 2018: (a) October 14, 2019, (b) December 18, 2019; and (c) January 7, 2019

The NDWI elaboration and analysis highlight particularly high NDWI values in the setback area from December 2018 to January 2019, indicating high moisture levels in this sector of the dam during this period. In particular:

- December 18, 2018: The NDWI image (Figure 54) shows the mid-south area with higher values of moisture with respect to the surroundings and with respect to the previous months. Although, the Moisture Index of the same date is unable to show this relative difference (possibly due to the type of soil composition), the NDVI confirms the absence of vegetation. This indicates that the higher moisture values are not connected with vegetation presence, but most likely with presence of wet soil.
- January 7, 2019: Similar high NDWI values as per the image of December 18, 2018.
- January 17, 2019: The NDWI image shows lower values in this area than those shown in the previous image acquisitions in December 2018 and January 2019.
- January 22, 2019: The NDWI image shows low values similar to the image acquisition on January 17, 2019 (Figure 53).

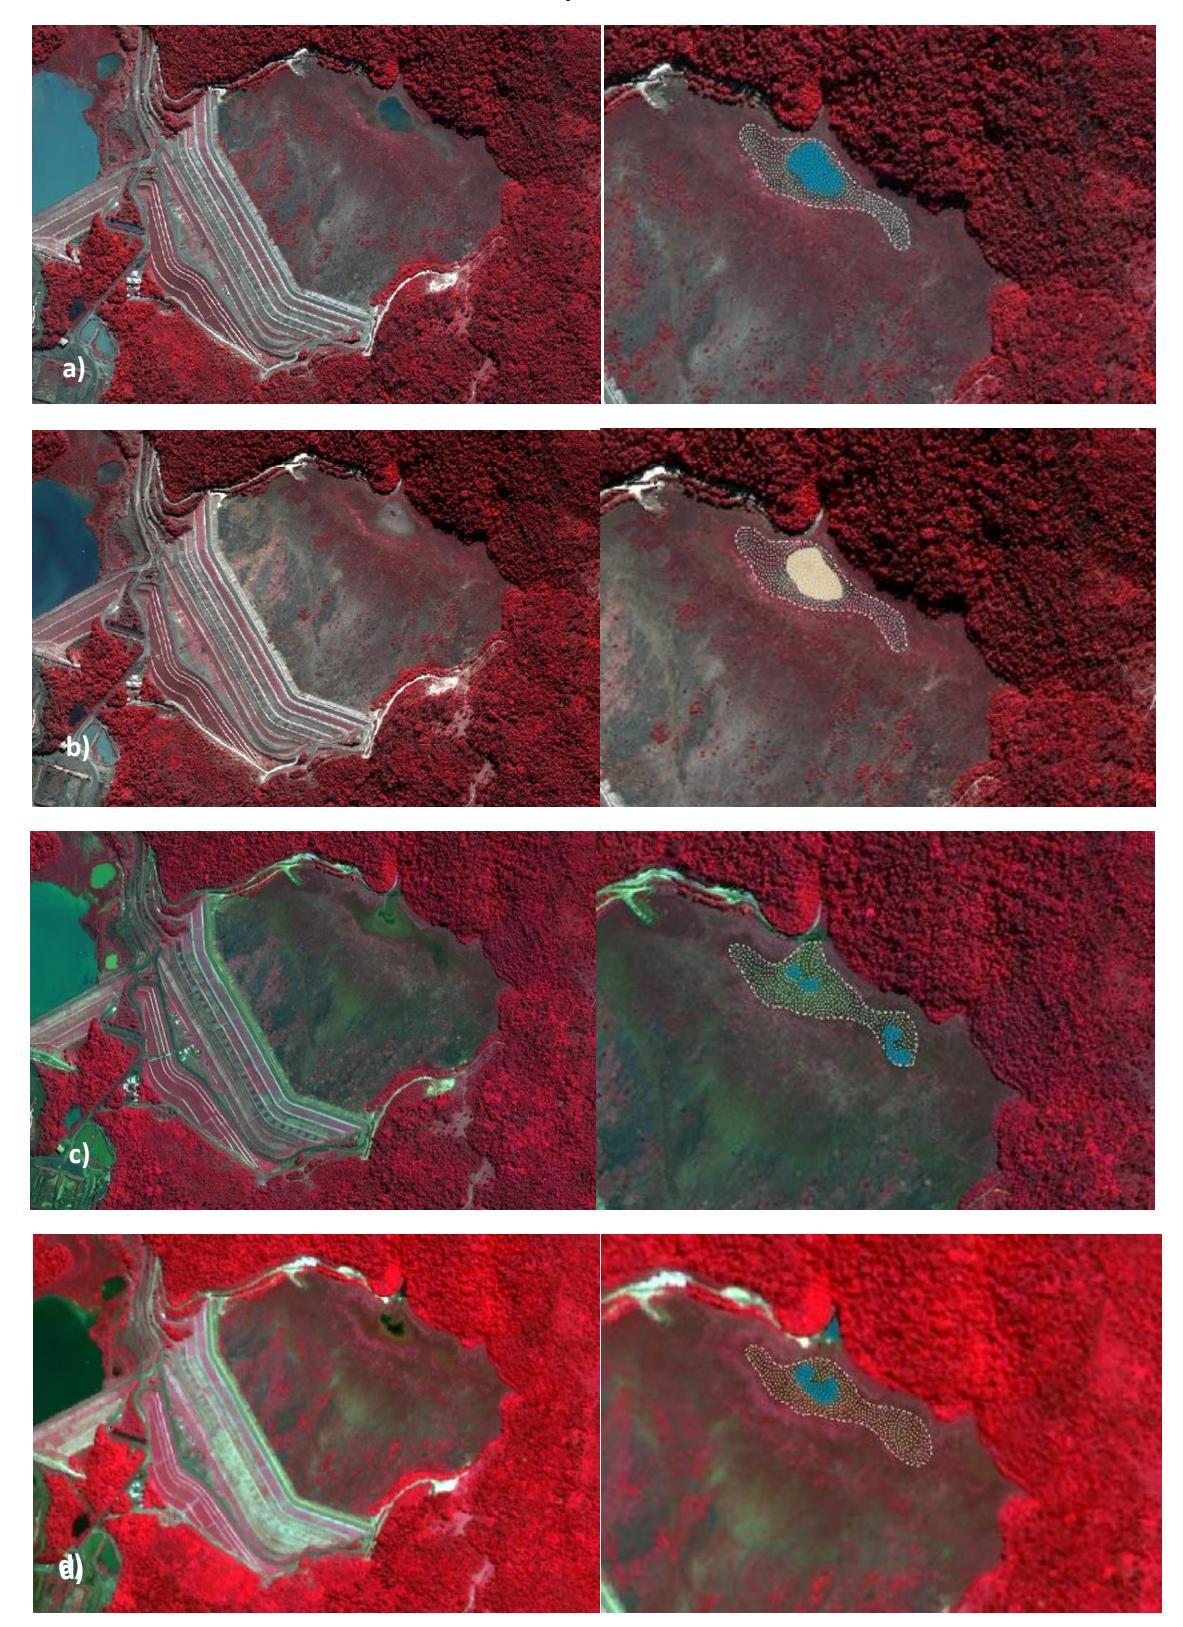
Figure 56: Left column: Dynamic of the Pond and Wet Area from June 2018 to January 2019: (a) June 2, 2018, WV3 RGB 654; (b) July 22, 2018, WV3 654; (c) September 23, 2018, GE-1 RGB

- In the June 2018 WV-3 acquisition (June 2, 2018) the pond (depicted in blue in the right column of Figure 56) has the same extension as projected in the Sentinel-2 data from the same period (June 1, 2018). The position and size of the water surface is confirmed by NDWI and NDVI indices.

- In the July 2018 WV3 acquisition (July 22, 2018), the pond completely disappears similar to the Sentinel-2 data (July 21, 2018). Due to the absence of surface water, the pond sediments are clearly visible (high reflectivity in all bands) (depicted in light brown in Figure 56b, right column).

- In the September 2018 GE-1 acquisition (September 23, 2018), the pond, as observed in Sentinel-2 data, is again visible and confirmed by NDWI and NDVI indices. A second pond is detected on the SE part of the wet area (depicted in blue in Figure 56c, right column). The increased resolution, in particular the panchromatic mode with 0.5 m, provided additional details for the surroundings of the pond area (Figure 57). An interesting feature is the possible damming of the main Dam I inlet by an earth berm first visible in September 2018 (Figure 57b).

- In the January 2019 Pleaides acquisition (January 18, 2019), the central pond is present and wider than in the September 2018 VHR image (Figure 56d). The second pond on the SE part of the wet area is not visible anymore. The damming is still present and complete in January 2019, probably causing water concentration upstream, confirmed by the NWVI index (Figure 57d).

- In the June 2018 WV-3 acquisition (June 2, 2018), the wet area (white boundary in Figure 56a, right column) has the same extension projected in the Sentinel-2 data from the same period (June 1, 2018). The size of the wet area also is confirmed by NDWI and NDVI indices.
- In the July 2018 WV3 acquisition (July 22, 2018), the boundary of the wet area (white boundary in Figure 56b) is the same as the previous month and as the Sentinel-2 data from the same period (July 21, 2018).
- In the September 2018 GE-1 acquisition (September 23, 2018), the wet area has a wider extension than that from July 2018, but similar to the Sentinel-2 data (September 24, 2018). The size of the wet area is confirmed by NDWI and NDVI GE-1 indices.

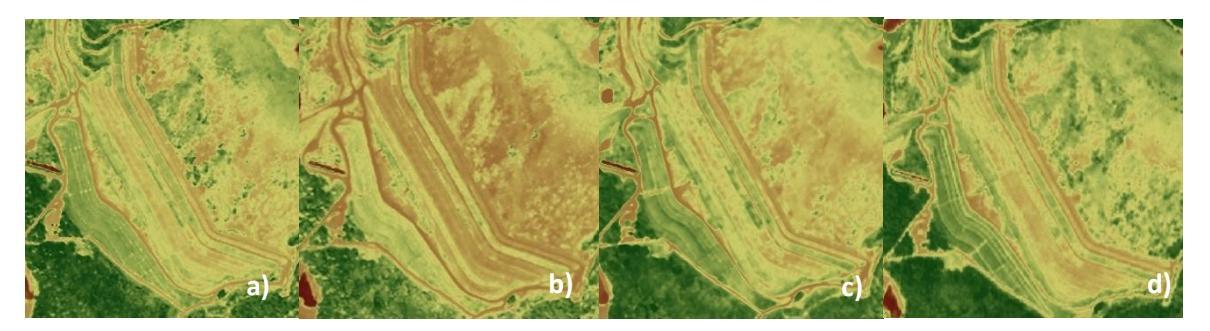
Figure 58: Comparison Among NDVI Indices From June 2018 to January 2019: (a) June 2, 2019; (b) July 22, 2018; (c) September 23, 2018; (d) January 18, 2019

Two different vegetation patterns are observed on the dam face. The lower part of the dam face shows grass and vegetation that is homogeneous and stable (Figure 58). The NDVI index and the colour composite only differs in the July 2018 acquisition (Figure 58b).

The upper part of the dam front is not homogeneously vegetated and is mostly bare (yellow to light brown in NDVI) with only small patches of grass (light green in NDVI) more visible in June 2018 and September 2018 (Figure 58a-c). In January 2019 (Figure 58d), this area of the dam face was characterized by two different zones: the northern zone is sparsely vegetated, and the southern zone is almost completely bare (vegetation cut). The same situation is shown in the Sentinel-2 image for January 17, 2019.

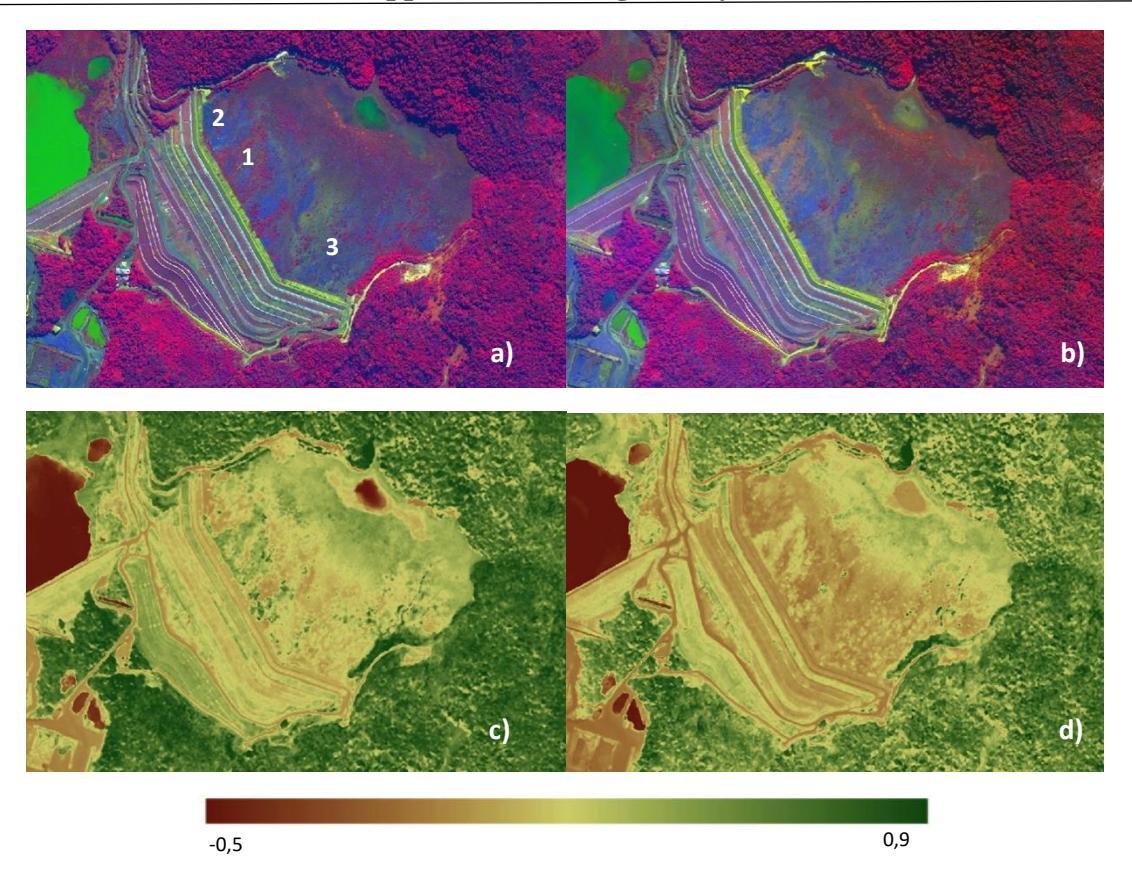
Figure 59: Comparison Between Main Seasonal Conditions: (Left) WV-3 Image of June 2018 (DS 641 and NDVI) and (Right) WV-3 Image of July 2018 (DS 641 and NDVI)

By comparing the four VHR dates, it is possible to identify three different zones in the tailings near the dam crest (Figure 59): the first ("1" in Figure 59a) is characterized by sparse and stable vegetation in the shape of an upside down "Y"; the second area ("2" in Figure 59a) is less vegetated and characterized by very dark tailings, probably connected with a level of NDWI-related moisture; the

third area ("3" in Figure 59a), on the SE part, seems dry and bright. These three areas remain stable over time, except in July 2018 when they undergo changes due to drier conditions (Figure 59b-d).

In particular, in June 2018, area "1" is characterized by the presence of vegetation; surrounding area "2" has less vegetation and dark soils; and area "3" can be distinguished by bright and dry soils. In July, all the area has evident changes: the vegetation in area "1" disappears, as confirmed by NDVI indices (Figure 59d); area "2" with dark soil appears also dryer and less vegetated; and area "3" appears brighter and less vegetated.

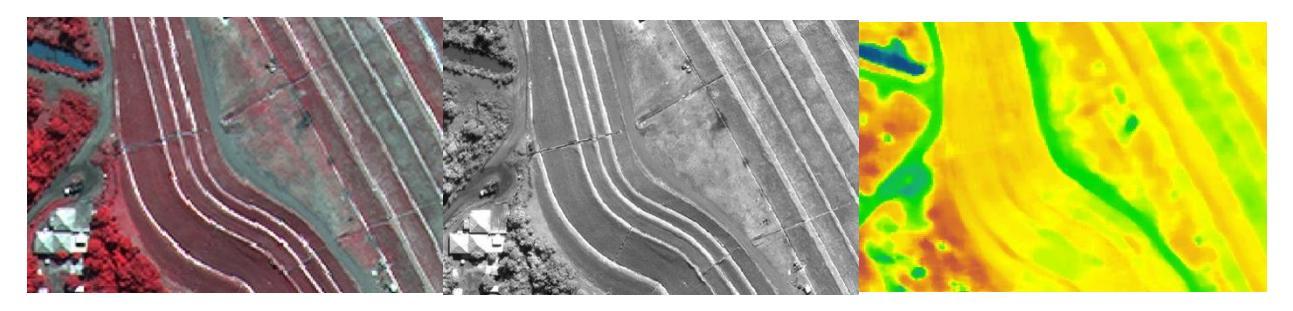
Figure 60: WV-3 of June 2, 2018. Left to Right: False Colour Composite RGB 654, Pan, and NDWI

In particular, in the June 2, 2018, WV-3 image, in the central flat part of the dam face, it is possible to see an area with a different spectral response compared to the surroundings. The higher value of the NDWI (probable moisture anomaly) compared to the surroundings, and the high absorption in False Color Composite (FCC) and in pan image (black pixels), are probably related to the presence of water (Figure 60).

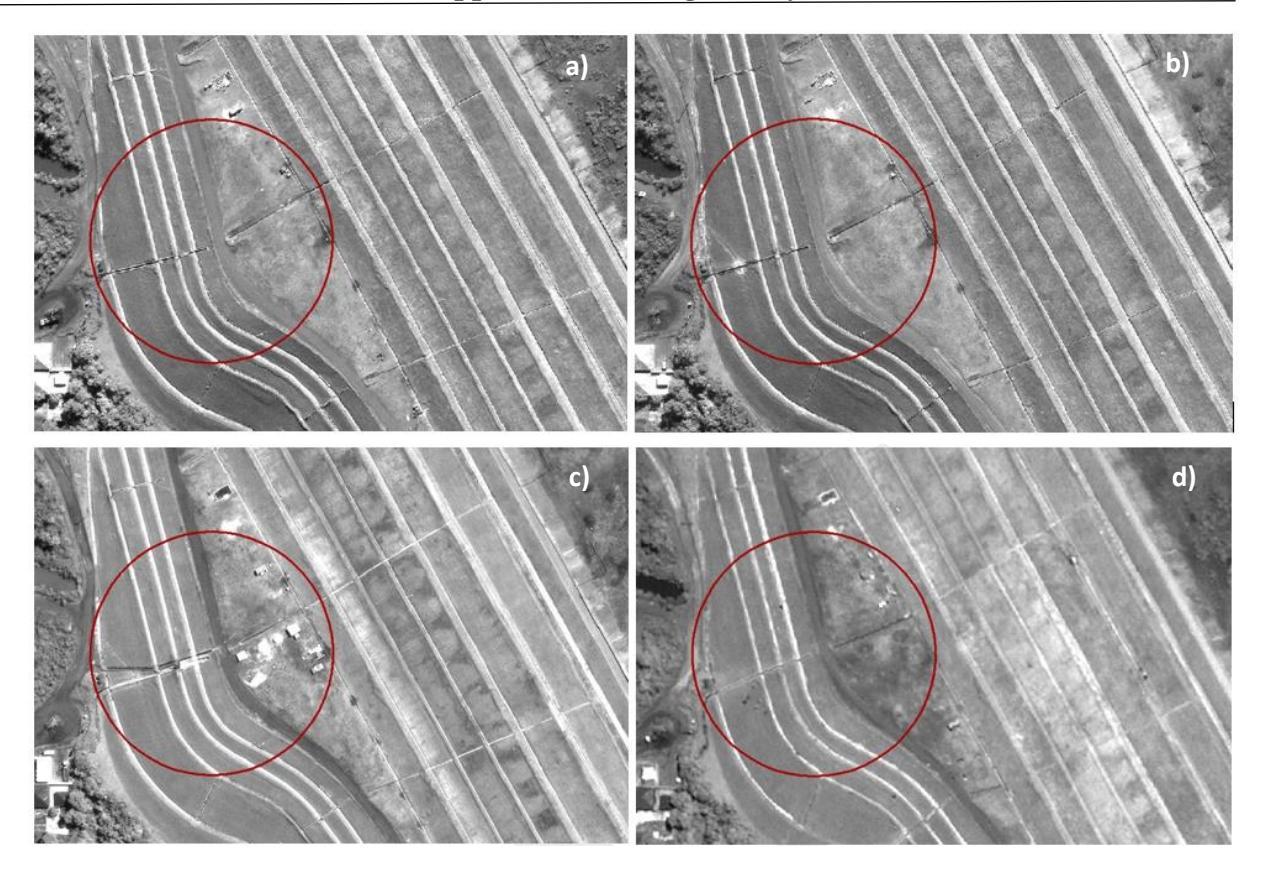
Figure 61: Pan Images of All Four VHR Dates: (a) June 2, 2018, (b) July 22, 2018, (c) September 23, 2018, and (d) July 18, 2019

In the September 23, 2018, image, the anomaly highlighted in June and July 2018 is masked by anthropogenic factors. There are barracks and working facilities in the area. It is possible to observe a new drainage channel construction (Figure 61c).

In the January 18, 2019, image, the anomaly and the working facilities are no longer present (Figure 61d).

- the presence of a probable moisture anomaly on the central flat part of the dam front, observable from June to July 2018 (Figure 60 and Figure 61a-b); in July 2018, it seems that the construction of a supplementary channel began (Figure 61b);

- man-made modifications to the same area in the September 2018 image, including drainage channel construction with support facilities (Figure 61c); in January 2019 this channel is not present (reverse situation to June 2018) nor are the facilities and barracks (Figure 61d);

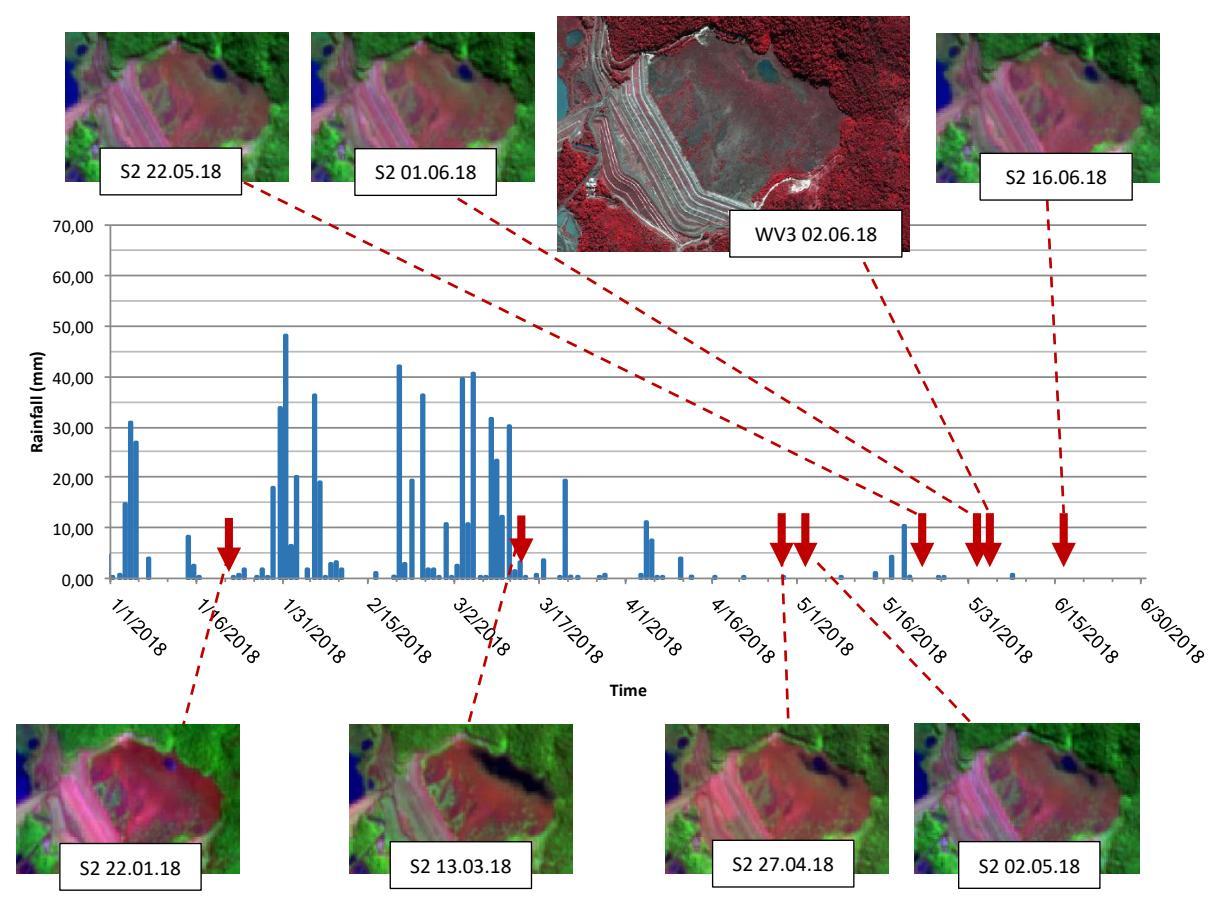
Figure 63: Rainfall Daily Data (Blue Bars) From January 1, 2018, to June 30, 2018. Time Position of Satellite Images is Shown by Red Arrows

From January to the end of June 2018 (Figure 63), most of the rainfall is concentrated in the first 3 months of the year. The high moisture level highlighted by the March 13, 2018, Sentinel-2 image is probably the consequence of this rainy period. Despite the progressive decrease in rainfall from

April to June 2018, all the images show a stable situation concerning the presence of the pond on the tailings.

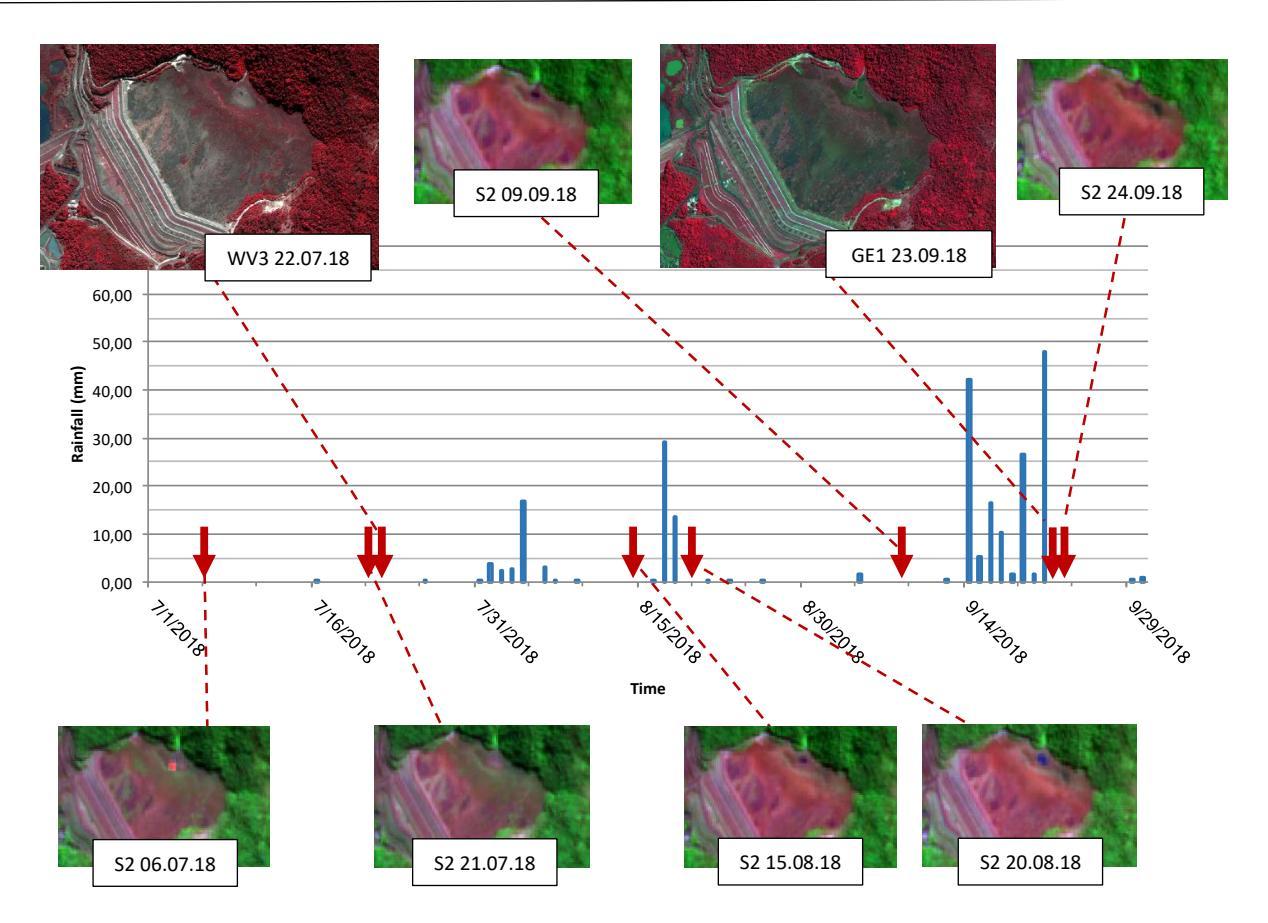
Figure 64: Rainfall Daily Data (Blue Bars) from July 1, 2018, to September 30, 2018. The Time Position of the Satellite Images is Shown by Red Arrows

From July 2018 to the end of September 2018 (Figure 64), the rainfall is concentrated after the middle of September. All the images for July 2018 confirm the dry period, with the absence of the pond and generally dry conditions of the dam (tailings, soils, and vegetation). In August 2018, despite the lack of intense rainfall, the pond is present in the Sentinel-2 image. The consequence of the rainfall in the middle of September 2018 is probably shown in the images by the presence of two ponds on the tailings.

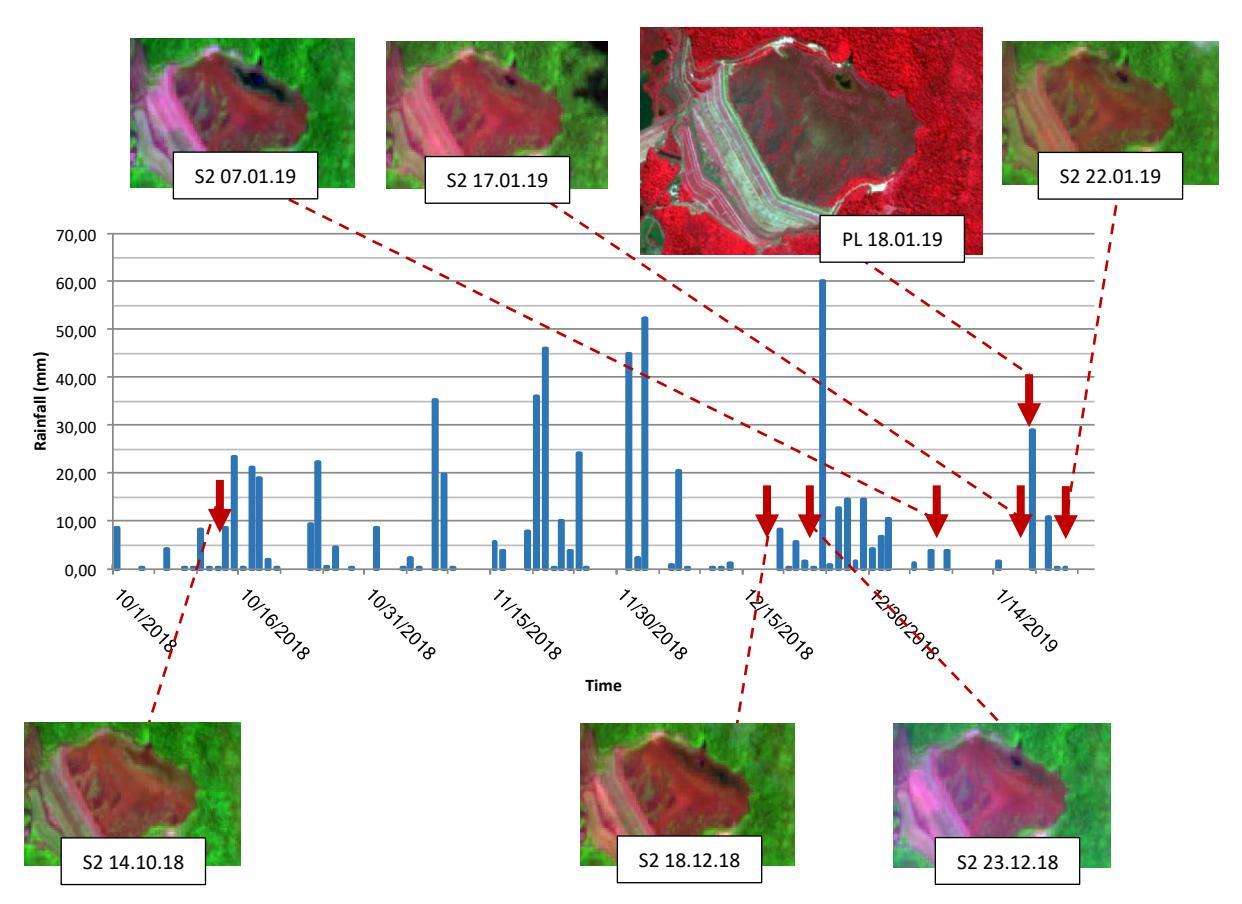
Figure 65: Rainfall Daily Data (Blue Bars) From October 1, 2018, to January 25, 2019. Time Position of Satellite Images is Shown by Red Arrows

The period from October 2018 to early January 2019 (Figure 65) is characterized by a more homogenous rainfall pattern. But, despite this, the October 14, 2018, image does not show the ponds of late September (GE-1 September 23, 2018, and S-2 September 24, 2018). The pond on the tailings is again visible in December 2018.

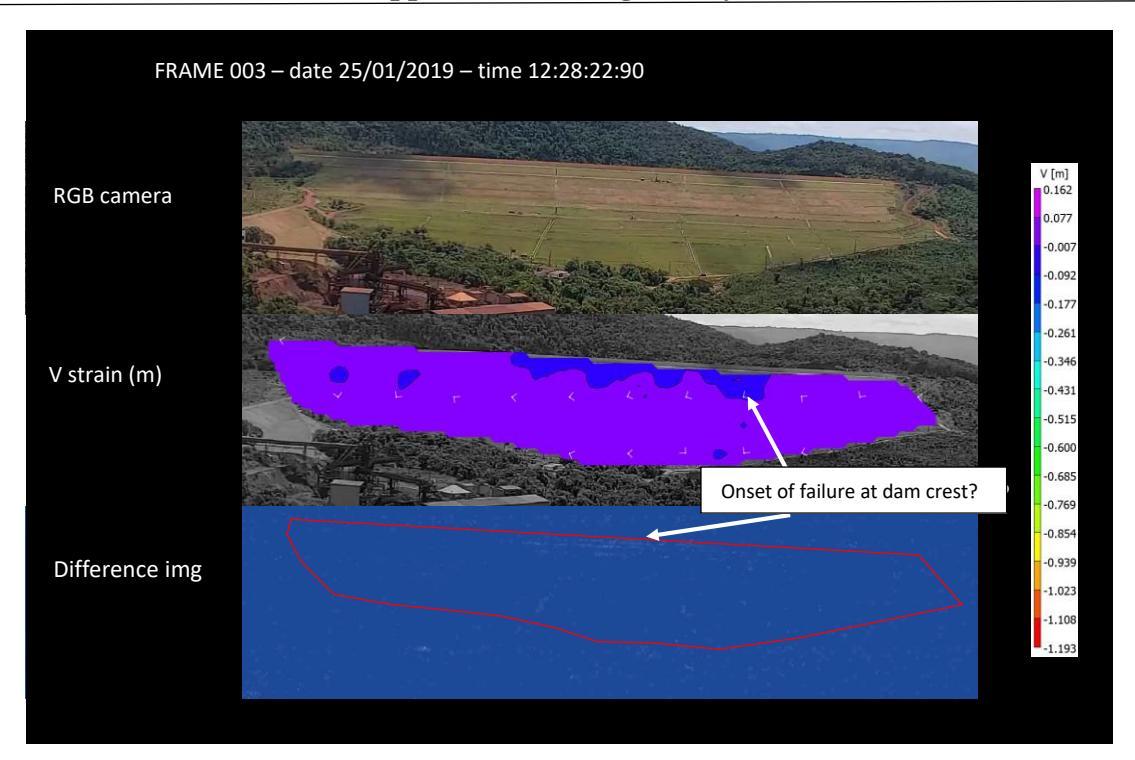
The first indication of deformation was at frame 003 (Figure 72). At this stage, the V component of the strain is negative, denoting a lowering of this portion of the dam crest by about 0.1 m in the vertical direction. No other deformation is measurable on the remaining dam front.

Figure 72: Frame 003. Initial Strain Develops at Top-center of Dam I

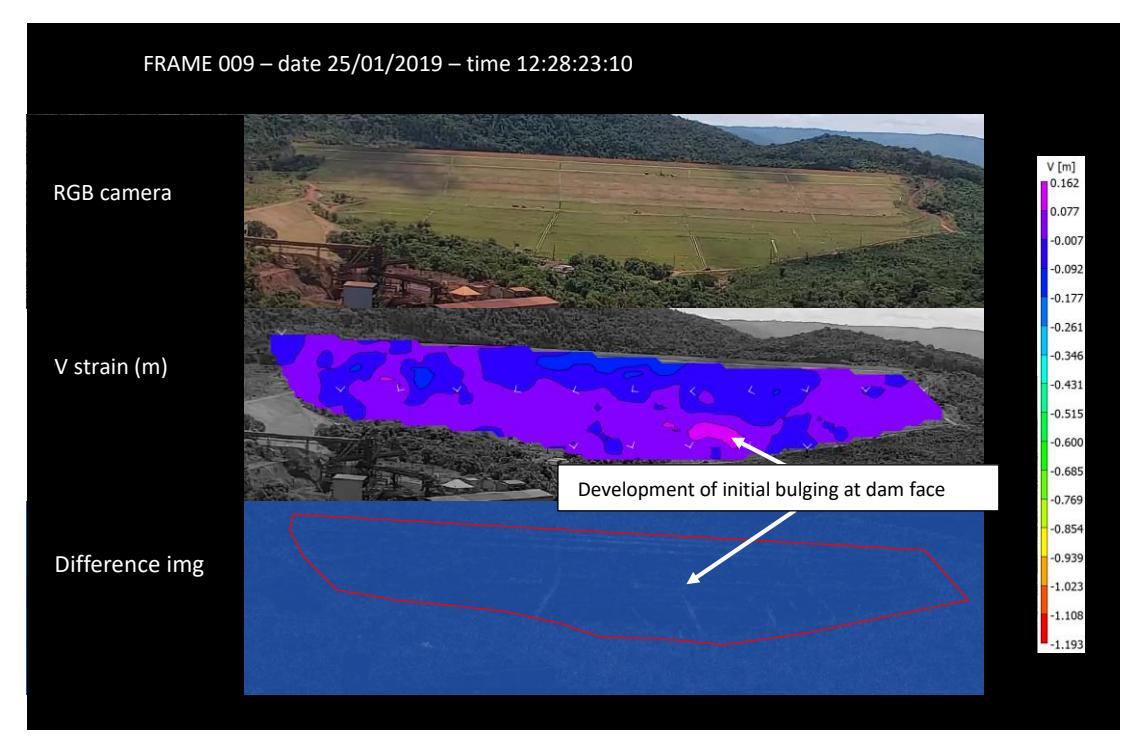
After 0.2 s, in frame 009, bulging seems to initiate in the central-right portion of the front of the dam (with reference to the observation point of view). As visible in Figure 73, in this case the *V* component of the strain deformation is positive, with a value of ~0.15 m. This indicates a vertical uplift, possibly due to the effect of line-of-sight geometry on the actual deformation vector.

The difference image in a blue to white colour scale at the bottom of Figure 73 does not show clearly the shape of the bulging. It highlights deformations in the same area that are mostly related to the change in reflectivity of the drainage channels and other along-slope linear features.

Figure 73: After 0.2 s From Beginning of Deformation at Dam Crest, a Bulging Starts Developing on Central-right Portion of the Dam Face

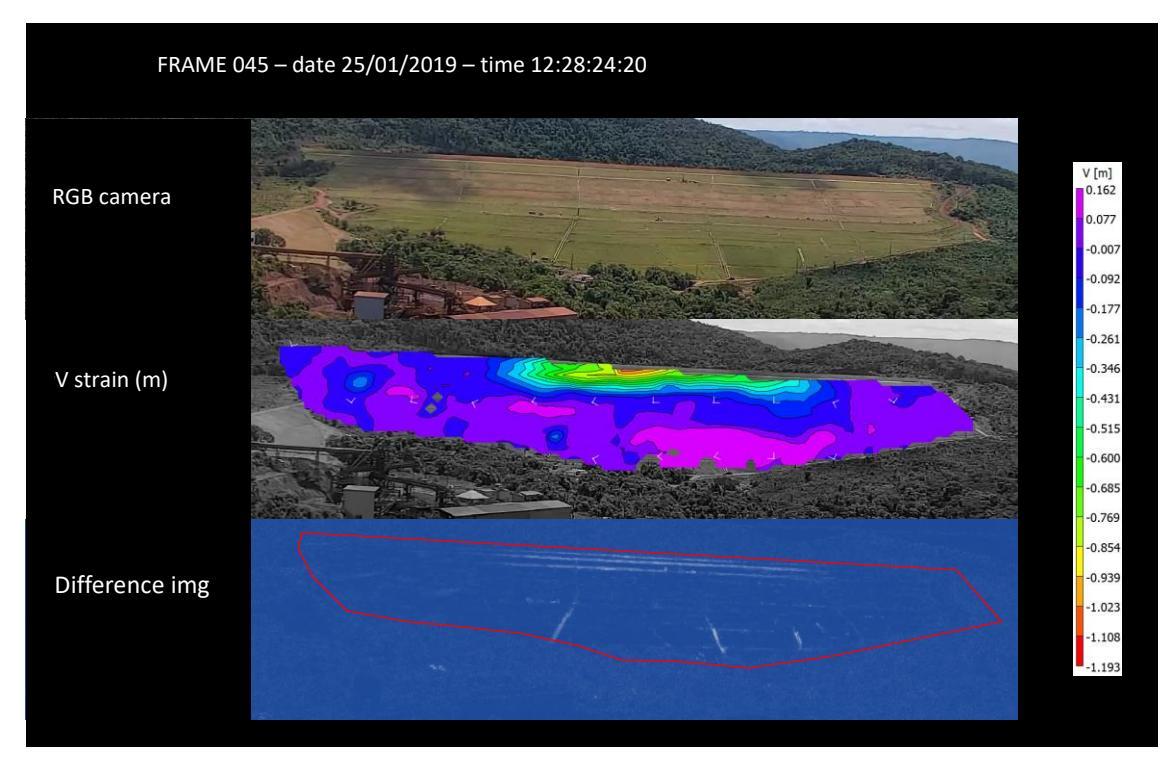
After 1 full second, at frame 045, Figure 74 shows the deformation at the dam crest accelerating rapidly away from a limited highly deformed area in the center. The deformation pattern is mainly developing horizontally, progressively involving more of the dam crest. The *V* component of the strain deformation is from about -1 m at the center down to zero at a distance of ~120 m on both sides of Dam I. The width of the deformed area is ~30 m.

At the same time, the bulging in the right-central part of the dam face also is developing and expanding, mostly horizontally. The V component of the strain deformation is still positive, and the deformation seems to be limited to 0.15 m. However, as already noted, the V component is the vector sum of three components along the line-of-sight of the camera. Therefore, the depicted color/value is only the combination of different effects developing on the dam face. Possibly, the vertical positive component is still dominating, but it is compensated, in this phase, by the initial development of a vertical failure component which is still not predominant.

Figure 74: After 45 Frames, Deformation at dam Crest is Accelerating Rapidly, While Bulging of Dam Face is Larger and Still Positive

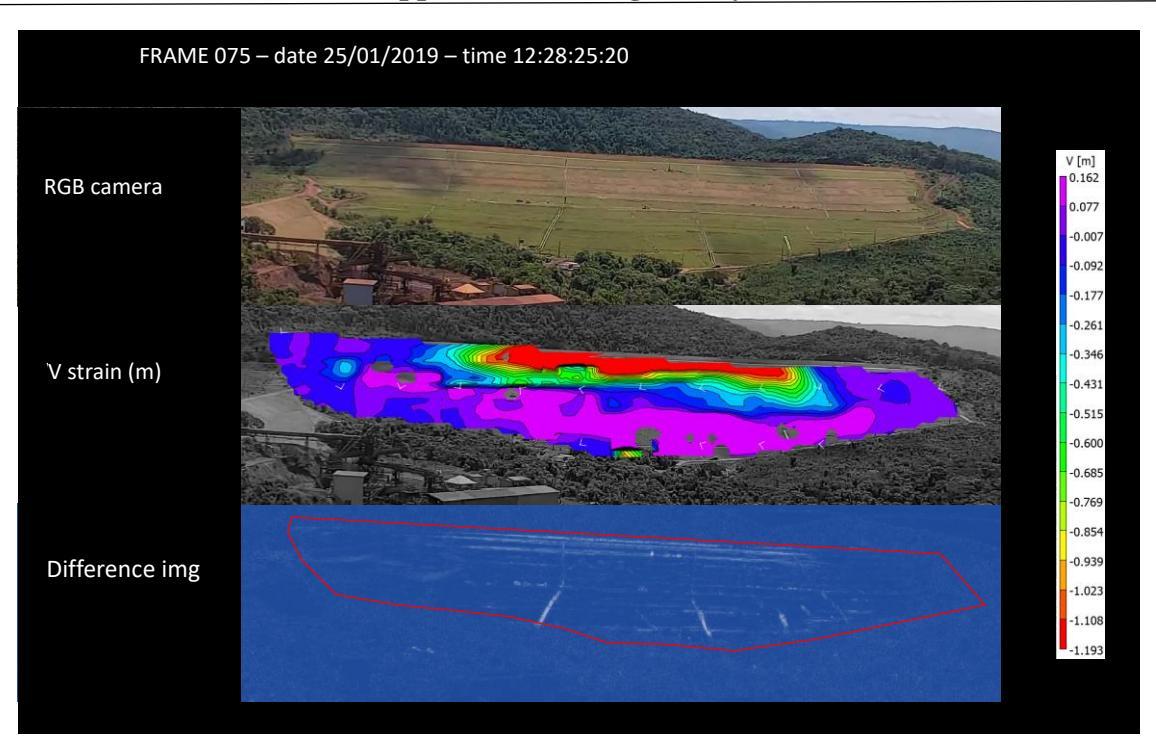
The final stage of this phase of deformation is visible in Figure 75, in which the crest deformation has developed to involve almost 80% of the dam crest width, with a maximum deformation of meters, and the bulging which now occupies most of the lower portion of the dam face.

Figure 75: Terminal Stage of Deformation Phase 1, in Which Bulging is Still Positive and Dam Crest is Collapsing Widely

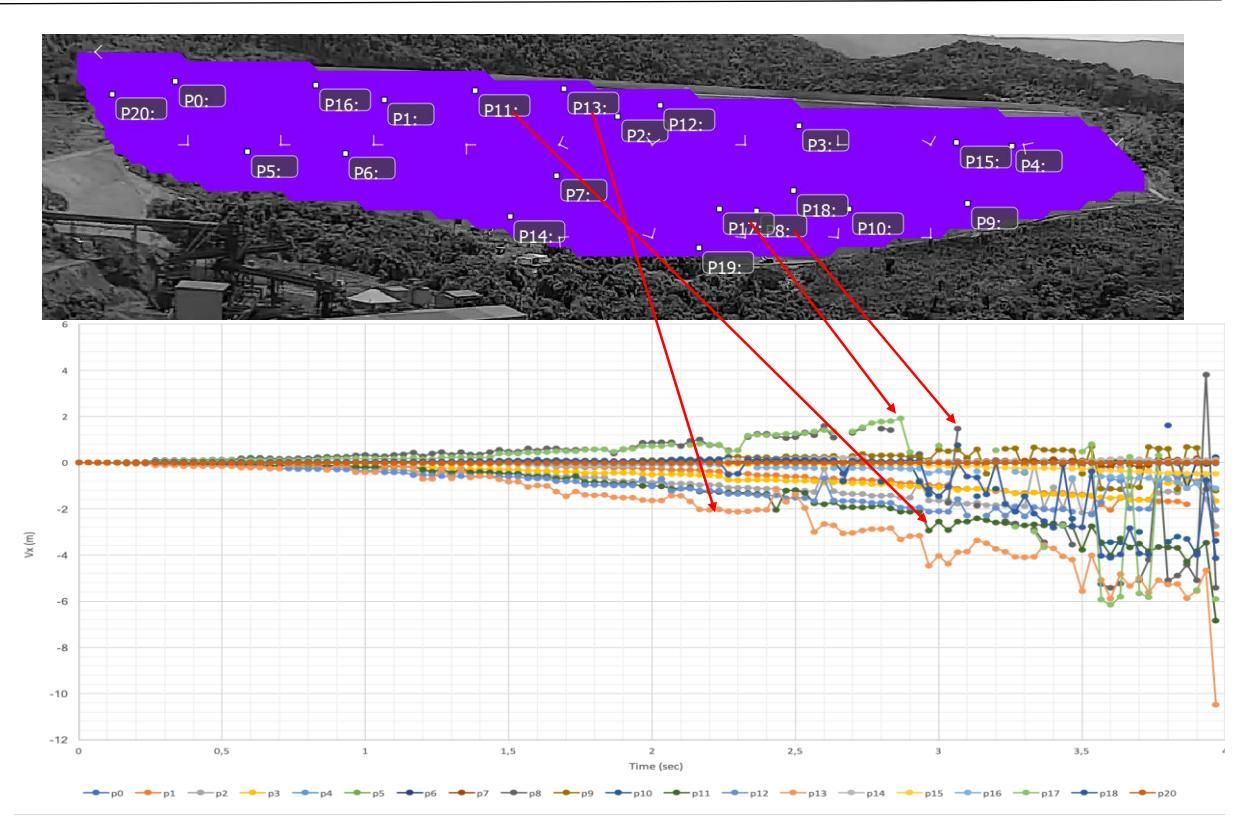
Figure 78 shows the summary of the V component deformation time series for those selected points over the 4 s time frame. Tracked points P11, P13 (on the crest) and P17, P8 (on the central dam face) show the highest rates and magnitudes of deformation. Figure 79 suggests that the V component of the deformation started at the same time in the two different portions of the dam for the two selected survey points. This is not reflected in the continuous deformation field, however, and may mean that only local deformation was active at that stage on the central dam face.

Figure 78: Summary of Point Tracking Analysis From Frame 0 (Time = 0 s) to Frame 120 (Time = 4 s) of Modeled *V* Component

The onset of failure is noted first at the dam crest and then on the lower right side of the dam, with a few tenths of a second between them. After that, deformation also develops on the central part of the dam face.

The deformation at the dam crest shows a steady increase of the negative V component of strain (compatible with a gravitational failure; that is, collapse within the body of the dam). The deformation at the central part of the dam face starts with a positive V component (probably indicating bulging) followed by inversion to negative values (gravitational failure) about 2 s after the initiation of the failure.

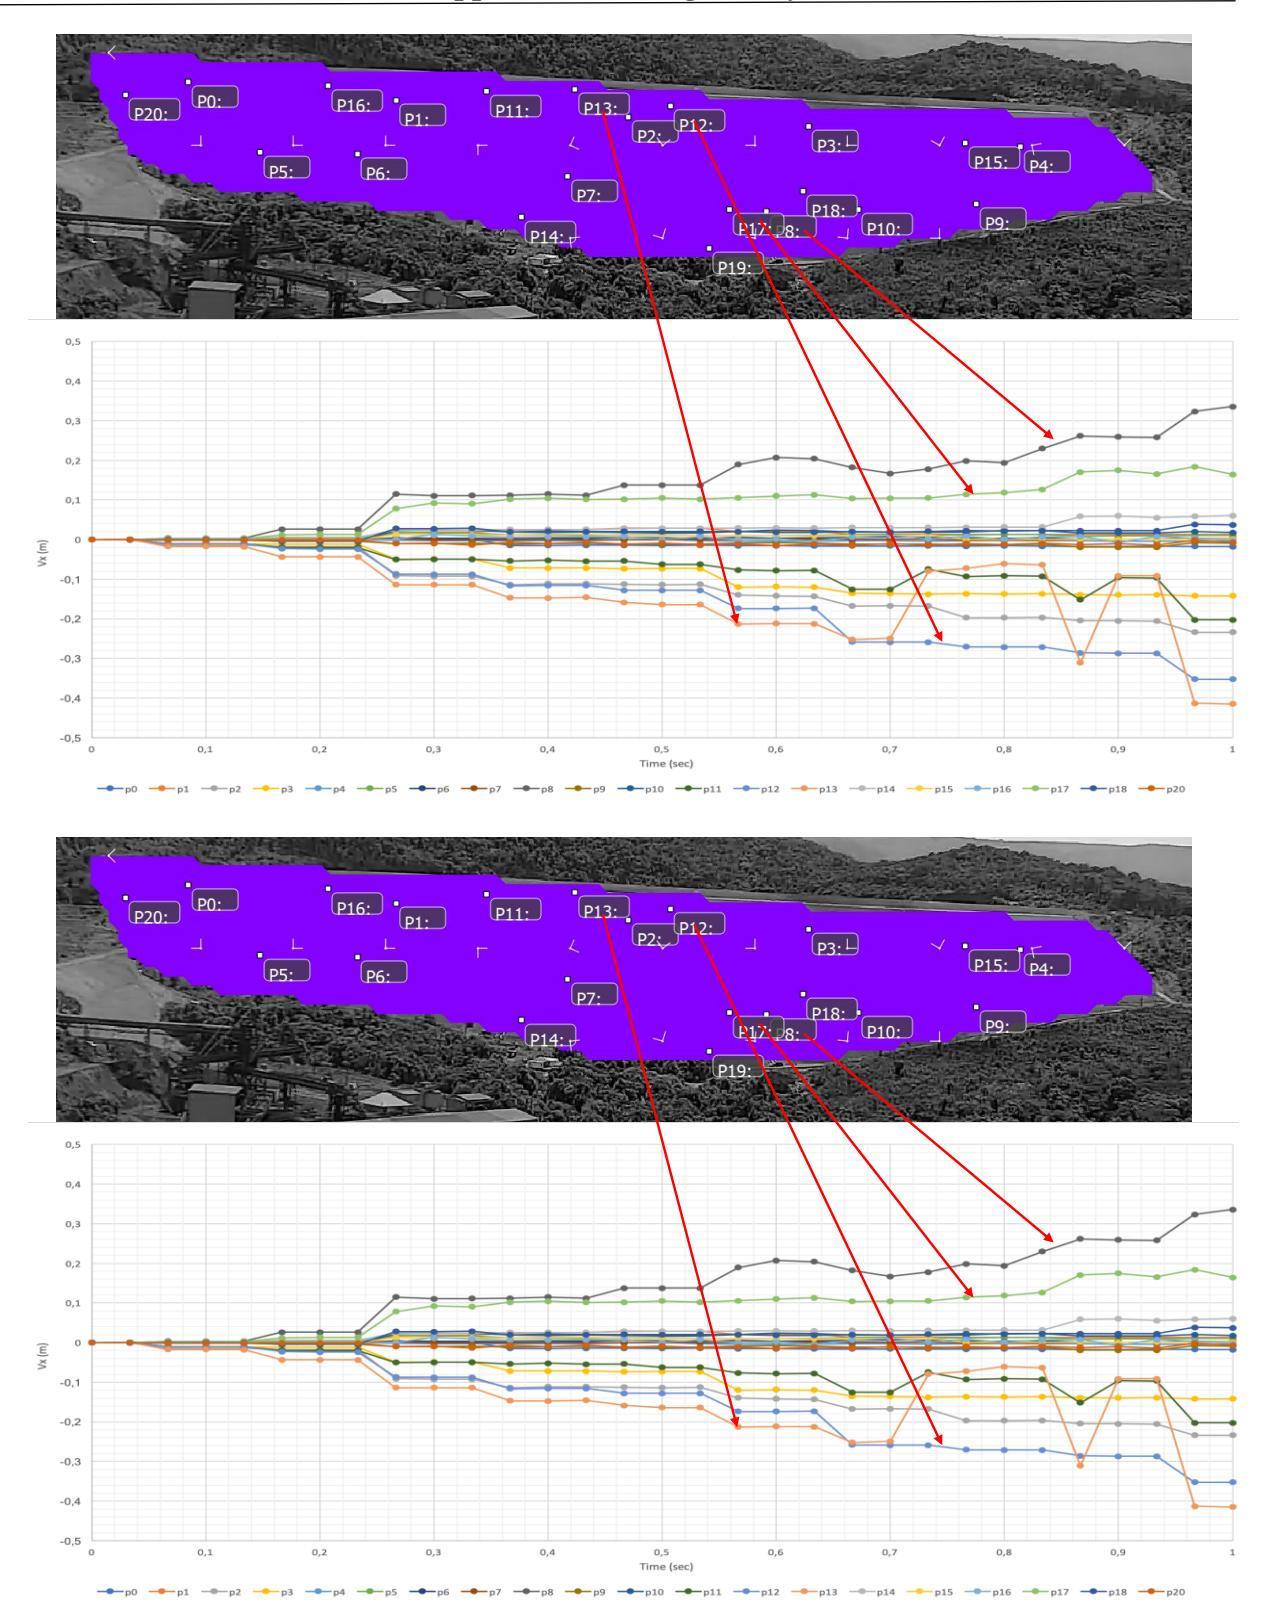
Figure 79: Detailed Point Tracking Analysis From Frame 0 (Time = 0 s) to Frame 30 (Time = 1 s) of Modeled *V* Component
