Appendix D Image Analysis

December 2019

Report of the Expert Panel on the Technical Causes of the Failure of Feijão Dam I Appendix D – Image Analysis

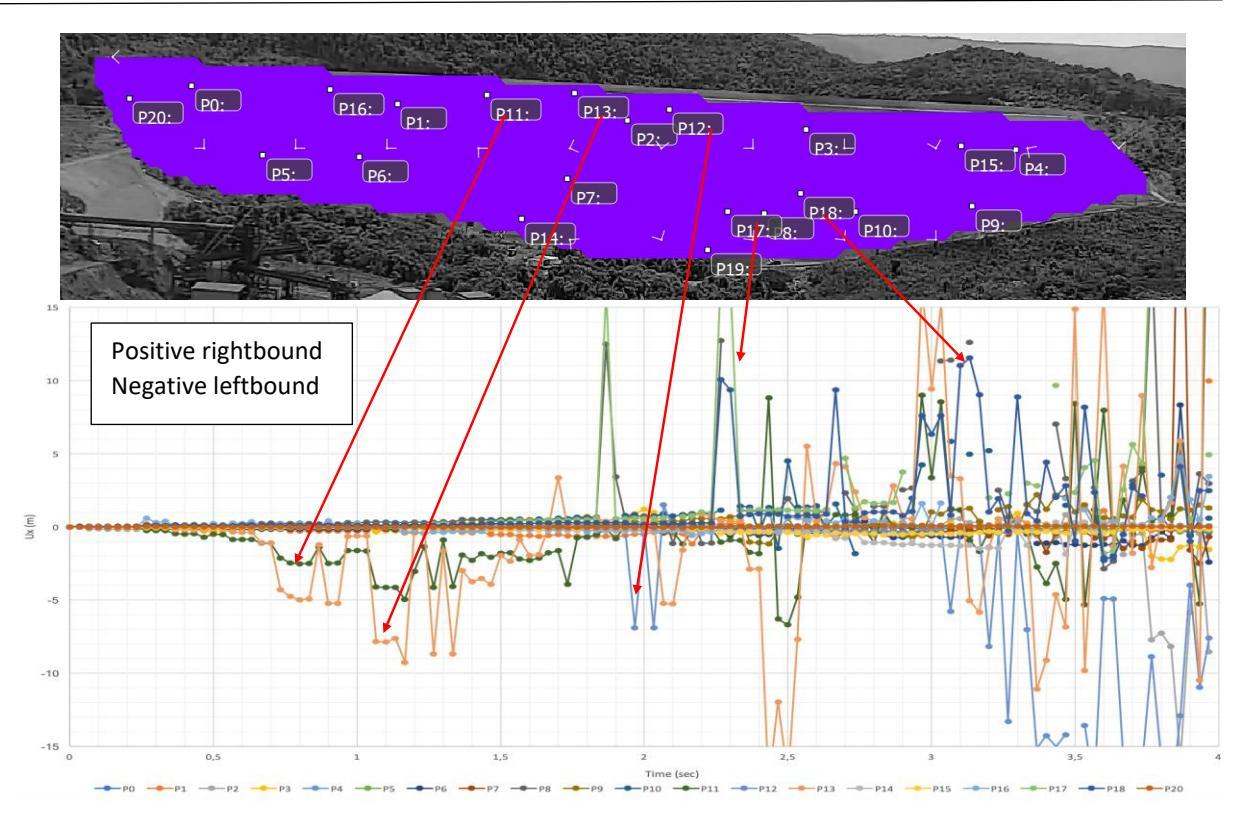
Figure 80 and Figure 81 show that the *U* component of the deformation of the central-right dam face is not visible, suggesting predominantly upward and outward (towards camera) deformations.

Figure 80: Summary of Point Tracking Analysis From Frame 0 (Time = 0 s) to Frame 120 (Time = 4 s) of Modeled *U* Component

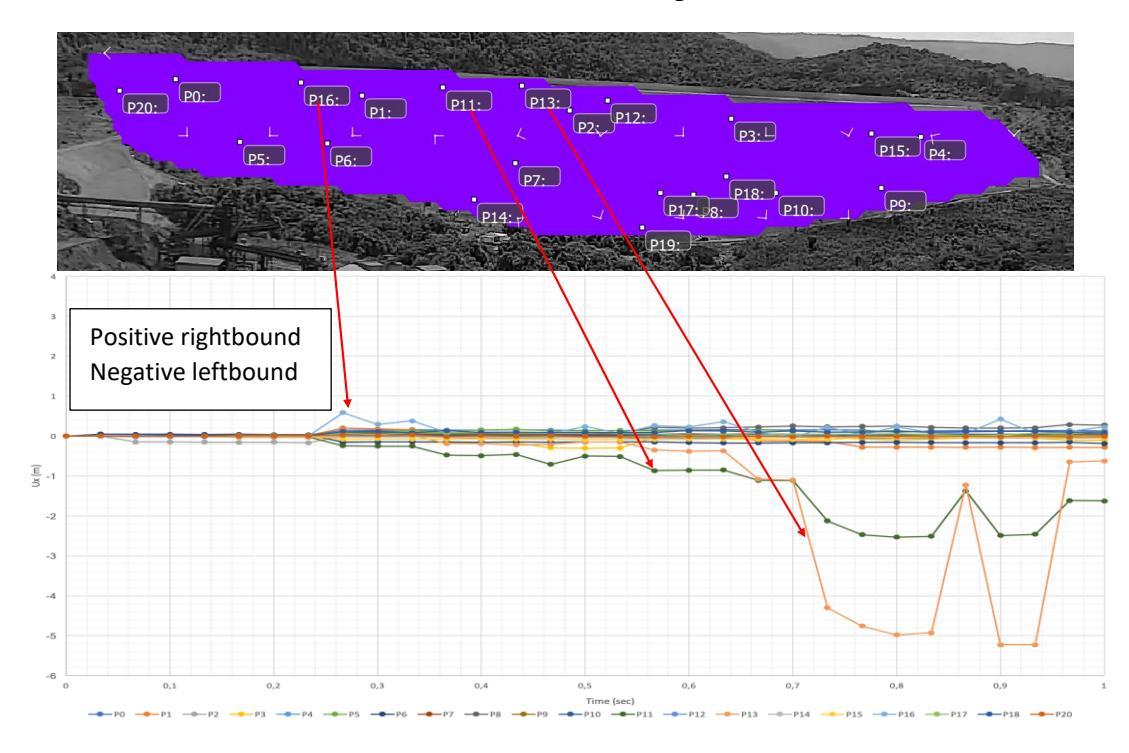
Figure 81: Detailed Point Tracking Analysis From Frame 0 (Time = 0 s) to Frame 30 (Time = 1 s) of Modeled *U* Component

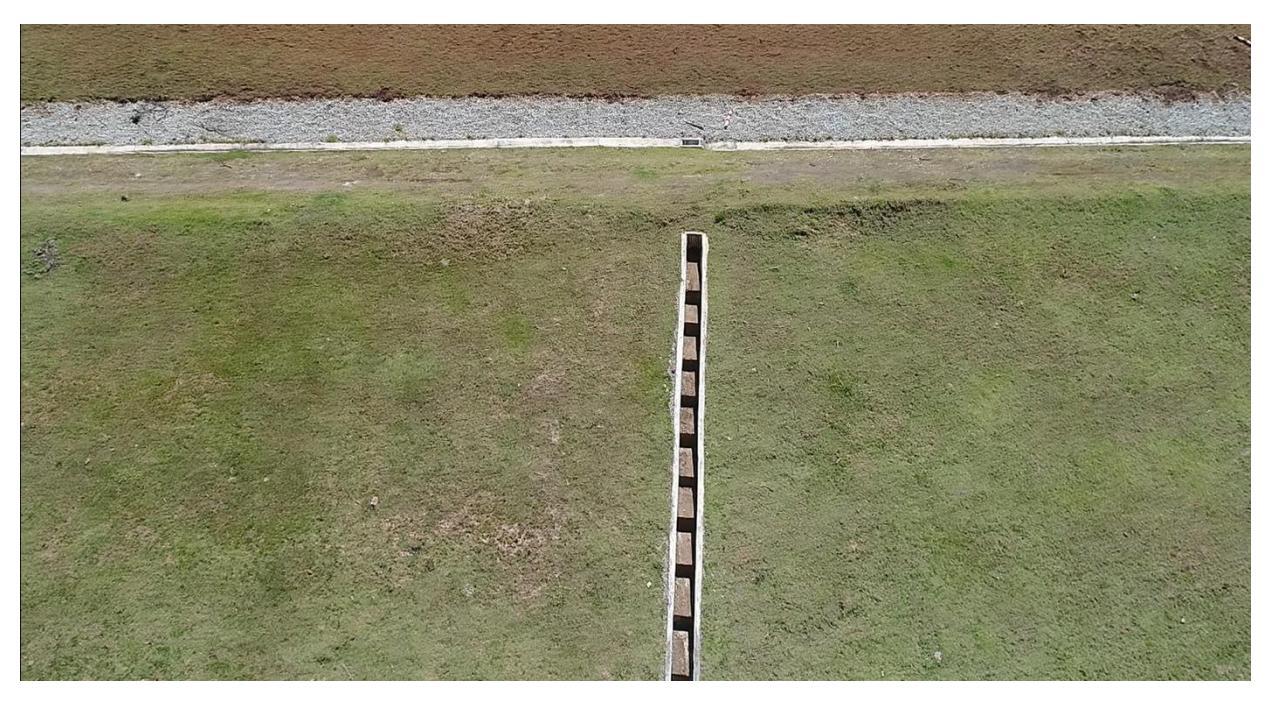
Figure 83: Drone Footage at 06:20 of Video DJI_0142.mov

- Wet areas: No wet areas were visible in the drone footage at the time of the flight.
- Drainage channels: Clean and dry drainage channels were present in the upper and central part of the dam (Figure 83), but the channels in the lower part of the dam had flowing water that was brown in color (probably wet mud inside) (Figure 84).

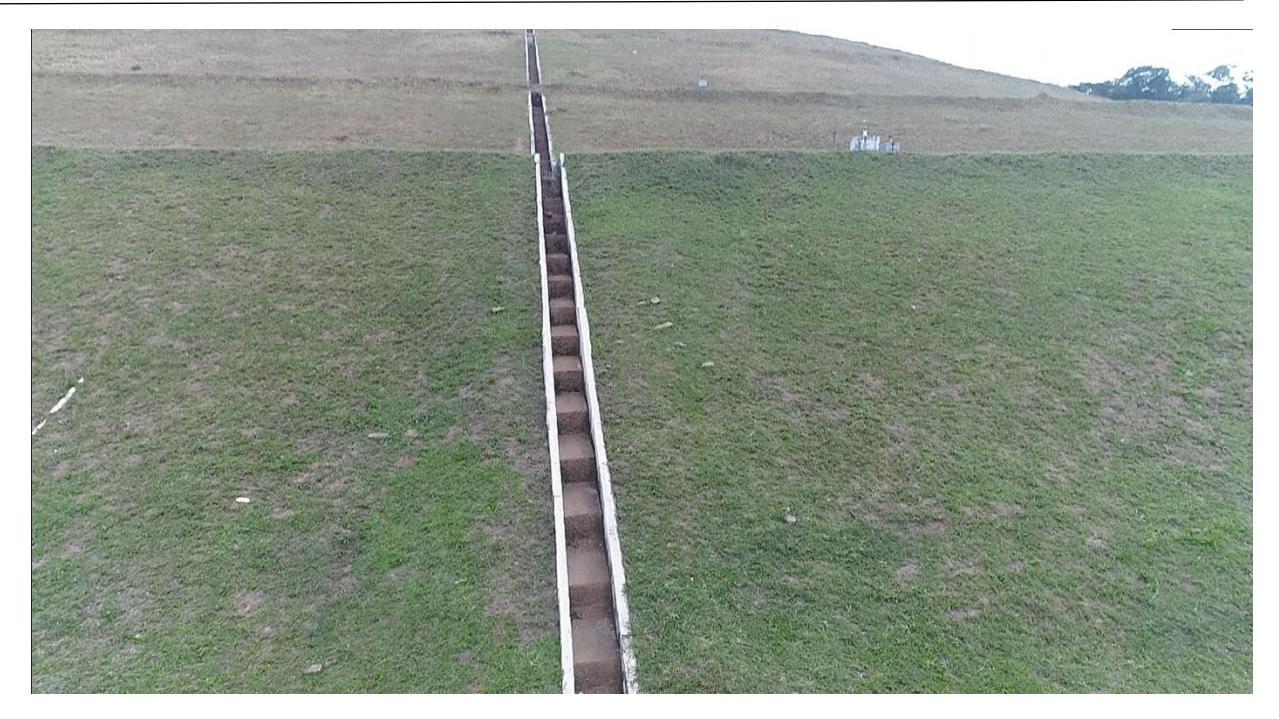
Figure 84: Drone Footage at 05:32 of Video DJI_0143.mov Showing Drainage Channel With Brown Mud and Flowing Water

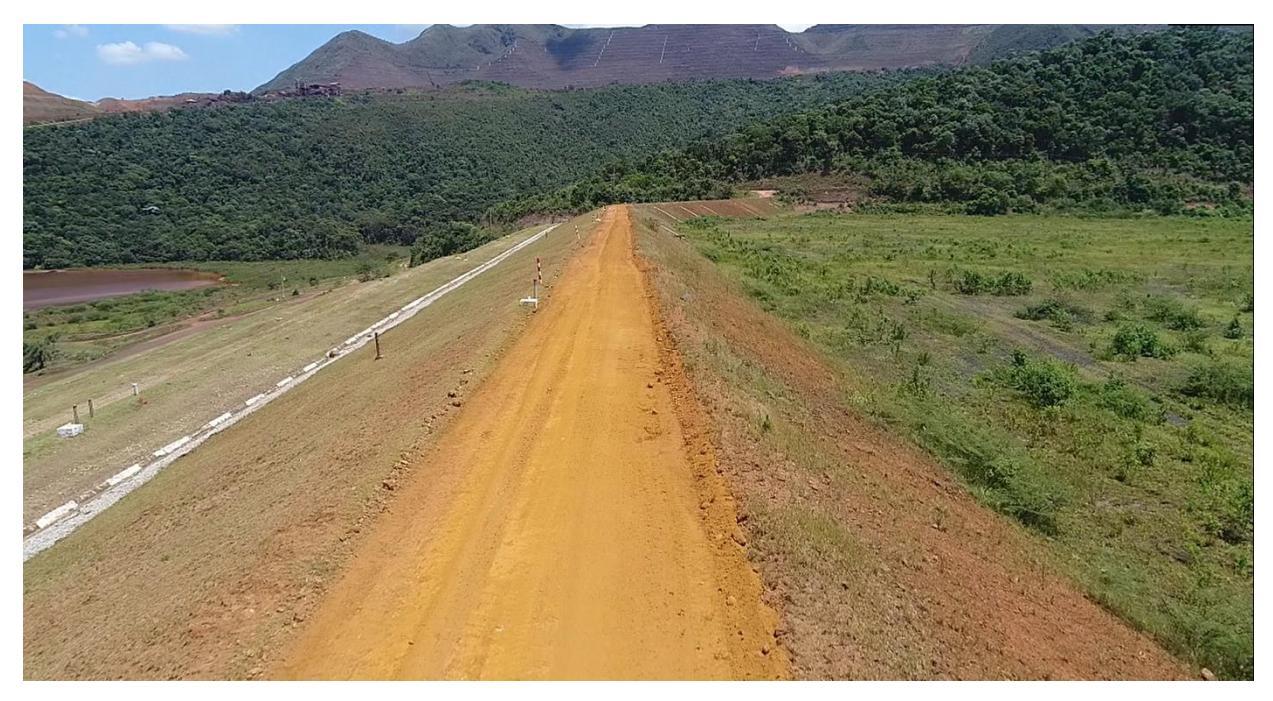
Figure 85: Drone Footage at 02:10 of Video DJI_0142.mov

- Morphology: By flying along the crest and the different raisings, neither convex nor concave morphologies potentially associated with past or ongoing deformations were identified (Figure 85). Some localized sectors of the central part of the dam with rough, irregular, and gibbousness morphology may be associated with superficial past deformations or with cows walking on the dam (03:30 of second video) (Figure 86).

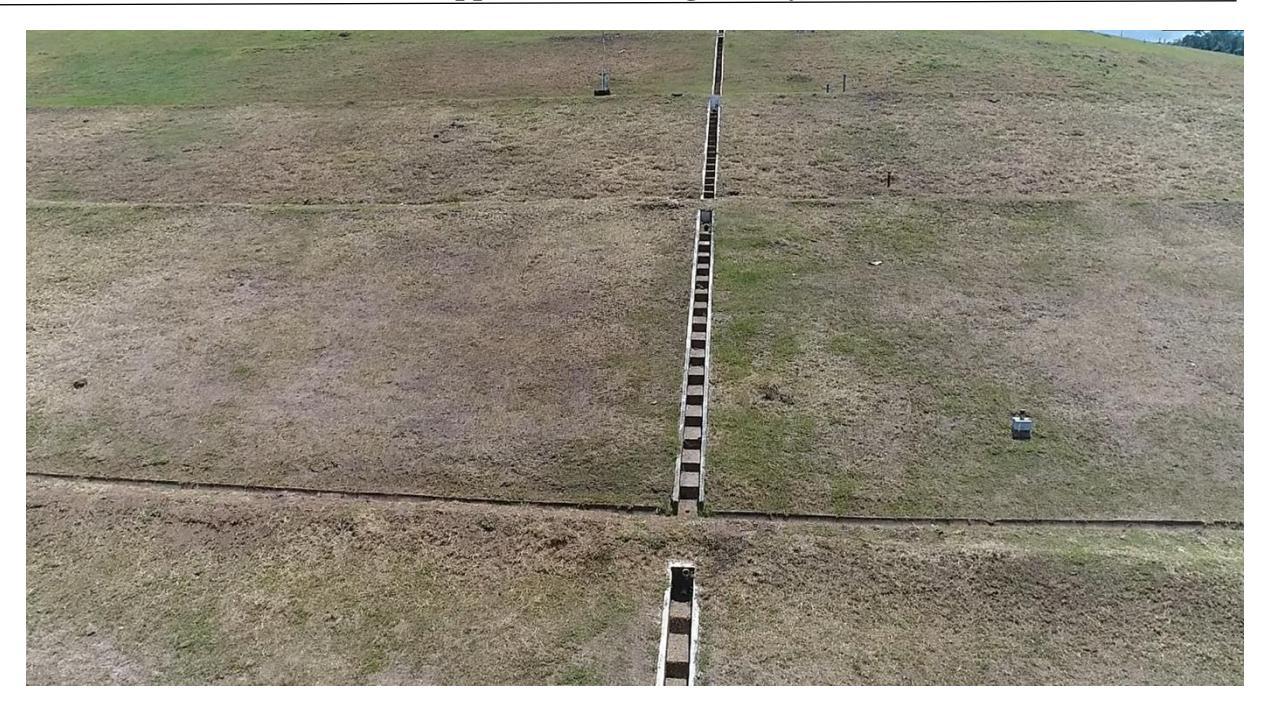
Figure 86: Drone Footage at 01:48 of Video DJI_0143.mov Showing a Rough Morphology in Central Part of Dam

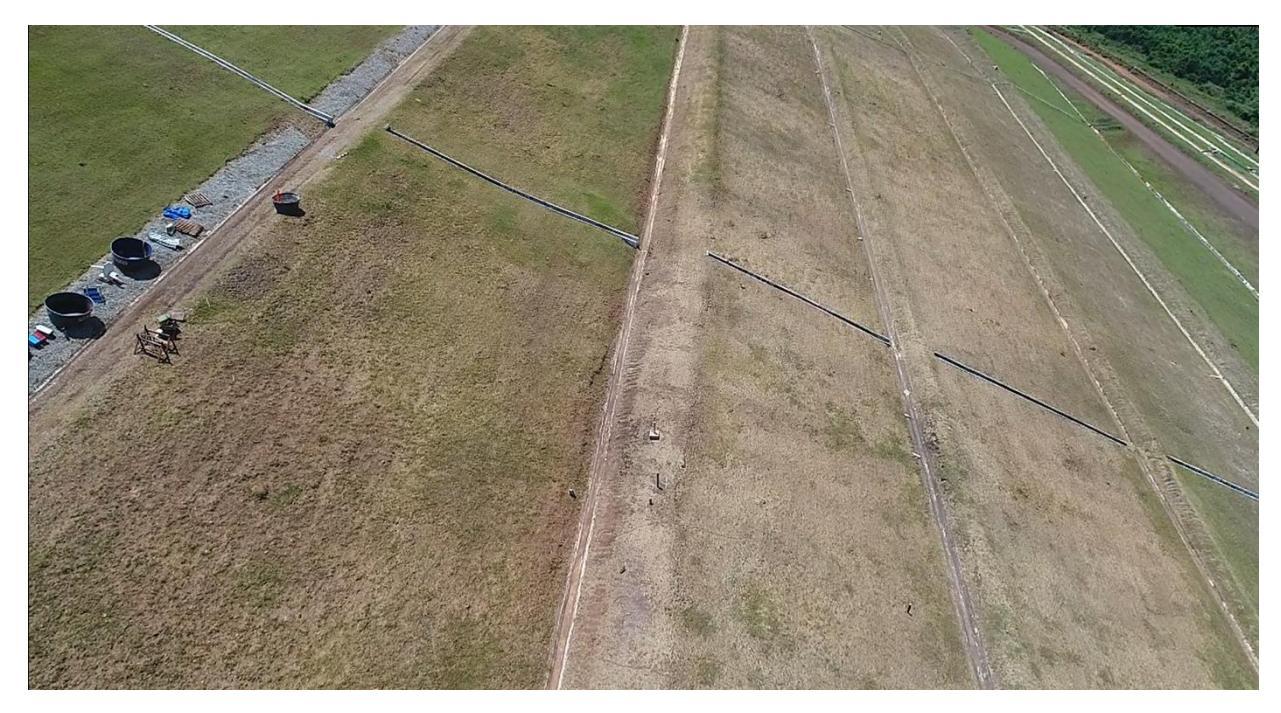
- Instability evidences: There were no sign of cracks, trenches, or any clear evidence of ongoing instabilities. On the Seventh Raising, a linear feature, a few meters long, was identified (Figure 87). This feature appears to be local settlement of fill related to the construction of the adjacent concrete drainage channel.

Figure 87: Drone Footage at 09:30 of Video DJI_0142.mov Showing a Linear Feature Parallel to Bottom of Seventh Raising
