## **3D Computer Model Development**

**December 2019**

**Report of the Expert Panel on the Technical Causes of the Failure of Feijão Dam I**  
**Appendix F – 3D Computer Model Development**

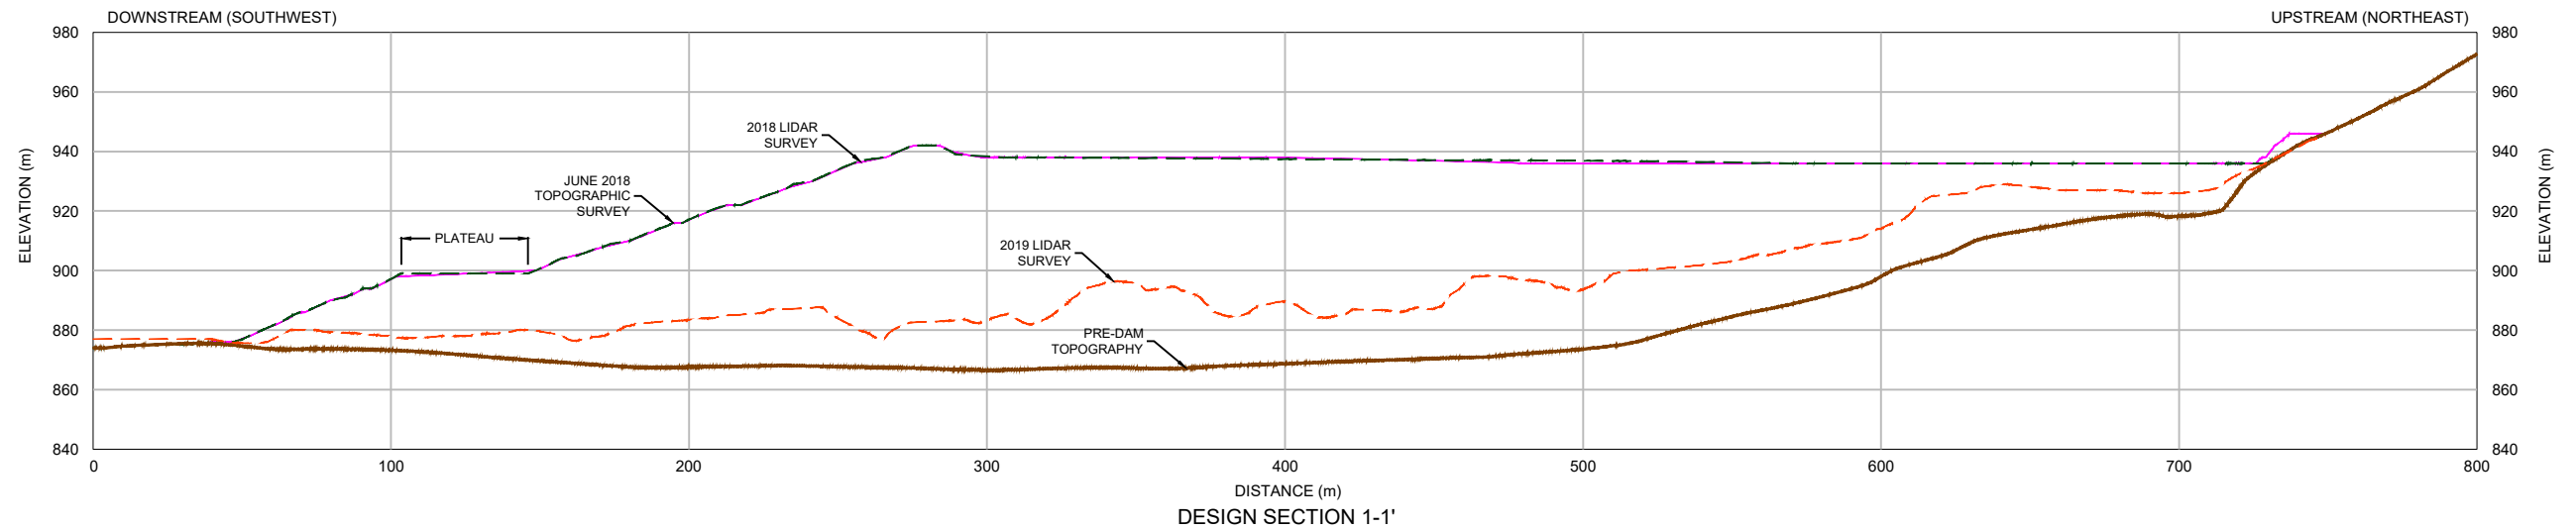
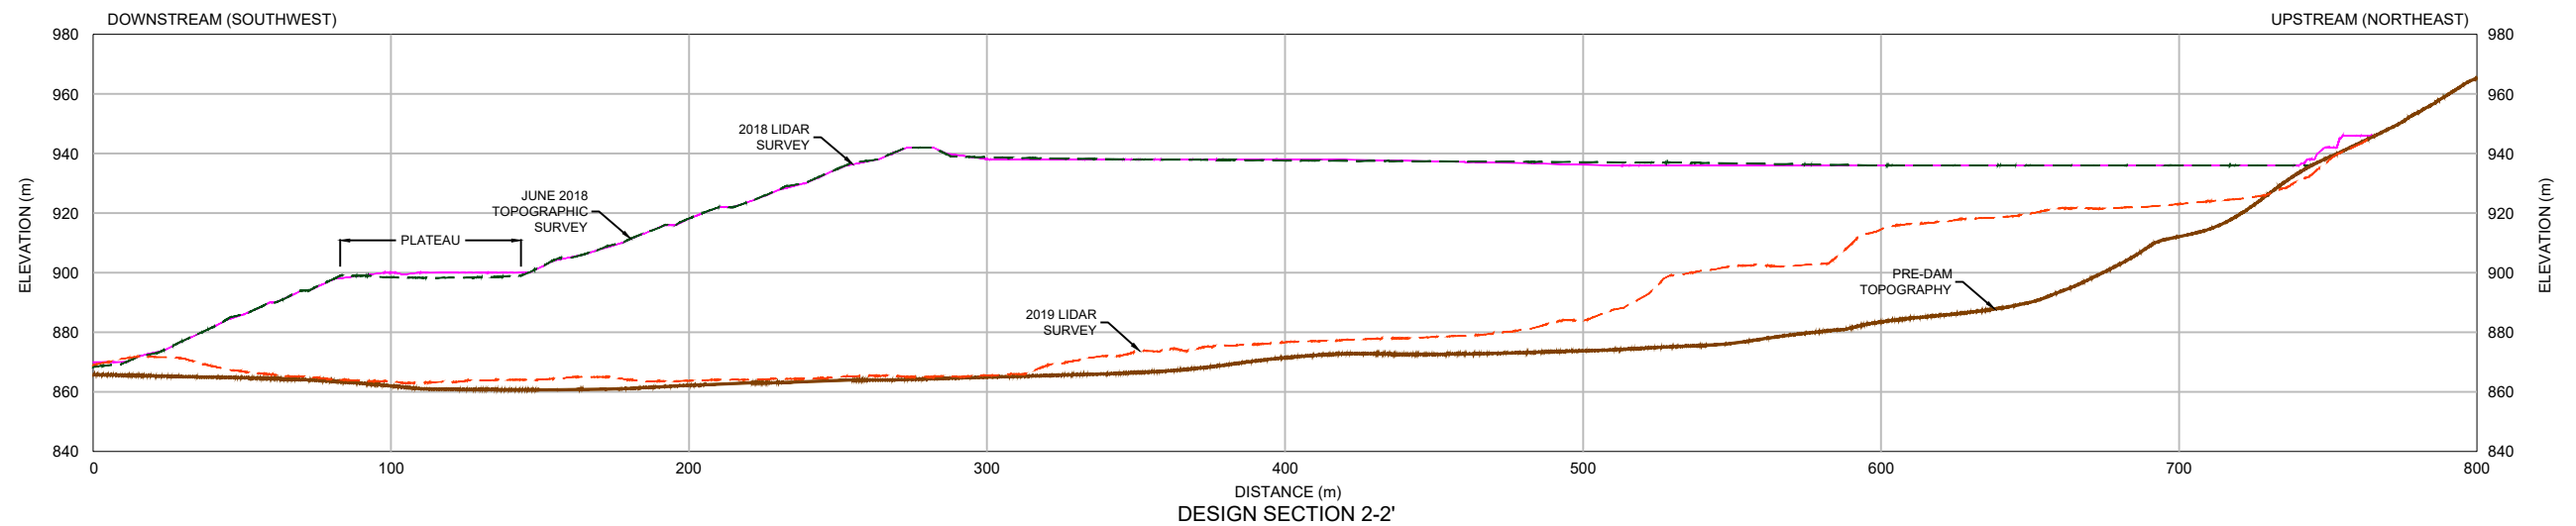
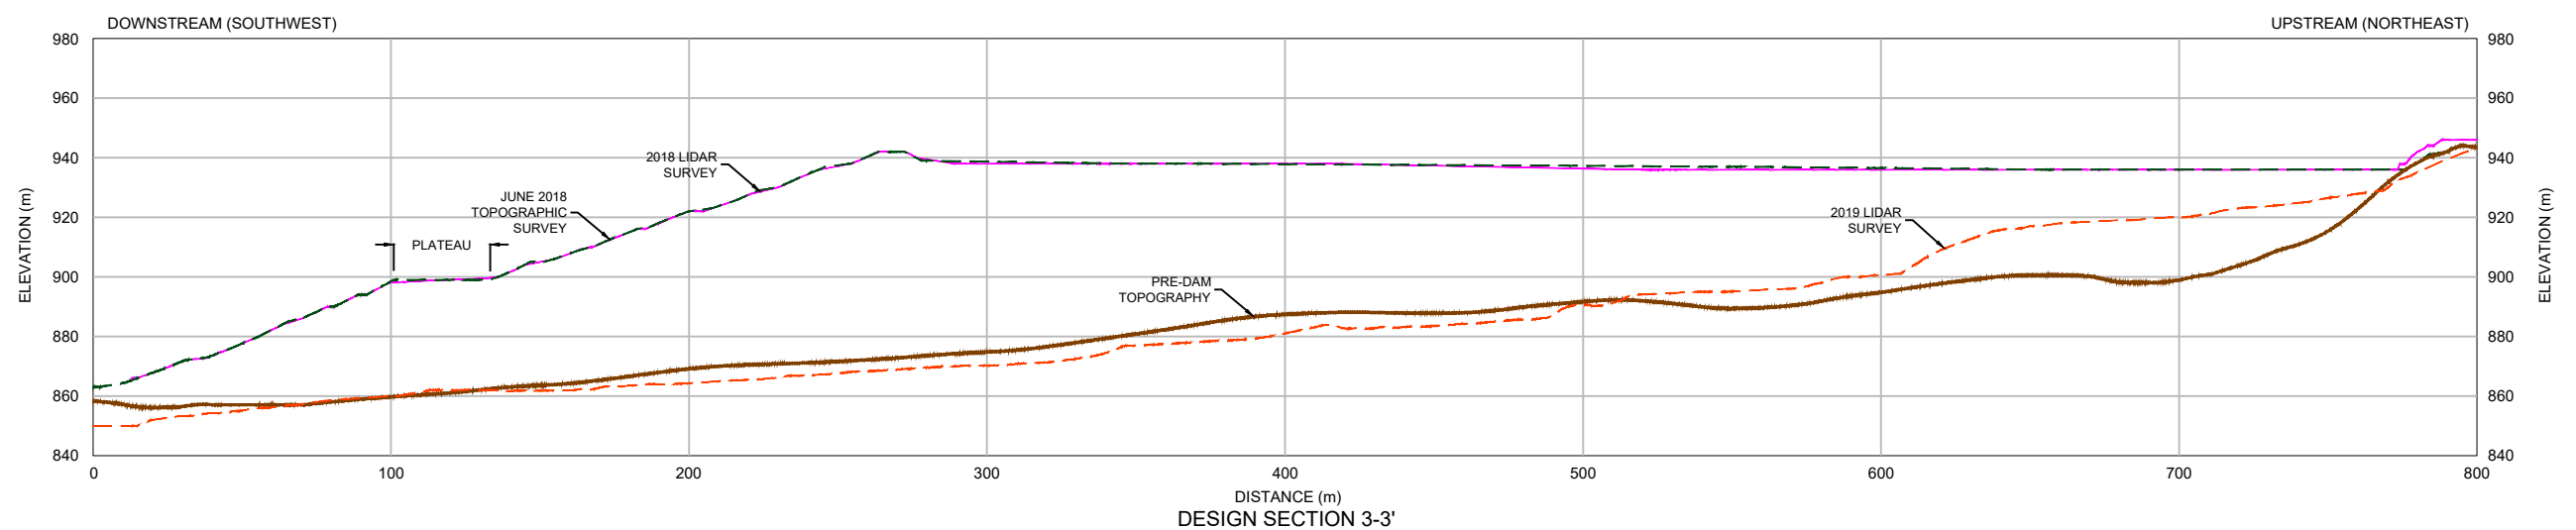
SCALE	PROJECT No.	FIG. No.
1:3,000	A03355A01	1

A summary of the topographic surveys used as part of the 3D computer model development is provided in Table 2. Figure 1 in Annex 1 provides a plan view of the Dam I design sections (1-1', 2-2' and 3-3') used to develop the 2D sections. Figure 2 of Annex 1 provides a profile view through Dam I at each of the three design sections shown in Figure 1.
