Appendix G

Seepage Analysis

December 2019

Report of the Expert Panel on the Technical Causes of the Failure of Feijão Dam I
Appendix G – Seepage Analysis

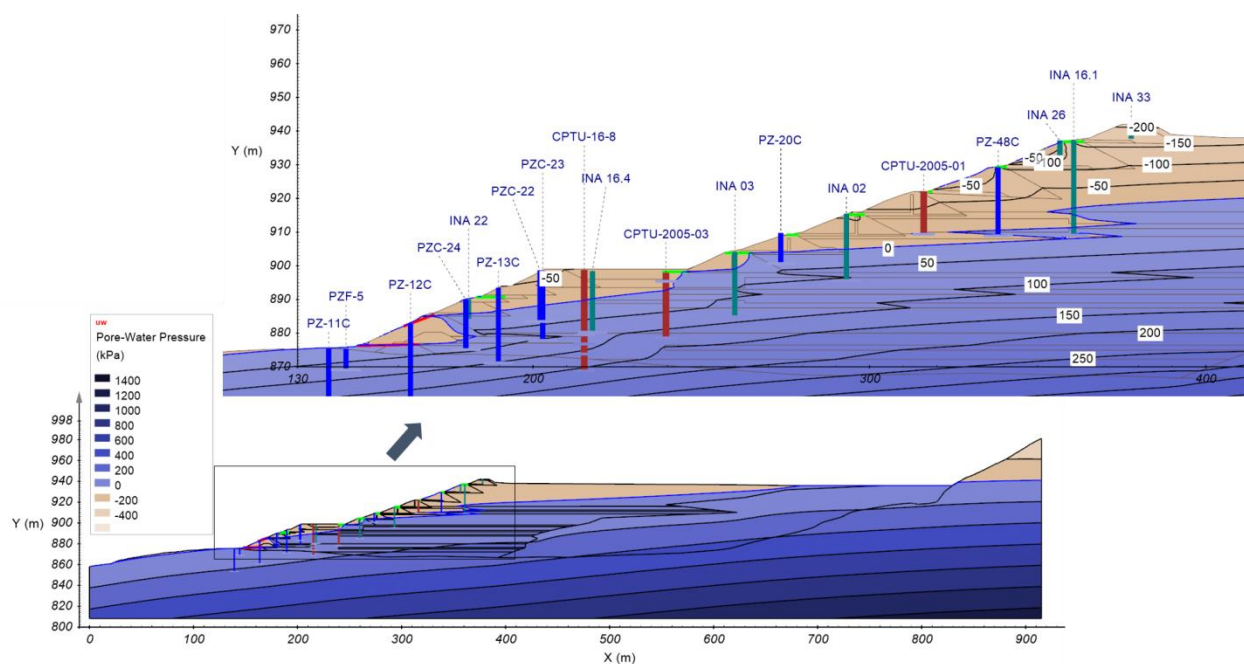
Figure 28: Calibration to Groundwater Flow for Cross-section 1-1

The results of the calibration for cross-section 1-1 can be seen in Figure 28. The pond boundary condition was set 300 m back from the crest of the top berm as an approximation of the 3D pond location. Numerical models with $k_h/k_v = 5$ and 10 were analyzed, and the best calibration was obtained with a $k_h/k_v = 5$. A foundation permeability of 9.3×10^{-7} m/s provided the best calibration. The INA heads measured are overlain on the model with a light blue line. The pressures measured in the piezometers and CPTu instruments are represented with a horizontal line that is colored the same color scheme as the pore water pressure contour color scheme. This display allows visual identification of the consistency between field and model results all displayed in terms of pressure units in kPa.

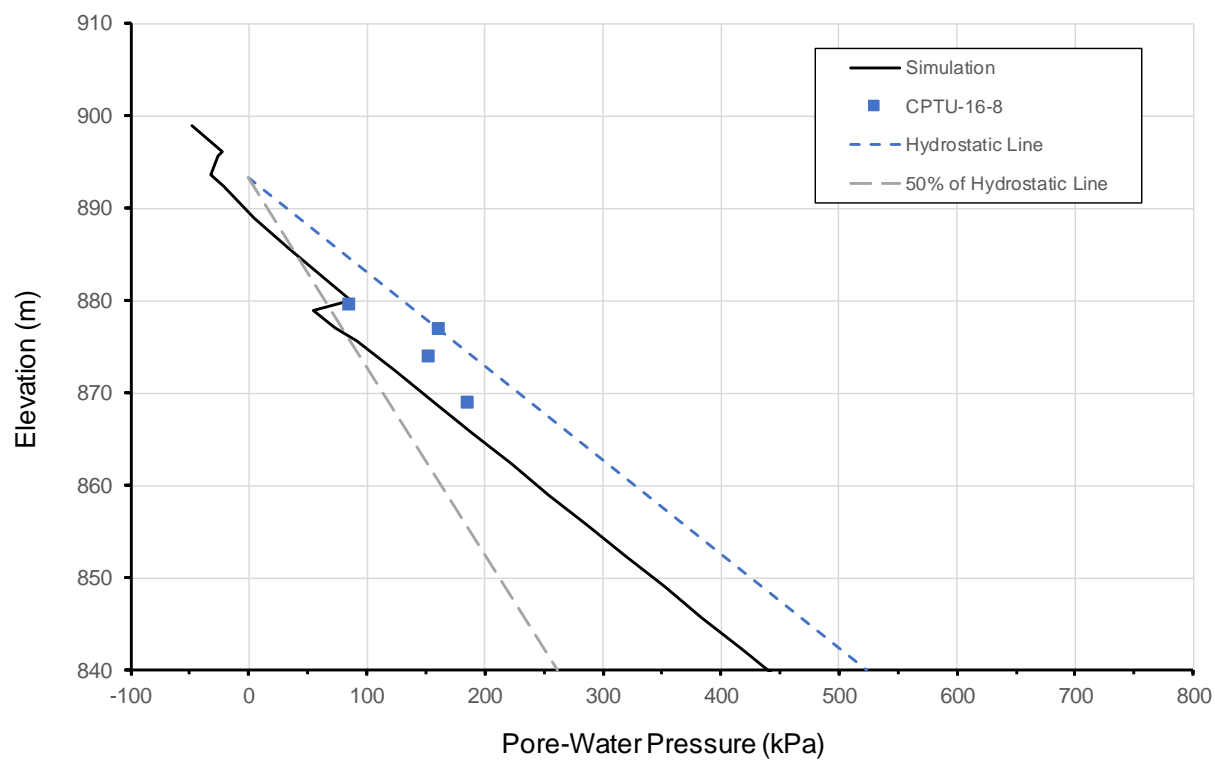
Figure 30: Example Calibration to CPTu Data on Cross-section 1-1

The location of the CPTu instruments utilized in the calibration for cross-section 1-1 can be seen in Figure 29. The comparison of model results plotted against CPTu provided reasonable collaboration with the measured data as shown in Figure 30.

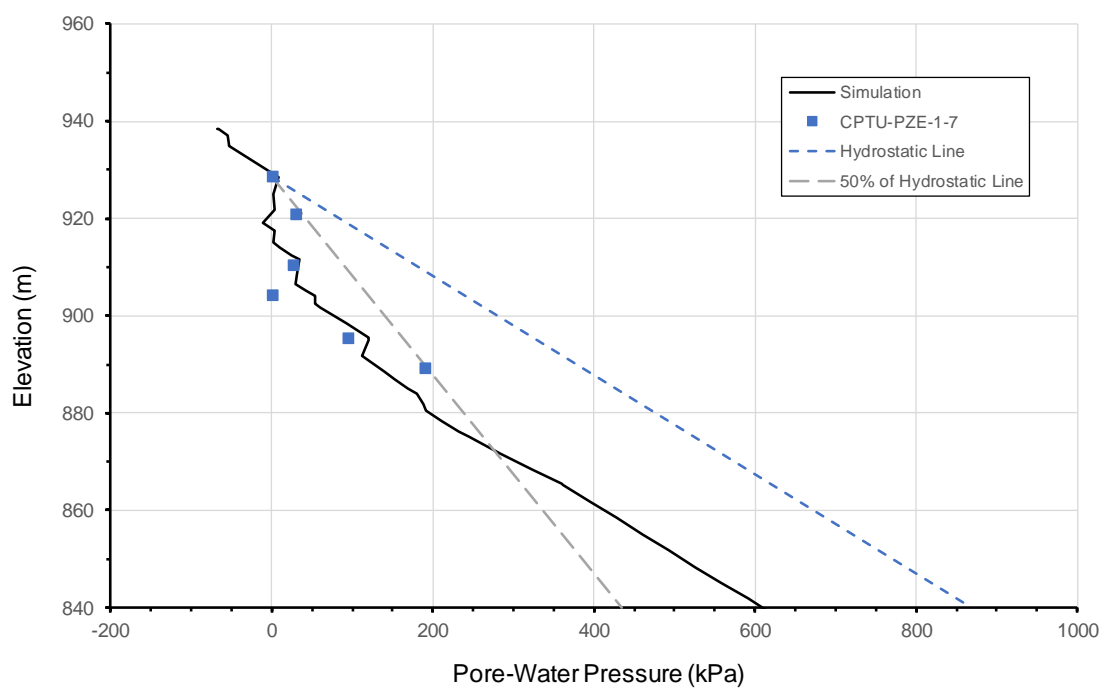
Figure 35: Example CPTu Profile and Comparison to Seepage Pore Water Pressure Results

example calibration can be seen in Figure 35. Some discrepancy with the data was noted that was primarily due to variations between the field and model water table. Overall the alignment of CPTu data with the model results was better when $k_h/k_v = 5$ for the coefficient of permeability was utilized.

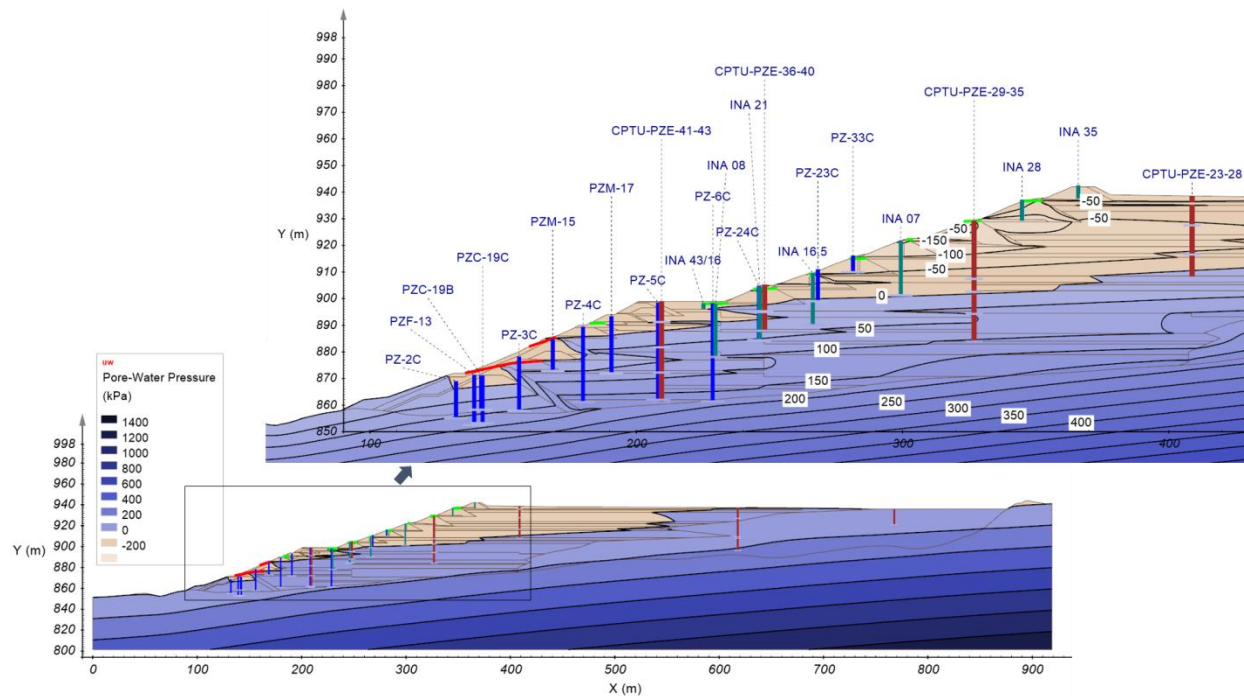
Figure 38: Calibration to Groundwater Flow for Cross-section 3-3

The calibrated model is shown in Figure 38. The water table is high at Elevation 900 m msl, and the drains assumed to have been installed in the Second Raising allow for a reasonable calibration to field data below 900 m msl. A water table higher than the one calculated would provide a slightly better fit to the data behind the dam crest berm, but the layering of coarse and fine materials and the related coefficient of permeabilities dictate the location of the water table.

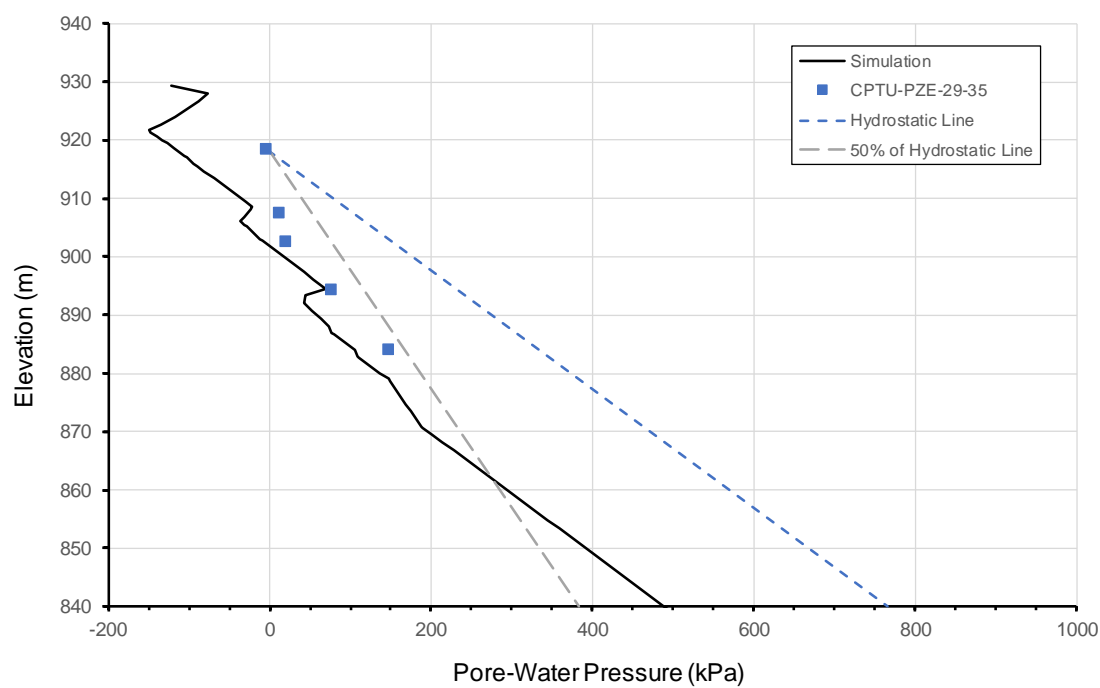
Figure 40: Example Calibration to CPTu Data on Cross-section 3-3

Six CPTu profiles were used to calibrate the model, and their locations are shown in Figure 39. The CPTu data calibrated well with measured values (see example in Figure 40) and confirmed the initial estimate of the pore water pressures being at about 50% of hydrostatic values. The effect of the fine/coarse layering can be seen in the pore water pressure profile results.

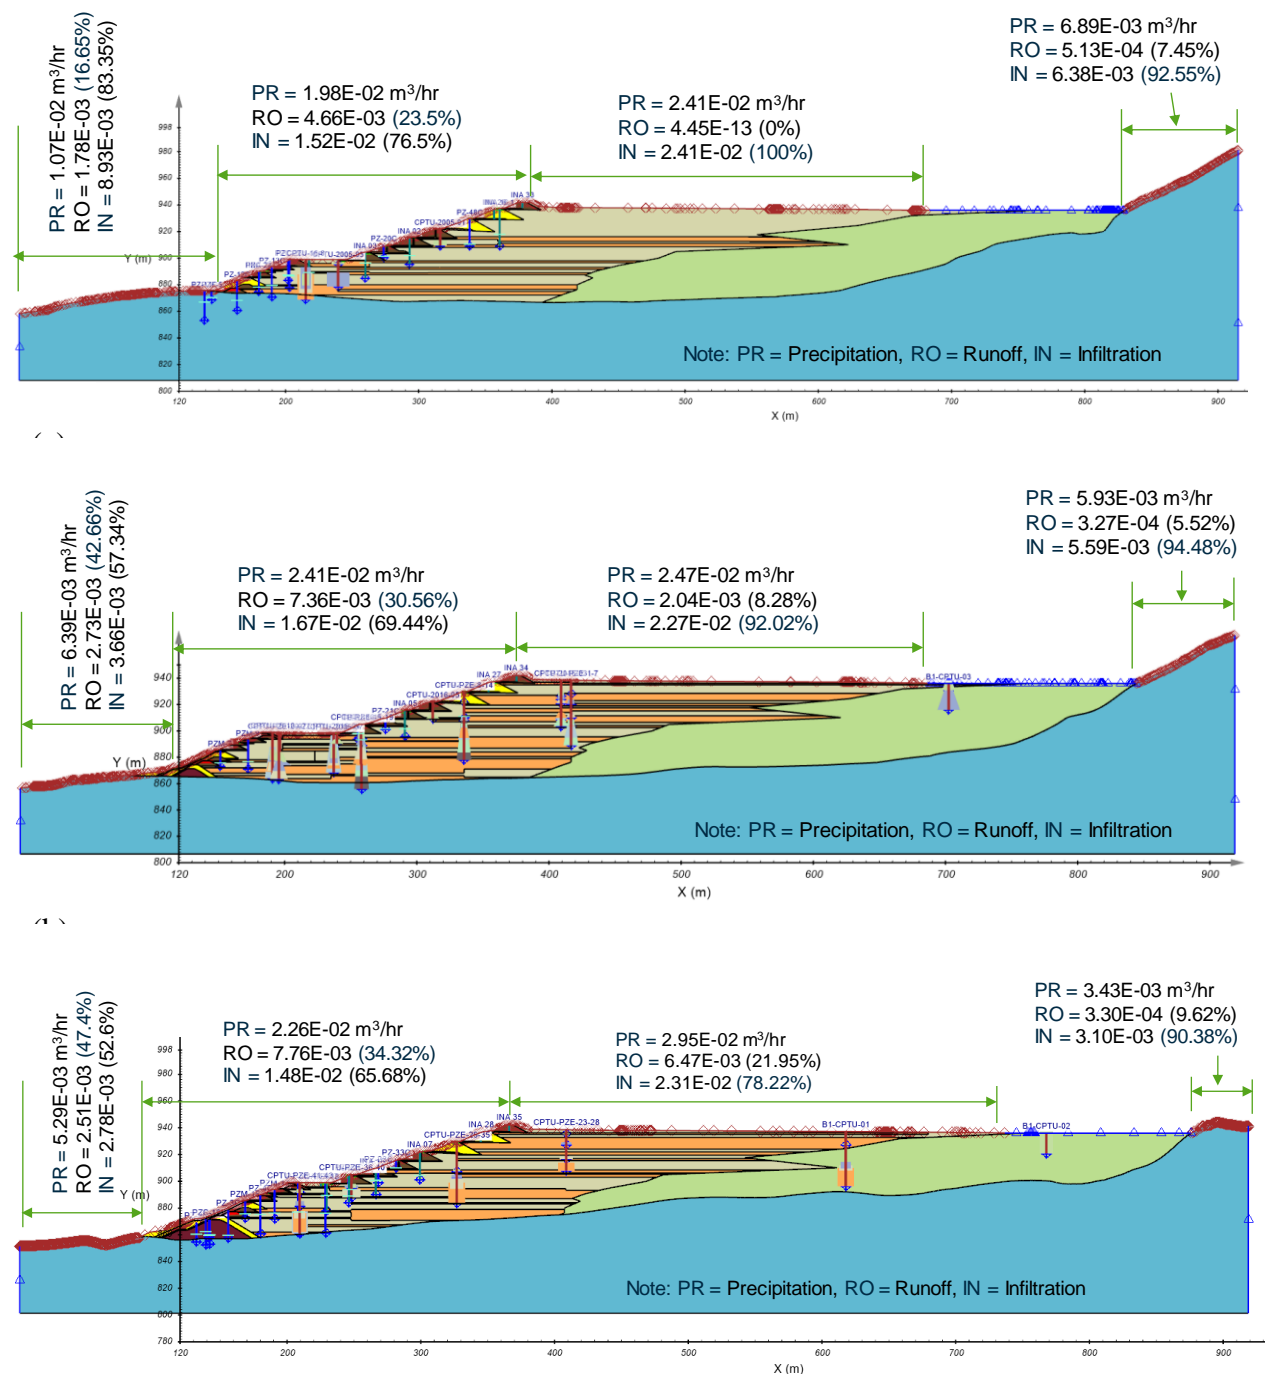
Figure 42: Summary of Climate Water Balance (With 50% Rainfall): (a) Cross-section 1-1; (b) Cross-section 2-2; and (c) Cross-section 3-3

The amount of infiltration that enters the model on the tailings beach is dependent on the material near the surface. In cross-section 1-1, the top surface is comprised entirely of coarse tailings and therefore 100% of applied flow enters the model, as shown in Figure 42. In cross-section 2-2, the runoff is 8.2% and in cross-section 3-3, the runoff is 22%.

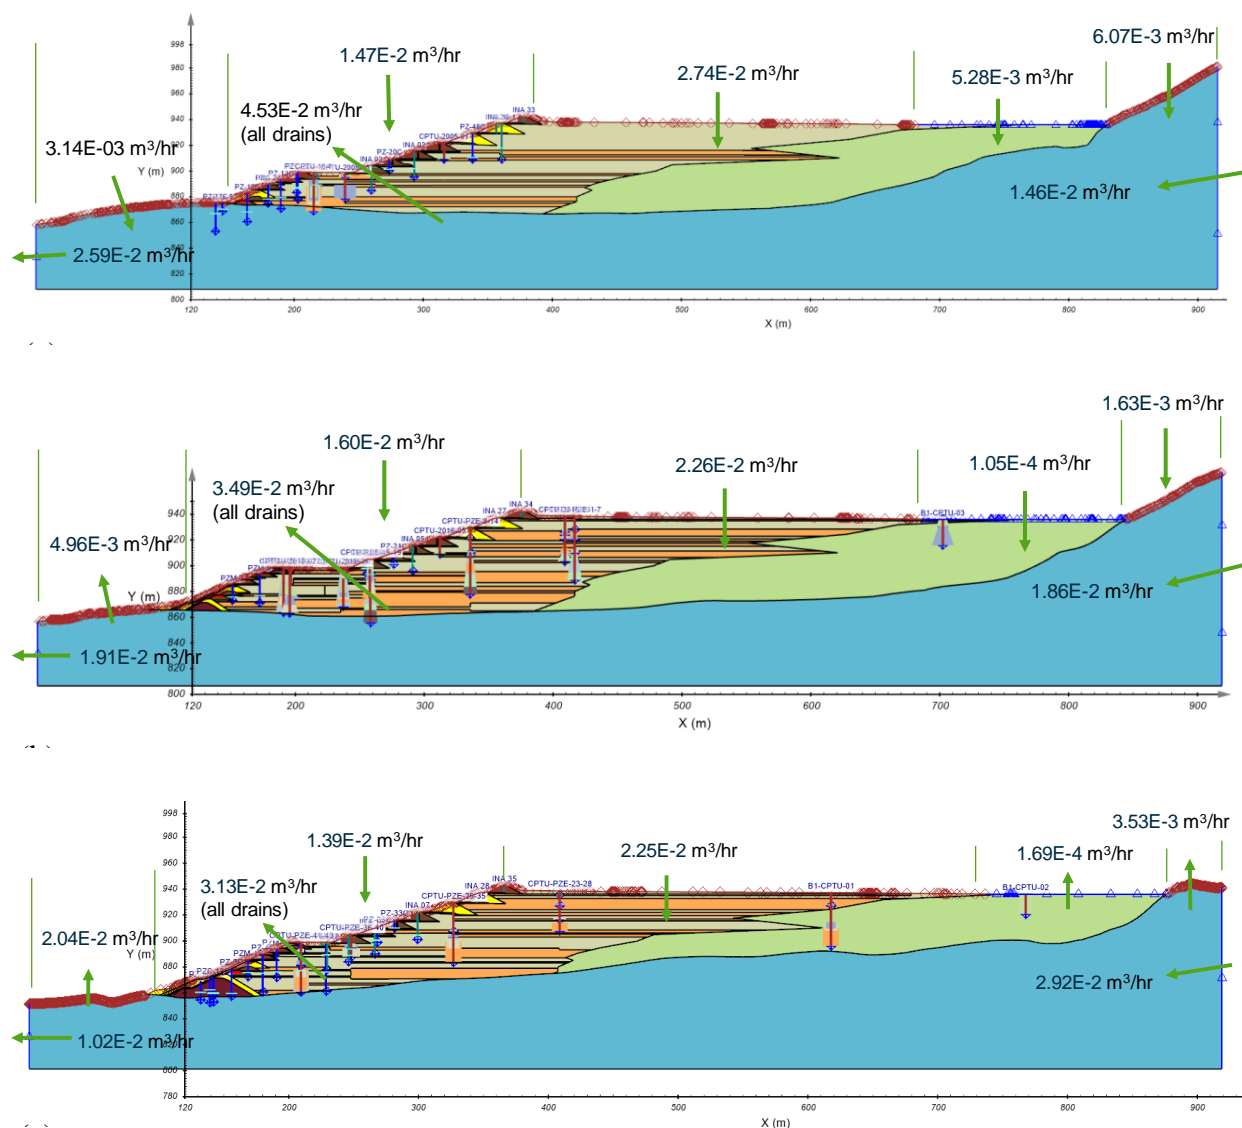
Figure 43: Summary of Water Balance: (a) Cross-section 1-1; (b) Cross-section 2-2; and (c) Cross-section 3-3

The majority of flow leaving the system is through the drains installed in the dam structure or through the downstream foundation as shown in the water balance in Figure 43. The amount of

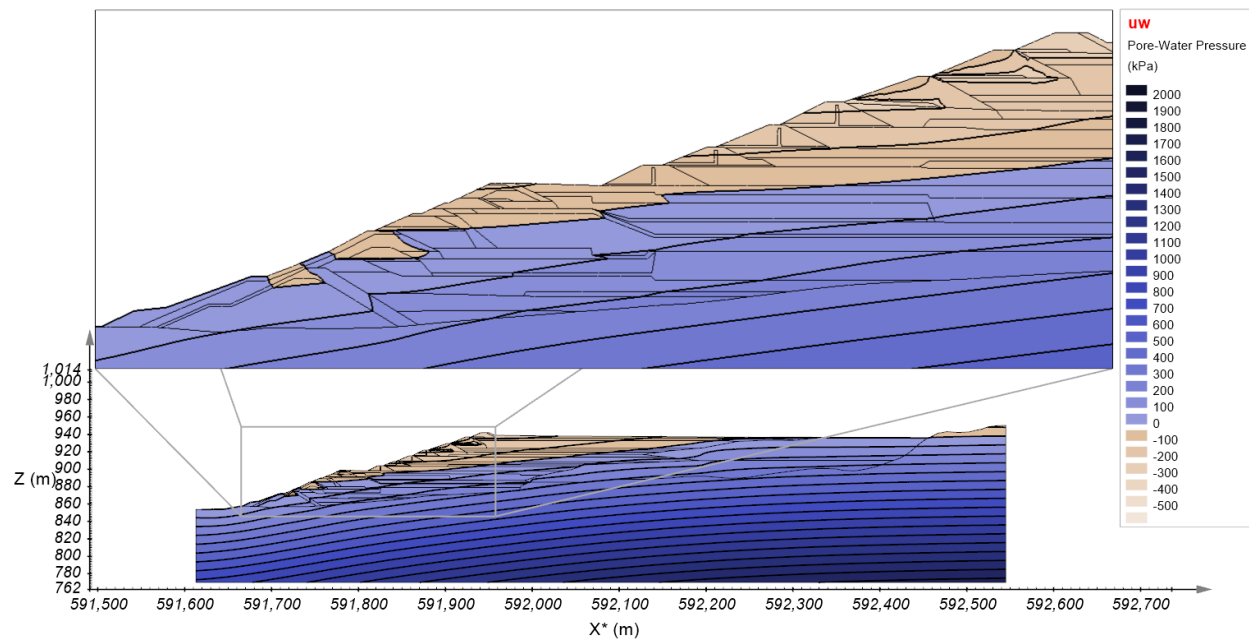
Figure 44: Display of Water Table in 3D Model Along Cross-section 3-3

The results of the model are demonstrated in Figure 44 and Figure 45. A large beach length was formed on the tailings surface, and the water table daylights only on the Second and Third Raises. The water table is slightly lower (Figure 38) than the 2D counterpart. This was to be expected, given the difference in the location of the pond between the 2D and 3D models. The calibration of the existing model was good as shown in Figure 45.

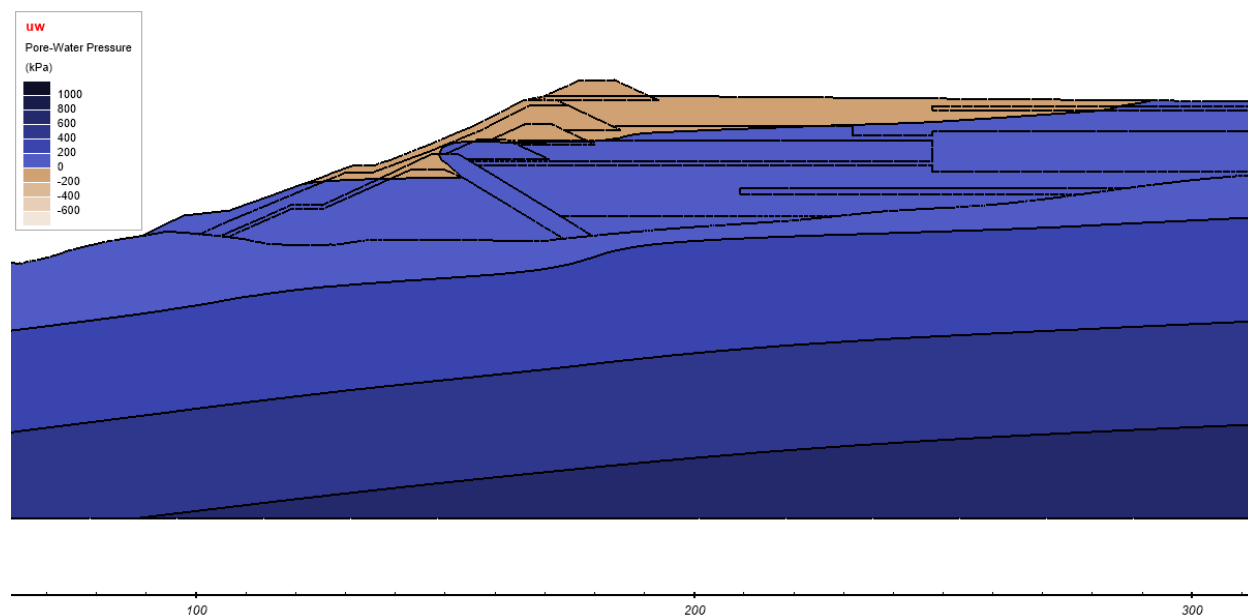
Figure 50: Pore Water Pressure Profile at Construction Stage 5 With Saturated Material Properties in a 2D Analysis

The water level in Figure 49 is slightly lower when compared to the water level from a 2D analysis for cross-section 3-3 (Figure 50). The difference in the results can be attributed to the unsaturated material properties used for 2D analysis.
